## Profile/Photo Observation Report

| Street: | <b>LINCOLN ST</b> | Flow Control: | <b>Not Controlled</b> |
| City: | <b>Hobart, IN</b> | Year Renewed: | |

| US MH: | <b>M-707-021</b> | DS MH: | <b>M-707-020</b> |

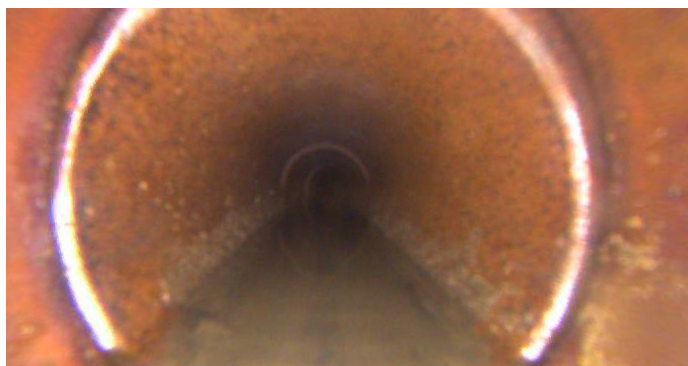
Code: **AMH**  
 Description: **Manhole**

Distance (ft): **.0**  
 Structural Grade: **0**  
 O&M Grade: **0**  
 Clock Start/From:  
 Clock To:  
 1st Value:  
 2nd Value:  
 Value Percent:  
 Continuous Index:  
 Within 8" of Joint: **NO**  
 Remarks: **M-707-021**

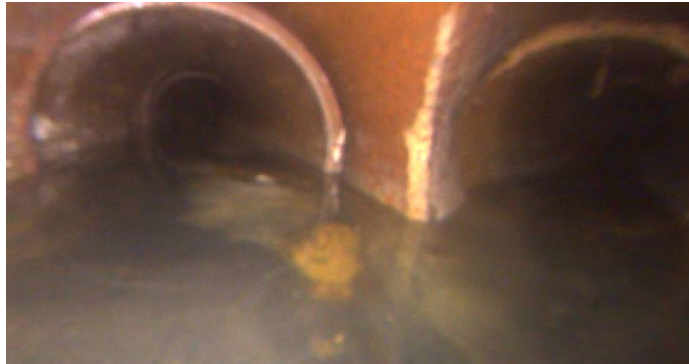
| Code: | <b>TF</b> |
| Description: | <b>Tap Factory</b> |
| Distance (ft): | <b>24.5</b> |

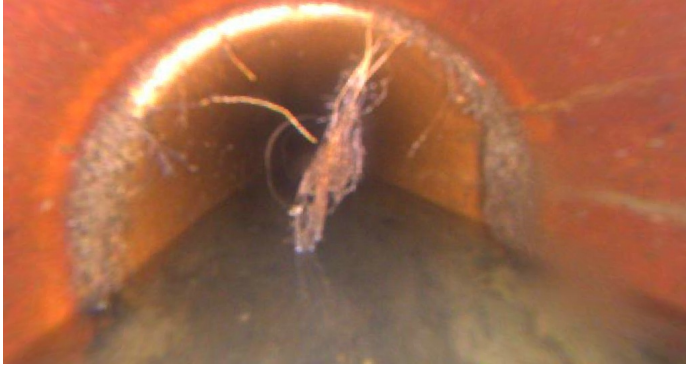
Code: **RFJ**  
Description: **Roots Fine Joint**

Distance (ft): **69.3**  
Structural Grade: **0**  
O&M Grade: **1**  
Clock Start/From: **7**  
Clock To: **5**  
1st Value:  
2nd Value:  
Value Percent:  
Continuous Index:  
Within 8" of Joint: **YES**  
Remarks:

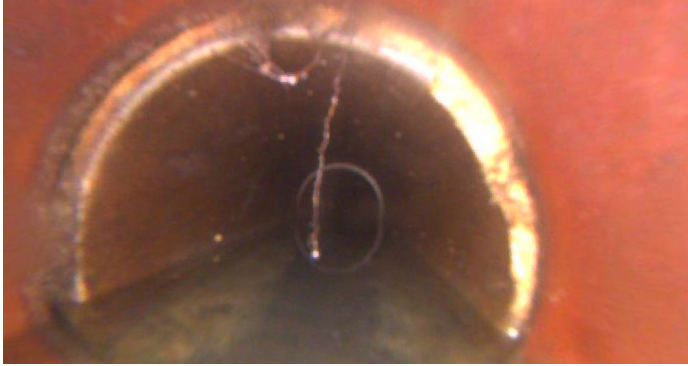
Code: **RFJ**  
Description: **Roots Fine Joint**

Distance (ft): **77.5**  
Structural Grade: **0**  
O&M Grade: **1**  
Clock Start/From: **12**  
Clock To:  
1st Value:  
2nd Value:  
Value Percent:  
Continuous Index:  
Within 8" of Joint: **YES**  
Remarks:

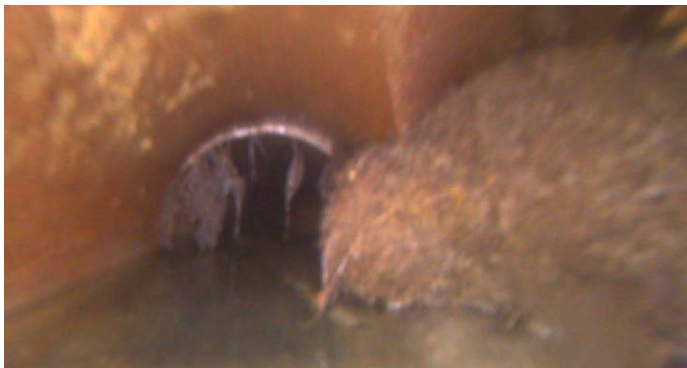
Code: **RML**  
Description: **Roots Medium Lateral**

Distance (ft): **83.0**  
Structural Grade: **0**  
O&M Grade: **3**  
Clock Start/From: **4**  
Clock To:  
1st Value:  
2nd Value:  
Value Percent: **20.000**  
Continuous Index:  
Within 8" of Joint: **NO**  
Remarks:

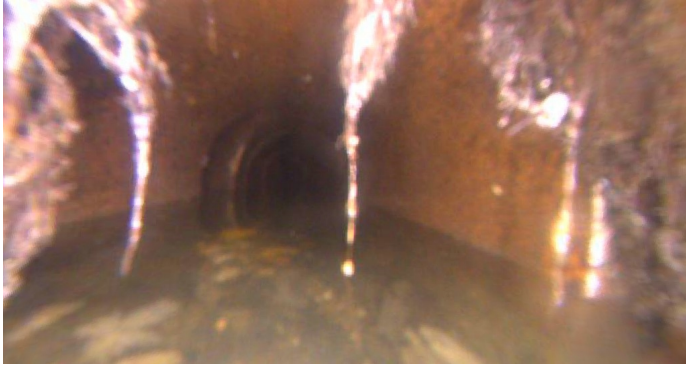
Code: **RFJ**  
Description: **Roots Fine Joint**

Distance (ft): **83.8**  
Structural Grade: **0**  
O&M Grade: **1**  
Clock Start/From: **7**  
Clock To: **5**  
1st Value:  
2nd Value:  
Value Percent:  
Continuous Index: **S01**  
Within 8" of Joint: **YES**  
Remarks:

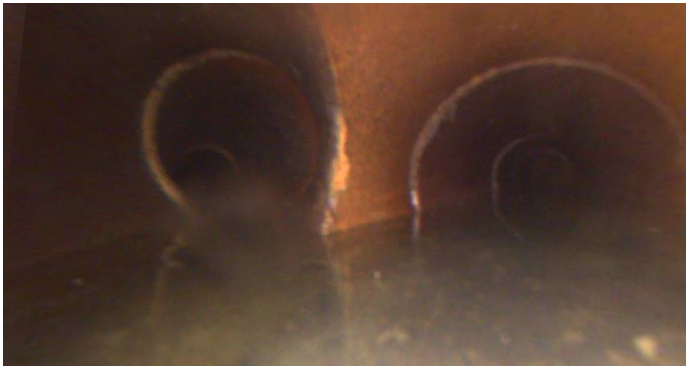
Code: **TF**  
Description: **Tap Factory**

Distance (ft): **85.0**  
Structural Grade: **0**  
O&M Grade: **0**  
Clock Start/From: **8**  
Clock To:  
1st Value: **4.000**  
2nd Value:  
Value Percent:  
Continuous Index:  
Within 8" of Joint:  
Remarks:

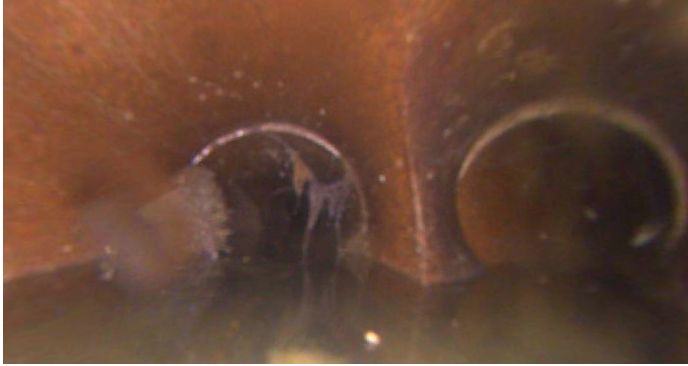
Code: **TF**  
Description: **Tap Factory**

Distance (ft): **135.0**  
Structural Grade: **0**  
O&M Grade: **0**  
Clock Start/From: **4**  
Clock To:  
1st Value: **4.000**  
2nd Value:  
Value Percent:  
Continuous Index:  
Within 8" of Joint:  
Remarks:
