## Profile/Photo Observation Report

Date:	<b>04/09/2018</b>	Weather:		Coding:	<b>PACP 6.0</b>
Pipe Length (ft):	<b>250.8</b>	Owner:	<b>NA</b>	Pre Clean:	<b>Not Known</b>
P.O.#:		Surveyor:	<b>Mark Ruby</b>	PSR:	<b>P-707-020-021</b>
Customer:		Clean Date:	<b>01/01/1900</b>	Shape:	<b>C</b>

Street:	<b>Capitol</b>	Flow Control:	<b>Not Controlled</b>
City:	<b>Hobart, IN</b>	Year Renewed:	
Location:	<b>Light Highway</b>	Tape/Media #:	
Purpose:	<b>Maintenance Related</b>	Dia/Height:	<b>8"</b>
Use:	<b>Sanitary</b>	Material:	<b>VCP</b>
Drain Area:	<b>NA</b>	Lining:	<b>Cured in Place</b>
Category:	<b>NA</b>		
Comment:

Location Details:		Direction of Survey:	<b>Downstream</b>
US MH:	<b>M-707-021</b>	DS MH:	<b>M-707-020</b>
		Total Length Surveyed (ft):	<b>137.5</b>

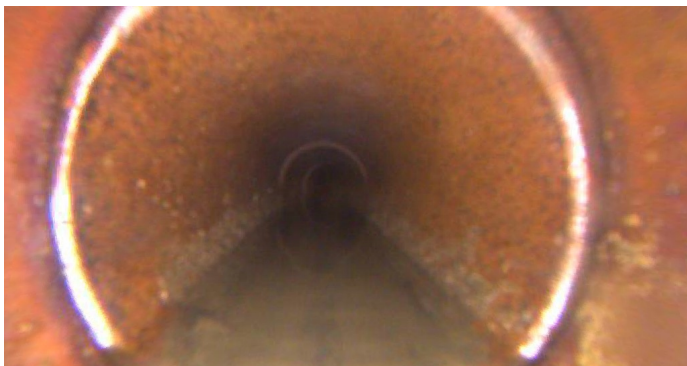
Code: **AMH**  
 Description: **Manhole**

Distance (ft): **.0**  
 Structural Grade: **0**  
 O&M Grade: **0**  
 Clock Start/From:  
 Clock To:  
 1st Value:  
 2nd Value:  
 Value Percent:  
 Continuous Index:  
 Within 8" of Joint: **NO**  
 Remarks: **M-707-021**

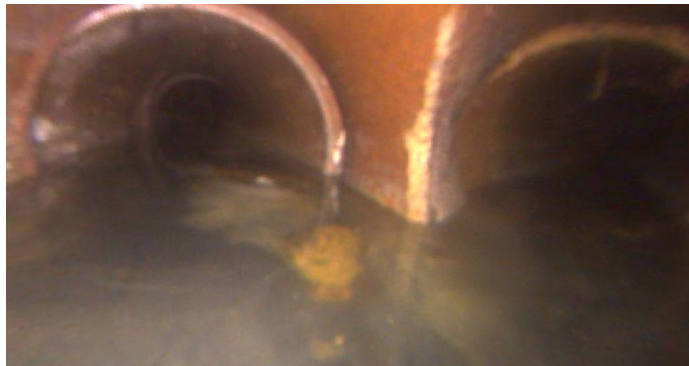
Code: **TF**  
Description: **Tap Factory**

Distance (ft): **24.5**  
Structural Grade: **0**  
O&M Grade: **0**  
Clock Start/From: **5**  
Clock To:  
1st Value: **4.000**  
2nd Value:  
Value Percent:  
Continuous Index:  
Within 8" of Joint:  
Remarks:

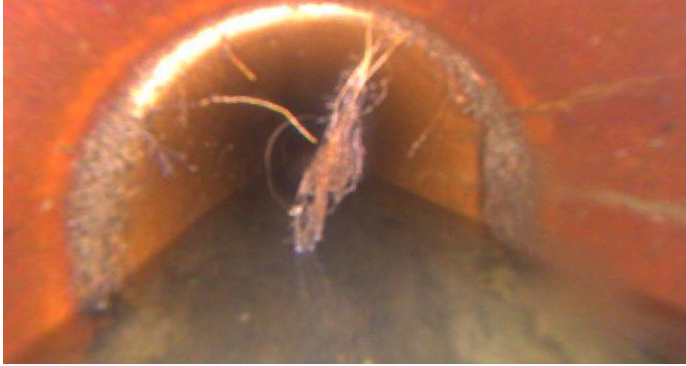
Code: **RFJ**  
Description: **Roots Fine Joint**

Distance (ft): **69.3**  
Structural Grade: **0**  
O&M Grade: **1**  
Clock Start/From: **7**  
Clock To: **5**  
1st Value:  
2nd Value:  
Value Percent:  
Continuous Index:  
Within 8" of Joint: **YES**  
Remarks:

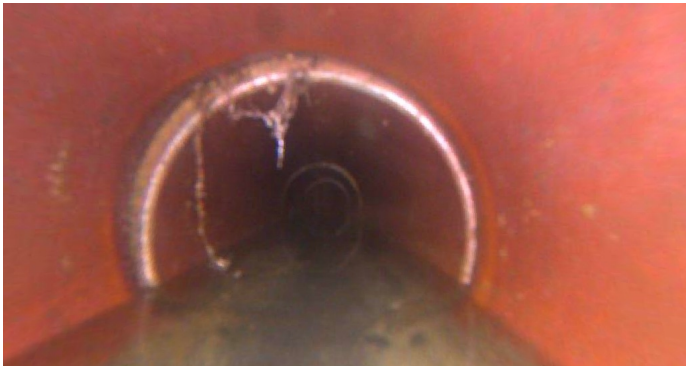
Code: **RFJ**  
Description: **Roots Fine Joint**

Distance (ft): **75.3**  
Structural Grade: **0**  
O&M Grade: **1**  
Clock Start/From: **10**  
Clock To:  
1st Value:  
2nd Value:  
Value Percent:  
Continuous Index:  
Within 8" of Joint: **YES**  
Remarks:

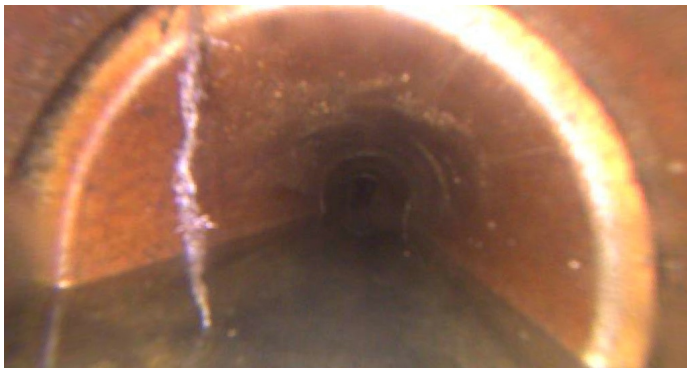
Code: **RFJ**  
Description: **Roots Fine Joint**

Distance (ft): **79.6**  
Structural Grade: **0**  
O&M Grade: **1**  
Clock Start/From: **10**  
Clock To:  
1st Value:  
2nd Value:  
Value Percent:  
Continuous Index:  
Within 8" of Joint: **YES**  
Remarks:

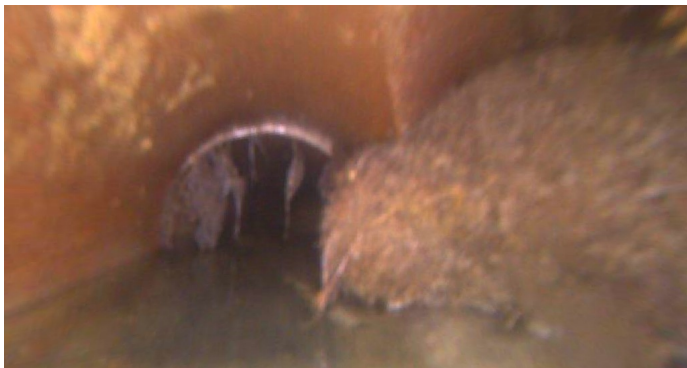
Code: **RML**  
Description: **Roots Medium Lateral**

Distance (ft): **83.0**  
Structural Grade: **0**  
O&M Grade: **3**  
Clock Start/From: **4**  
Clock To:  
1st Value:  
2nd Value:  
Value Percent: **20.000**  
Continuous Index:  
Within 8" of Joint: **NO**  
Remarks:

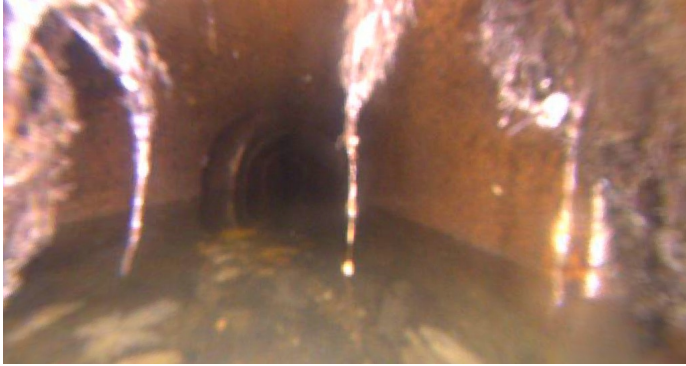
Code: **RFJ**  
Description: **Roots Fine Joint**

Distance (ft): **83.8**  
Structural Grade: **0**  
O&M Grade: **1**  
Clock Start/From: **7**  
Clock To: **5**  
1st Value:  
2nd Value:  
Value Percent:  
Continuous Index: **S01**  
Within 8" of Joint: **YES**  
Remarks:

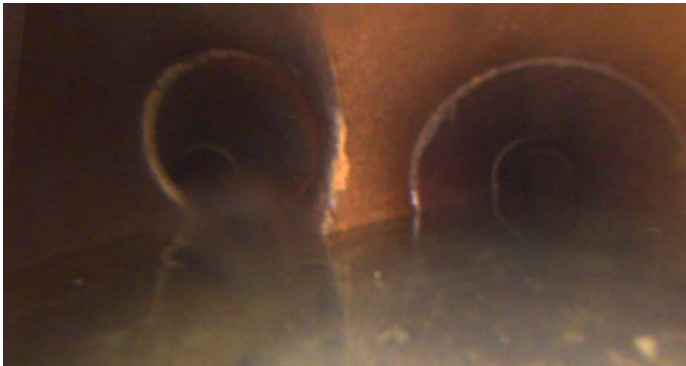
Code: **TF**  
Description: **Tap Factory**

Distance (ft): **85.0**  
Structural Grade: **0**  
O&M Grade: **0**  
Clock Start/From: **8**  
Clock To:  
1st Value: **4.000**  
2nd Value:  
Value Percent:  
Continuous Index:  
Within 8" of Joint:  
Remarks:

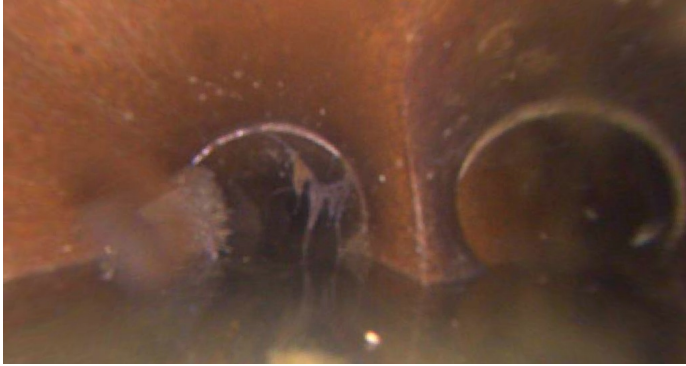
Code: **TF**  
Description: **Tap Factory**

Distance (ft): **135.0**  
Structural Grade: **0**  
O&M Grade: **0**  
Clock Start/From: **4**  
Clock To:  
1st Value: **4.000**  
2nd Value:  
Value Percent:  
Continuous Index:  
Within 8" of Joint:  
Remarks:
