Profile/Photo Observation Report

Street:	E 13TH ST	Flow Control:	Not Controlled
City:	Hobart, IN	Year Renewed:	
Location:	Light Highway	Tape/Media #:	
Purpose:	Maintenance Related	Dia/Height:	8"
Use:	Sanitary	Material:	VCP
Drain Area:	NA	Lining:	Cured in Place
Category:	NA		
Comment:

Location Details:		Direction of Survey:	Downstream
US MH:	M-707-023	DS MH:	M-707-024
		Total Length Surveyed (ft):	268.0

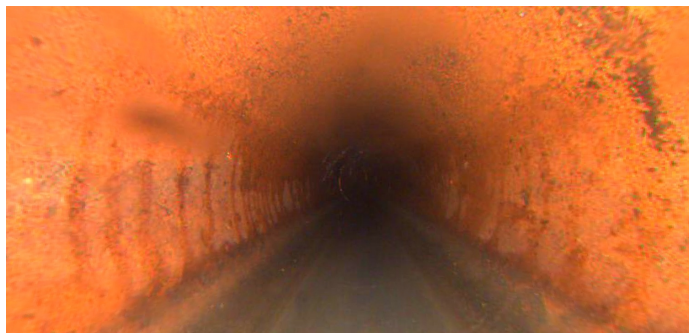
Code: **AMH**
 Description: **Manhole**
 Distance (ft): **.0**
 Structural Grade: **0**
 O&M Grade: **0**
 Clock Start/From:
 Clock To:
 1st Value:
 2nd Value:
 Value Percent:
 Continuous Index:
 Within 8" of Joint: **NO**
 Remarks: **M-707-023**

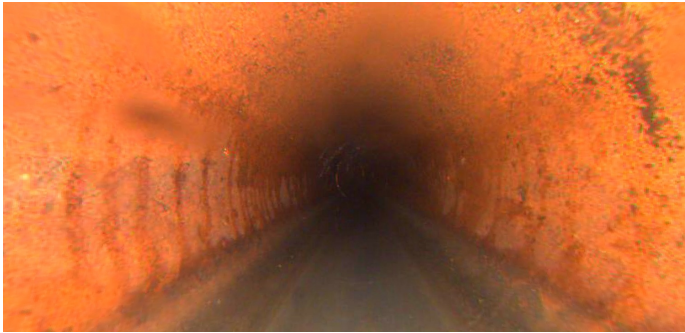
Code:	MWL
Description:	Water Level

Distance (ft):	.0
Structural Grade:	0
O&M Grade:	0
Clock Start/From:	
Clock To:	
1st Value:	
2nd Value:	
Value Percent:	10.000
Continuous Index:	
Within 8" of Joint:	NO
Remarks:

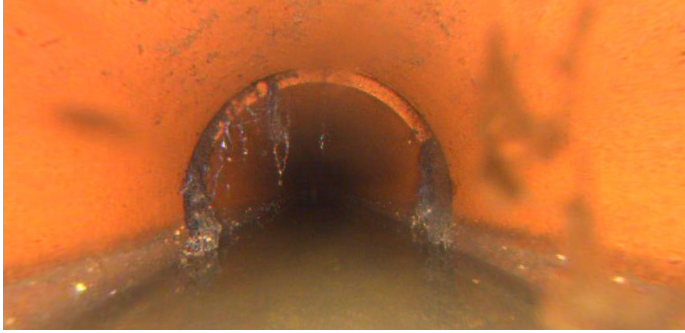
Code: **RMJ**
Description: **Roots Medium Joint**

Distance (ft): **85.3**
Structural Grade: **0**
O&M Grade: **3**
Clock Start/From: **8**
Clock To: **4**
1st Value:
2nd Value:
Value Percent: **5.000**
Continuous Index:
Within 8" of Joint: **YES**
Remarks:

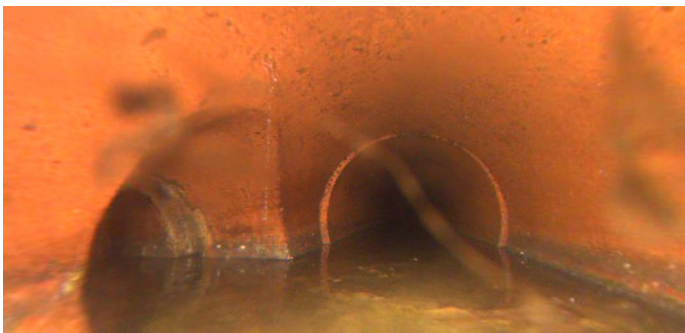
Code: **TFA**
Description: **Tap Factory Active**

Distance (ft): **97.2**
Structural Grade: **0**
O&M Grade: **0**
Clock Start/From: **9**
Clock To:
1st Value: **4.000**
2nd Value:
Value Percent:
Continuous Index:
Within 8" of Joint:
Remarks:

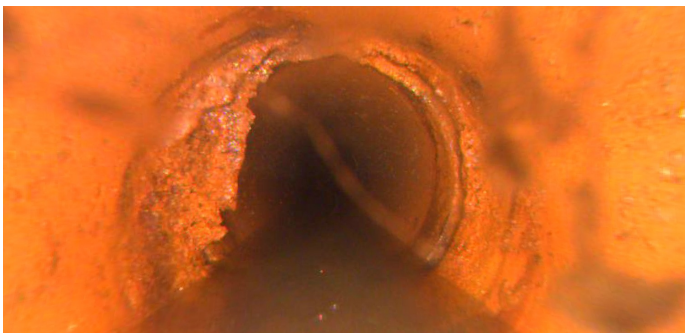
Code: **DAE**
Description: **Deposits Attached Encrustation**

Distance (ft): **143.3**
Structural Grade: **0**
O&M Grade: **3**
Clock Start/From: **8**
Clock To: **4**
1st Value:
2nd Value:
Value Percent: **15.000**
Continuous Index:
Within 8" of Joint: **YES**
Remarks:

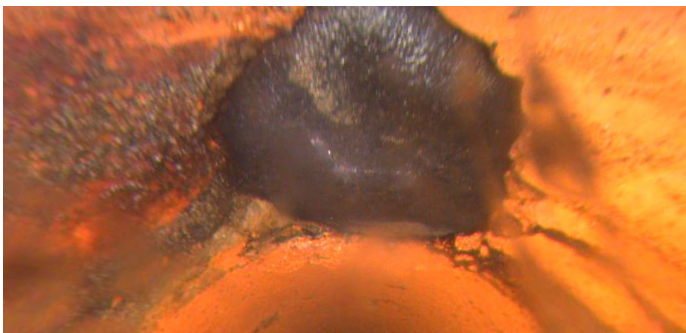
Code: **TBC**
Description: **Tap Break-in Capped**

Distance (ft): **205.3**
Structural Grade: **0**
O&M Grade: **2**
Clock Start/From: **12**
Clock To:
1st Value: **4.000**
2nd Value:
Value Percent:
Continuous Index:
Within 8" of Joint:
Remarks:

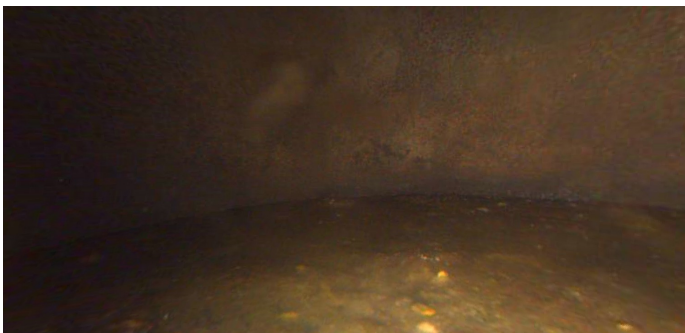
Code: **AMH**
Description: **Manhole**

Distance (ft): **268.0**
Structural Grade: **0**
O&M Grade: **0**
Clock Start/From:
Clock To:
1st Value:
2nd Value:
Value Percent:
Continuous Index:
Within 8" of Joint: **NO**
Remarks: **M-707-024**
