Profile/Photo Observation Report

Street:	LINCOLN ST	Flow Control:	Not Controlled
City:	Hobart, IN	Year Renewed:	
Location:	Light Highway	Tape/Media #:	
Purpose:	Maintenance Related	Dia/Height:	8"
Use:	Sanitary	Material:	PVC
Drain Area:	NA	Lining:	Cured in Place
Category:	NA		
Comment:	blk silt at 13'-flow incorrect.

Location Details:		Direction of Survey:	Upstream
US MH:	M-707-026	DS MH:	M-707-022
		Total Length Surveyed (ft):	14.8

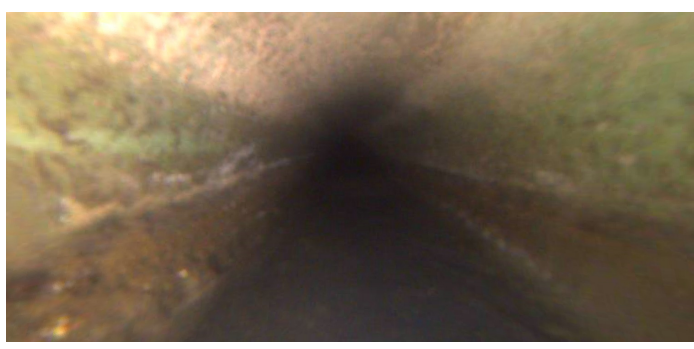
Code: **AMH**
Description: **Manhole**

Distance (ft): **.0**
Structural Grade: **0**
O&M Grade: **0**
Clock Start/From:
Clock To:
1st Value:
2nd Value:
Value Percent:
Continuous Index:
Within 8" of Joint: **NO**
Remarks: **M-707-022**

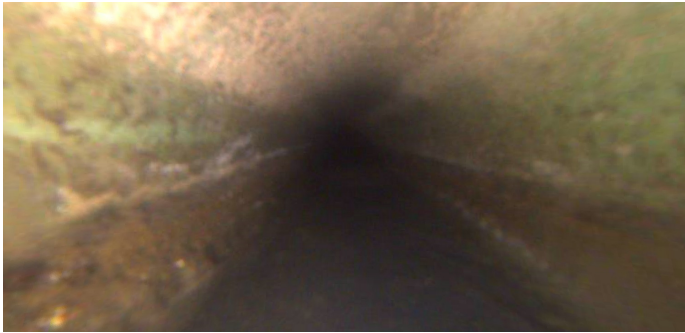
Code:	MWL
Description:	Water Level

Distance (ft):	.0
Structural Grade:	0
O&M Grade:	0
Clock Start/From:	
Clock To:	
1st Value:	
2nd Value:	
Value Percent:	10.000
Continuous Index:	
Within 8" of Joint:	NO
Remarks:

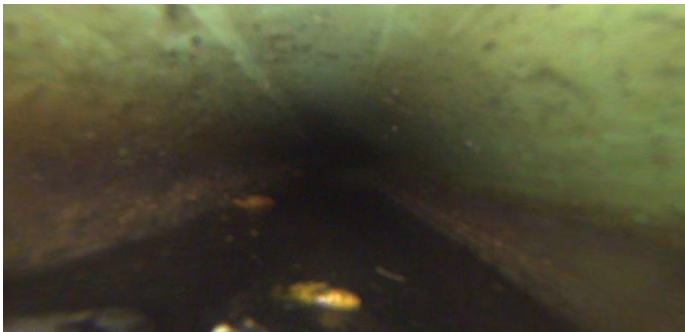
Code:	MSA
Description:	Abandoned Survey

Distance (ft):	14.8
Structural Grade:	0
O&M Grade:	0
Clock Start/From:	
Clock To:	
1st Value:	
2nd Value:	
Value Percent:	
Continuous Index:	
Within 8" of Joint:	NO
Remarks:	debris under water
