## Profile/Photo Observation Report

Street:	<b>South Lincoln Street</b>	Flow Control:	<b>Not Controlled</b>
City:	<b>Hobart, IN</b>	Year Renewed:	
Location:	<b>Local rural streets with light traffic, t</b>	Tape/Media #:	
Purpose:	<b>Routine Assessment</b>	Dia/Height:	<b>8"</b>
Use:	<b>Sanitary Sewage Pipe</b>	Material:	<b>PVC</b>
Drain Area:		Lining:	<b>None</b>
Category:	<b>NA</b>		
Comment:			
Location Details:		Direction of Survey:	<b>Downstream</b>
US MH:	<b>M-707-026</b>	DS MH:	<b>M-707-022</b>
		Total Length Surveyed (ft):	<b>223.2</b>

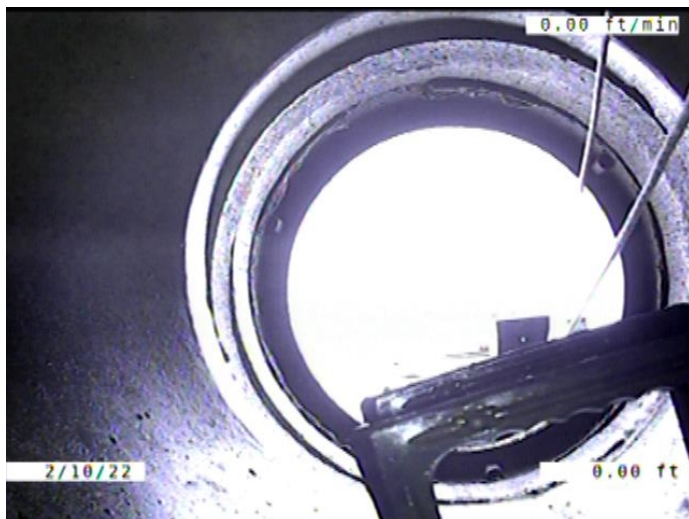
Code: **AMH**  
Description: **Manhole**

Distance (ft): **.0**  
Structural Grade: **0**  
O&M Grade: **0**  
Clock Start/From:  
Clock To:  
1st Value:  
2nd Value:  
Value Percent:  
Continuous Index:  
Within 8" of Joint: **NO**  
Remarks: **M-707-026**

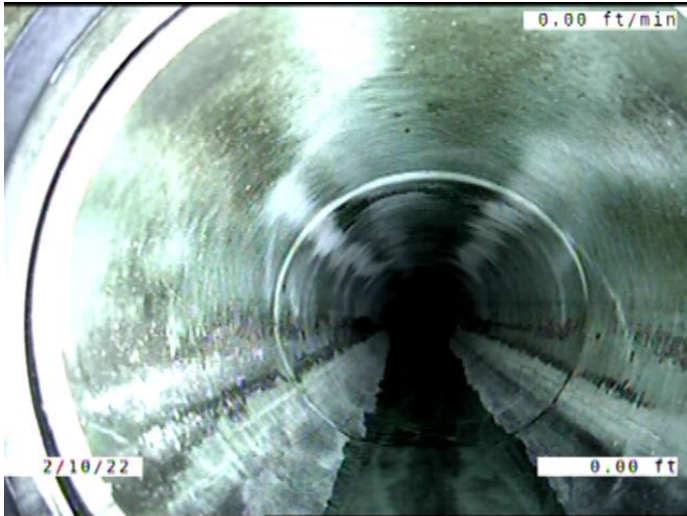
Code: **MWL**  
Description: **Miscellaneous Water Level**

Distance (ft): **.0**  
Structural Grade: **0**  
O&M Grade: **0**  
Clock Start/From:  
Clock To:  
1st Value:  
2nd Value:  
Value Percent: **5.000**  
Continuous Index:  
Within 8" of Joint: **NO**  
Remarks:

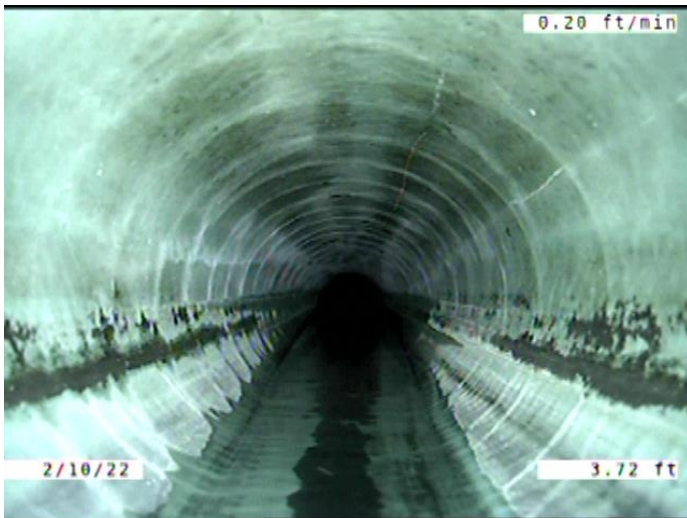
Code: **DSF**  
Description: **Deposits Settled Fine**

Distance (ft): **3.7**  
Structural Grade: **0**  
O&M Grade: **2**  
Clock Start/From: **5**  
Clock To: **7**  
1st Value:  
2nd Value:  
Value Percent: **5.000**  
Continuous Index: **S01**  
Within 8" of Joint: **YES**  
Remarks:

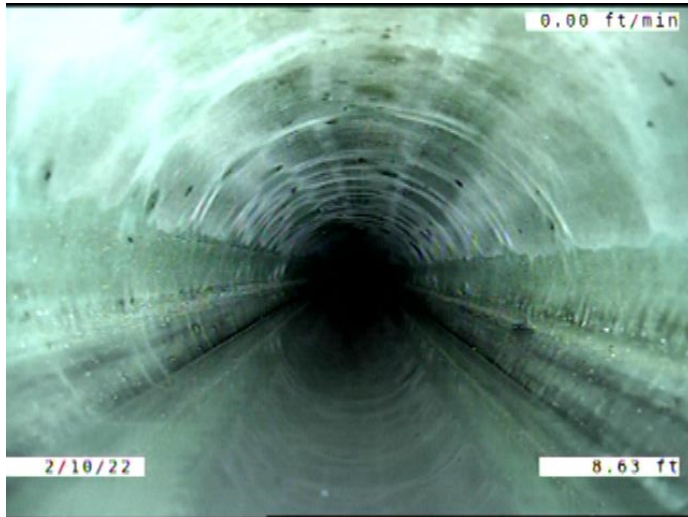
Code: **MWL**  
 Description: **Miscellaneous Water Level**

Distance (ft): **8.6**  
 Structural Grade: **0**  
 O&M Grade: **0**  
 Clock Start/From:  
 Clock To:  
 1st Value:  
 2nd Value:  
 Value Percent: **20.000**  
 Continuous Index:  
 Within 8" of Joint: **NO**  
 Remarks:

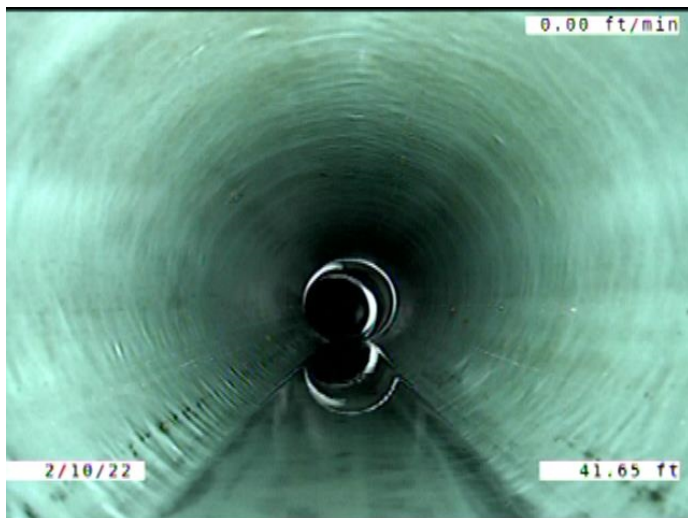
Code: **MWL**  
 Description: **Miscellaneous Water Level**

Distance (ft): **41.7**  
 Structural Grade: **0**  
 O&M Grade: **0**  
 Clock Start/From:  
 Clock To:  
 1st Value:  
 2nd Value:  
 Value Percent: **5.000**  
 Continuous Index:  
 Within 8" of Joint: **NO**  
 Remarks:

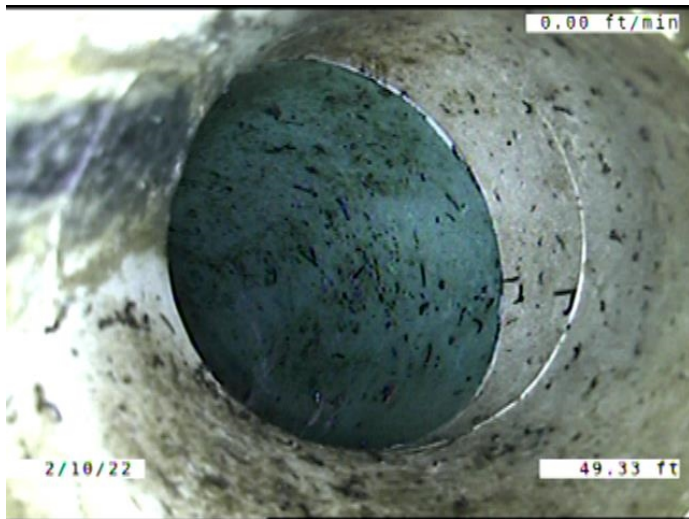
Code: **TF**  
Description: **Tap Factory**

Distance (ft): **49.3**  
Structural Grade: **0**  
O&M Grade: **0**  
Clock Start/From: **10**  
Clock To:  
1st Value: **4.000**  
2nd Value:  
Value Percent:  
Continuous Index:  
Within 8" of Joint: **YES**  
Remarks:

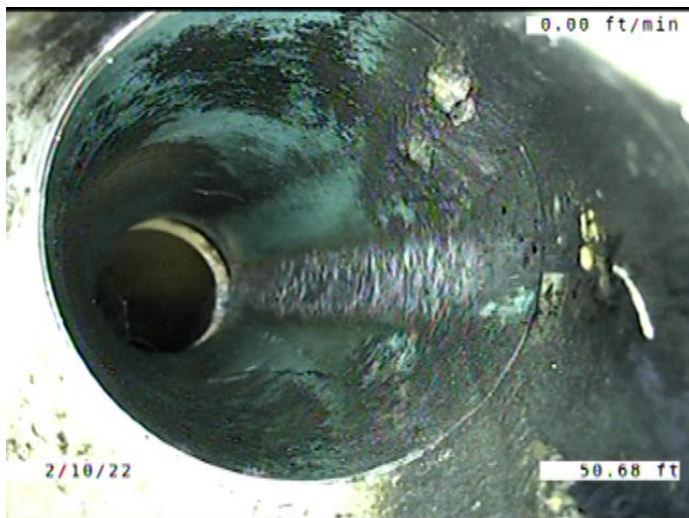
Code: **TF**  
Description: **Tap Factory**

Distance (ft): **50.7**  
Structural Grade: **0**  
O&M Grade: **0**  
Clock Start/From: **3**  
Clock To:  
1st Value: **4.000**  
2nd Value:  
Value Percent:  
Continuous Index:  
Within 8" of Joint: **YES**  
Remarks:

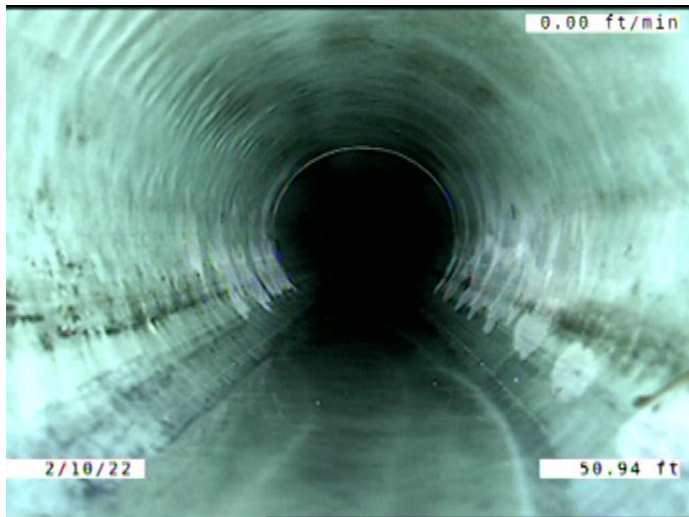
Code: **DSF**  
Description: **Deposits Settled Fine**

Distance (ft): **50.9**  
Structural Grade: **0**  
O&M Grade: **2**  
Clock Start/From: **5**  
Clock To: **7**  
1st Value:  
2nd Value:  
Value Percent: **5.000**  
Continuous Index: **F01**  
Within 8" of Joint: **YES**  
Remarks:

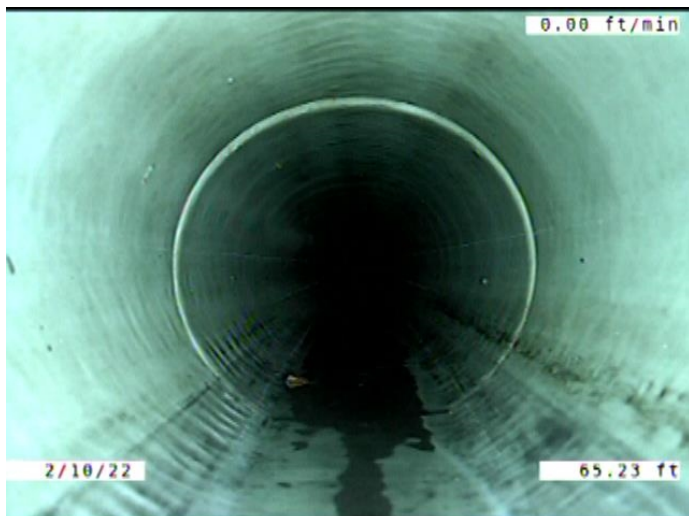
Code: **DSF**  
Description: **Deposits Settled Fine**

Distance (ft): **65.2**  
Structural Grade: **0**  
O&M Grade: **2**  
Clock Start/From: **5**  
Clock To: **7**  
1st Value:  
2nd Value:  
Value Percent: **5.000**  
Continuous Index: **S02**  
Within 8" of Joint: **YES**  
Remarks:

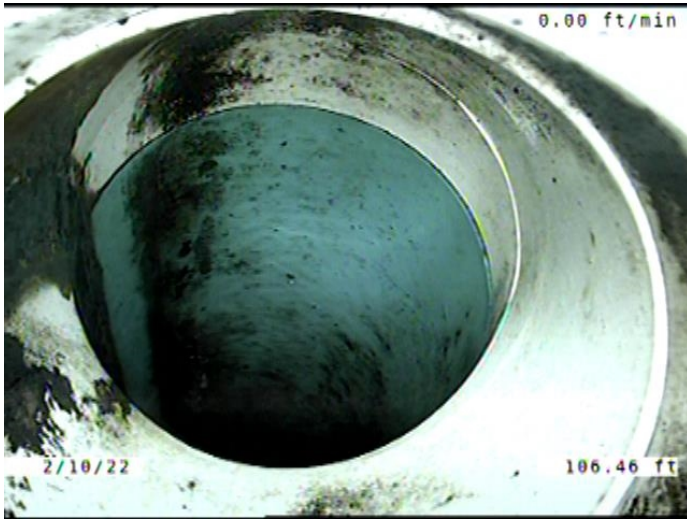
Code: **TF**  
Description: **Tap Factory**

Distance (ft): **106.5**  
Structural Grade: **0**  
O&M Grade: **0**  
Clock Start/From: **9**  
Clock To:  
1st Value: **4.000**  
2nd Value:  
Value Percent:  
Continuous Index:  
Within 8" of Joint: **YES**  
Remarks:

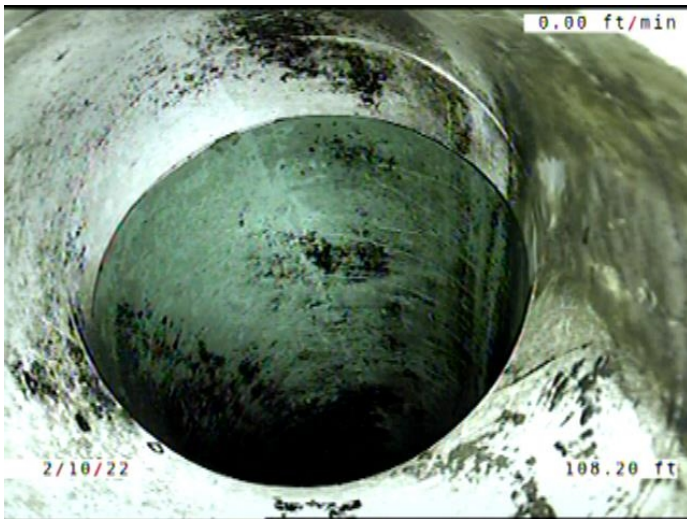
Code: **TF**  
Description: **Tap Factory**

Distance (ft): **108.2**  
Structural Grade: **0**  
O&M Grade: **0**  
Clock Start/From: **3**  
Clock To:  
1st Value: **4.000**  
2nd Value:  
Value Percent:  
Continuous Index:  
Within 8" of Joint: **YES**  
Remarks:

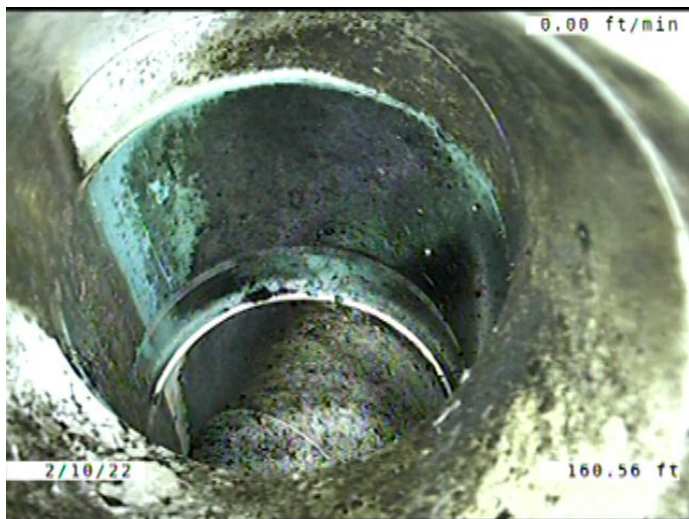
Code: **TF**  
 Description: **Tap Factory**

Distance (ft): **160.6**  
 Structural Grade: **0**  
 O&M Grade: **0**  
 Clock Start/From: **11**  
 Clock To:  
 1st Value: **4.000**  
 2nd Value:  
 Value Percent:  
 Continuous Index:  
 Within 8" of Joint: **YES**  
 Remarks:

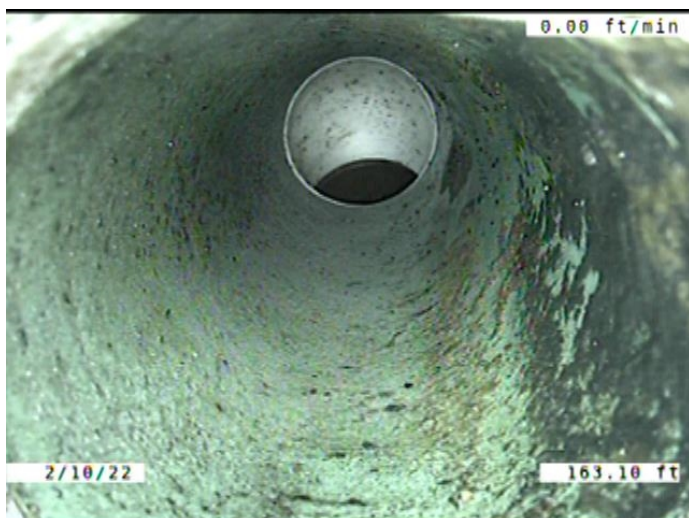
Code: **TF**  
 Description: **Tap Factory**

Distance (ft): **163.1**  
 Structural Grade: **0**  
 O&M Grade: **0**  
 Clock Start/From: **3**  
 Clock To:  
 1st Value: **4.000**  
 2nd Value:  
 Value Percent:  
 Continuous Index:  
 Within 8" of Joint: **YES**  
 Remarks:

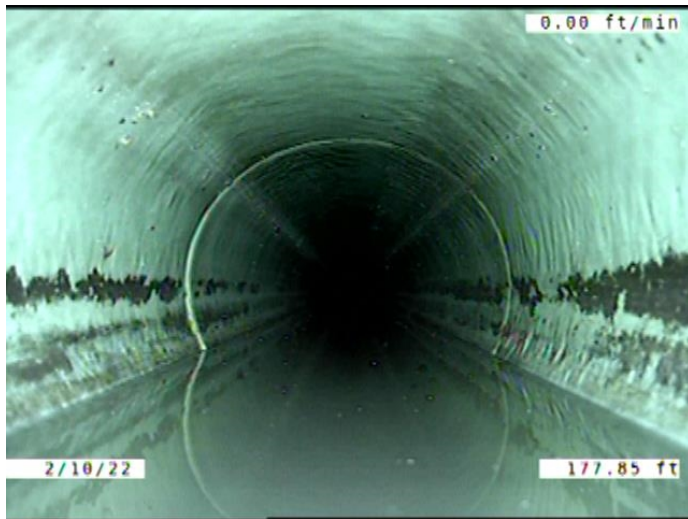
Code: **MWL**  
 Description: **Miscellaneous Water Level**

Distance (ft): **177.8**  
 Structural Grade: **0**  
 O&M Grade: **0**  
 Clock Start/From:  
 Clock To:  
 1st Value:  
 2nd Value:  
 Value Percent: **15.000**  
 Continuous Index:  
 Within 8" of Joint: **NO**  
 Remarks:

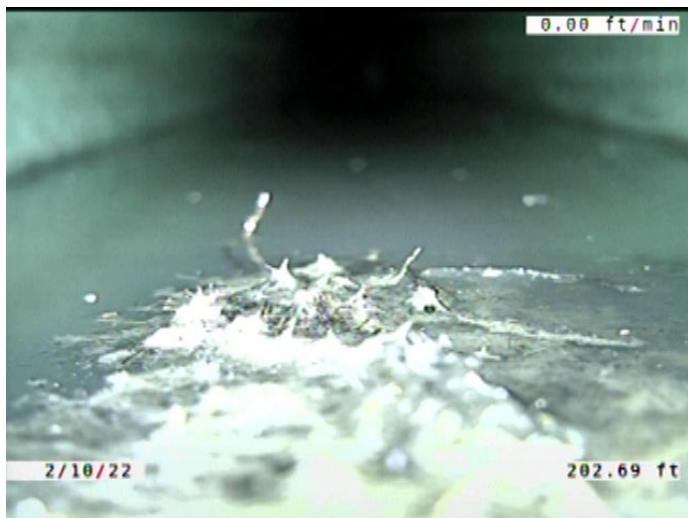
Code: **OBZ**  
 Description: **Obstruction Other**

Distance (ft): **202.7**  
 Structural Grade: **0**  
 O&M Grade: **2**  
 Clock Start/From: **5**  
 Clock To: **7**  
 1st Value:  
 2nd Value:  
 Value Percent: **5.000**  
 Continuous Index:  
 Within 8" of Joint: **YES**  
 Remarks: **ROOTS THAT HAVE BEEN CUT**

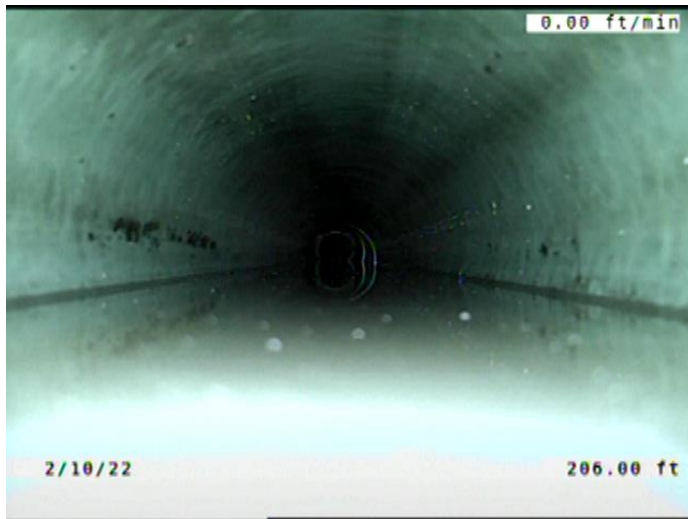
Code:	<b>MWL</b>
Description:	<b>Miscellaneous Water Level</b>
Distance (ft):	<b>206.0</b>
Structural Grade:	<b>0</b>
O&M Grade:	<b>0</b>
Clock Start/From:	
Clock To:	
1st Value:	
2nd Value:	
Value Percent:	<b>25.000</b>
Continuous Index:	
Within 8" of Joint:	<b>NO</b>
Remarks:

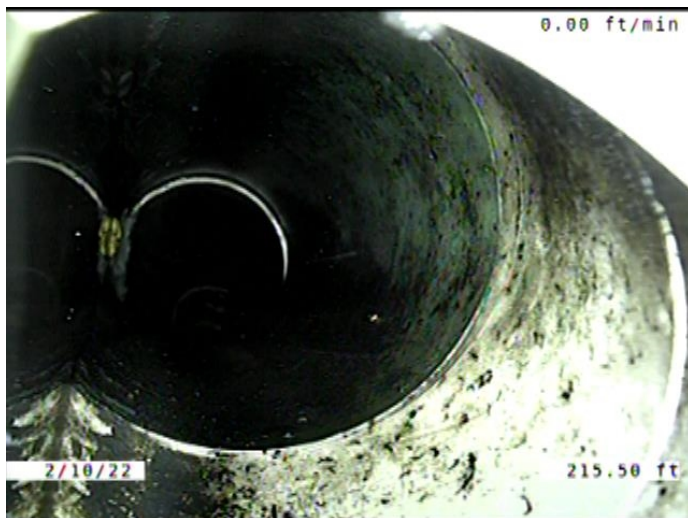
Code:	<b>TF</b>
Description:	<b>Tap Factory</b>
Distance (ft):	<b>215.5</b>
Structural Grade:	<b>0</b>
O&M Grade:	<b>0</b>
Clock Start/From:	<b>9</b>
Clock To:	
1st Value:	<b>4.000</b>
2nd Value:	
Value Percent:	
Continuous Index:	
Within 8" of Joint:	<b>YES</b>
Remarks:

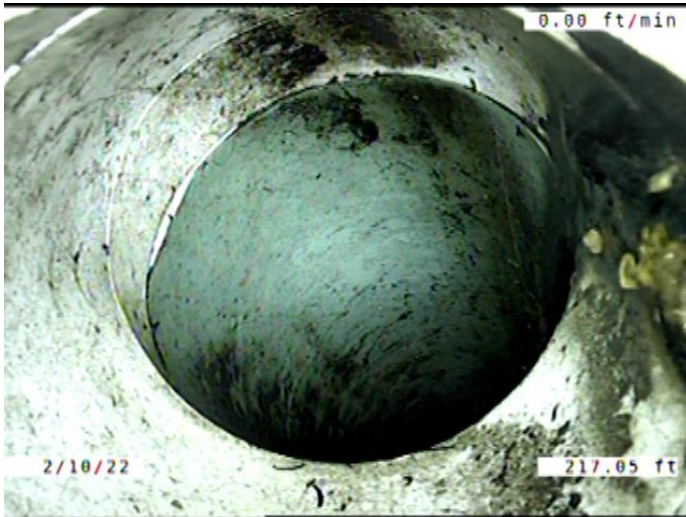
Code: **TF**  
 Description: **Tap Factory**

Distance (ft): **217.0**  
 Structural Grade: **0**  
 O&M Grade: **0**  
 Clock Start/From: **2**  
 Clock To:  
 1st Value: **4.000**  
 2nd Value:  
 Value Percent:  
 Continuous Index:  
 Within 8" of Joint: **YES**  
 Remarks:

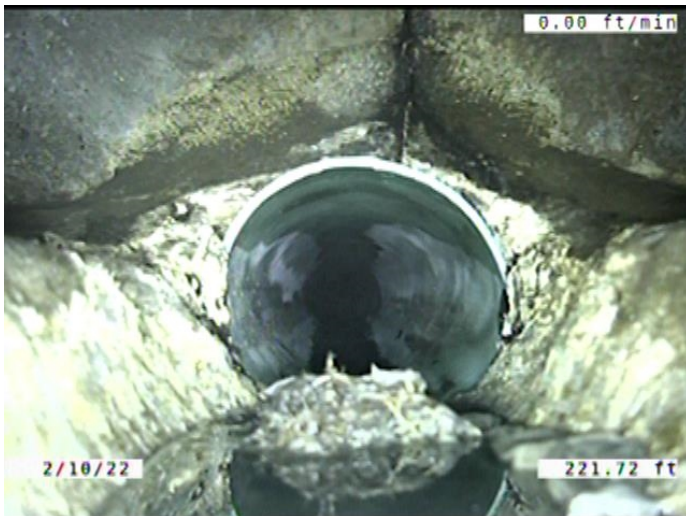
Code: **DSF**  
 Description: **Deposits Settled Fine**

Distance (ft): **221.7**  
 Structural Grade: **0**  
 O&M Grade: **2**  
 Clock Start/From: **5**  
 Clock To: **7**  
 1st Value:  
 2nd Value:  
 Value Percent: **5.000**  
 Continuous Index: **F02**  
 Within 8" of Joint: **YES**  
 Remarks:

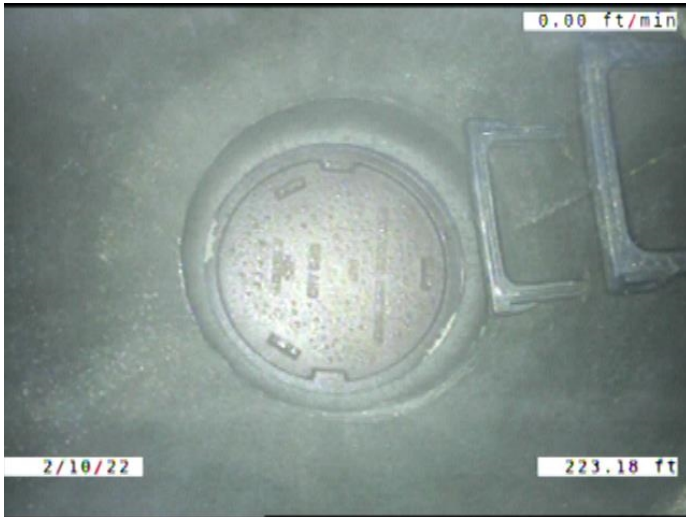
Code:	<b>AMH</b>
Description:	<b>Manhole</b>
Distance (ft):	<b>223.2</b>
Structural Grade:	<b>0</b>
O&M Grade:	<b>0</b>
Clock Start/From:	
Clock To:	
1st Value:	
2nd Value:	
Value Percent:	
Continuous Index:	
Within 8" of Joint:	<b>NO</b>
Remarks:	<b>M-707-022</b>
