## Profile/Photo Observation Report

Date:	<b>02/10/2022</b>	Weather:		Coding:	<b>PACP 7.0</b>
Pipe Length (ft):	<b>249.7</b>	Owner:	<b>City of Hobart</b>	Pre Clean:	<b>Heavy Cleaning</b>
P.O.#:	<b>YES502259</b>	Surveyor:	<b>S. Bucklin</b>	PSR:	<b>P-707-026-027</b>
Customer:	<b>City of Hobart</b>	Clean Date:	<b>02/09/2022</b>	Shape:	<b>C</b>

Street:	<b>South Lincoln Street</b>	Flow Control:	<b>Not Controlled</b>
City:	<b>Hobart, IN</b>	Year Renewed:	
Location:	<b>Local rural streets with light traffic, t</b>	Tape/Media #:	
Purpose:	<b>Routine Assessment</b>	Dia/Height:	<b>8"</b>
Use:	<b>Sanitary Sewage Pipe</b>	Material:	<b>PVC</b>
Drain Area:		Lining:	<b>None</b>
Category:	<b>NA</b>		
Comment:			
Location Details:		Direction of Survey:	<b>Downstream</b>
US MH:	<b>M-707-027</b>	DS MH:	<b>M-707-026</b>
		Total Length Surveyed (ft):	<b>249.7</b>

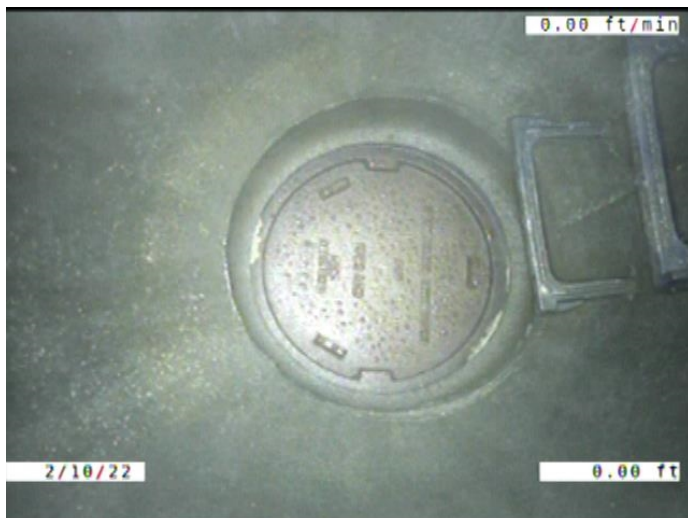
Code: **AMH**  
Description: **Manhole**

Distance (ft): **.0**  
Structural Grade: **0**  
O&M Grade: **0**  
Clock Start/From:  
Clock To:  
1st Value:  
2nd Value:  
Value Percent:  
Continuous Index:  
Within 8" of Joint: **NO**  
Remarks: **M-707-027**

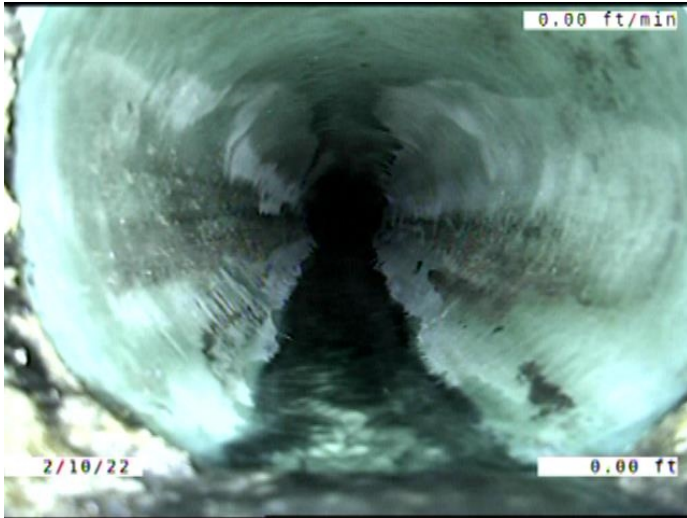
Code:	<b>MWL</b>
Description:	<b>Miscellaneous Water Level</b>
Distance (ft):	<b>.0</b>
Structural Grade:	<b>0</b>
O&M Grade:	<b>0</b>
Clock Start/From:	
Clock To:	
1st Value:	
2nd Value:	
Value Percent:	<b>5.000</b>
Continuous Index:	
Within 8" of Joint:	<b>NO</b>
Remarks:

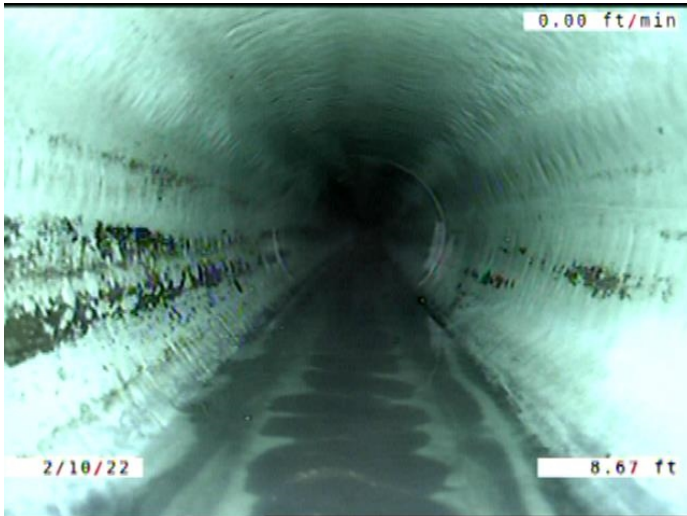
Code:	<b>DSF</b>
Description:	<b>Deposits Settled Fine</b>
Distance (ft):	<b>8.7</b>
Structural Grade:	<b>0</b>
O&M Grade:	<b>2</b>
Clock Start/From:	<b>5</b>
Clock To:	<b>7</b>
1st Value:	
2nd Value:	
Value Percent:	<b>5.000</b>
Continuous Index:	<b>S01</b>
Within 8" of Joint:	<b>YES</b>
Remarks:

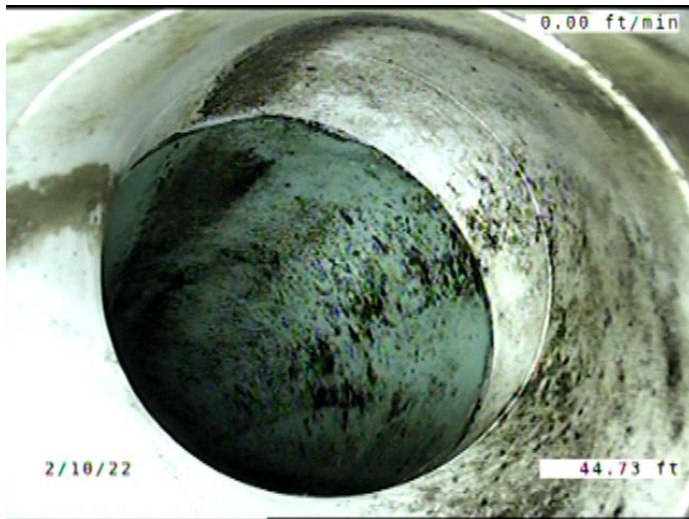
Code: **TF**  
Description: **Tap Factory**

Distance (ft): **44.7**  
Structural Grade: **0**  
O&M Grade: **0**  
Clock Start/From: **10**  
Clock To:  
1st Value: **4.000**  
2nd Value:  
Value Percent:  
Continuous Index:  
Within 8" of Joint: **YES**  
Remarks:

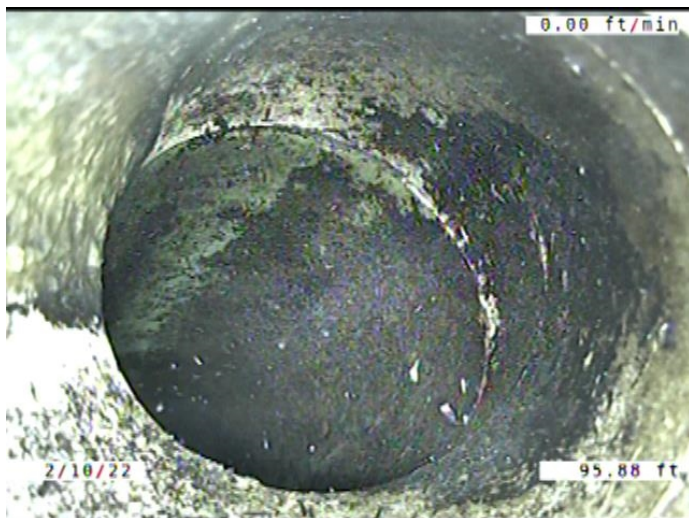
Code: **TF**  
Description: **Tap Factory**

Distance (ft): **95.9**  
Structural Grade: **0**  
O&M Grade: **0**  
Clock Start/From: **10**  
Clock To:  
1st Value: **4.000**  
2nd Value:  
Value Percent:  
Continuous Index:  
Within 8" of Joint: **YES**  
Remarks:

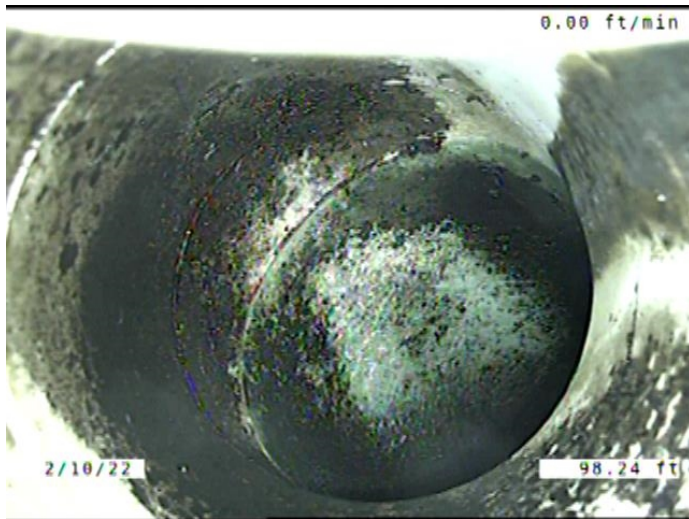
Code: **TF**  
 Description: **Tap Factory**

Distance (ft): **98.2**  
 Structural Grade: **0**  
 O&M Grade: **0**  
 Clock Start/From: **2**  
 Clock To:  
 1st Value: **4.000**  
 2nd Value:  
 Value Percent:  
 Continuous Index:  
 Within 8" of Joint: **YES**  
 Remarks:

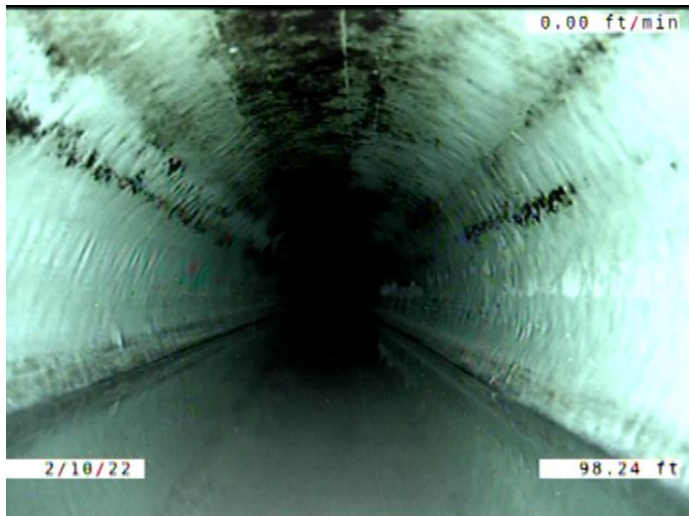
Code: **MWL**  
 Description: **Miscellaneous Water Level**

Distance (ft): **98.2**  
 Structural Grade: **0**  
 O&M Grade: **0**  
 Clock Start/From:  
 Clock To:  
 1st Value:  
 2nd Value:  
 Value Percent: **15.000**  
 Continuous Index:  
 Within 8" of Joint: **NO**  
 Remarks:

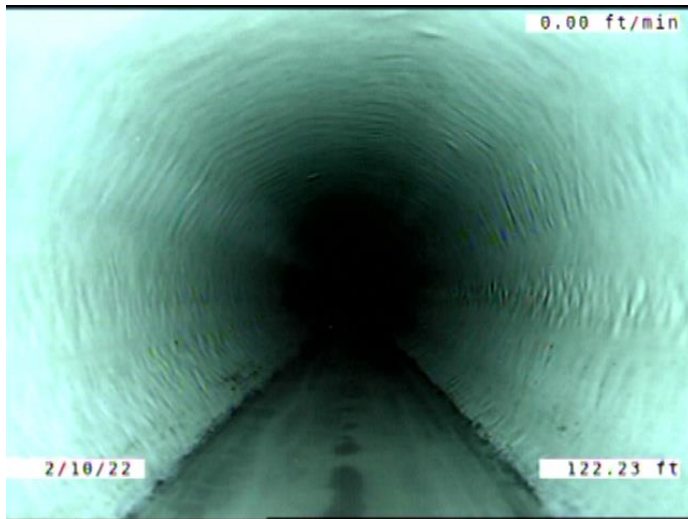
Code: **MWL**  
Description: **Miscellaneous Water Level**

Distance (ft): **122.2**  
Structural Grade: **0**  
O&M Grade: **0**  
Clock Start/From:  
Clock To:  
1st Value:  
2nd Value:  
Value Percent: **5.000**  
Continuous Index:  
Within 8" of Joint: **NO**  
Remarks:

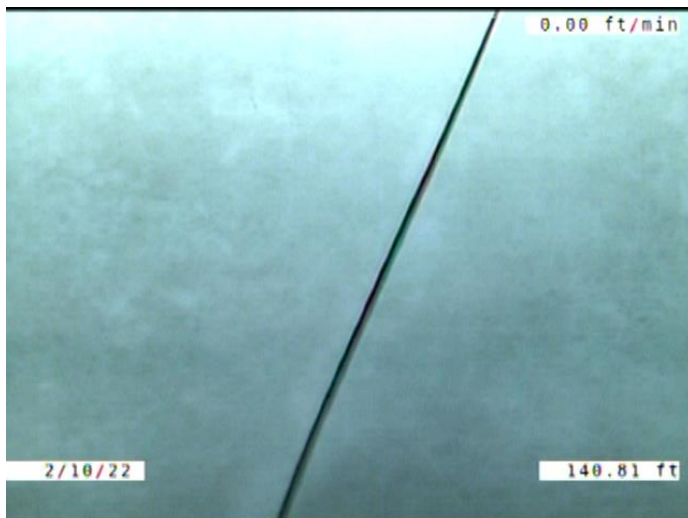
Code: **FM**  
Description: **Fracture Multiple**

Distance (ft): **140.8**  
Structural Grade: **4**  
O&M Grade: **0**  
Clock Start/From: **10**  
Clock To: **1**  
1st Value:  
2nd Value:  
Value Percent:  
Continuous Index:  
Within 8" of Joint: **YES**  
Remarks:

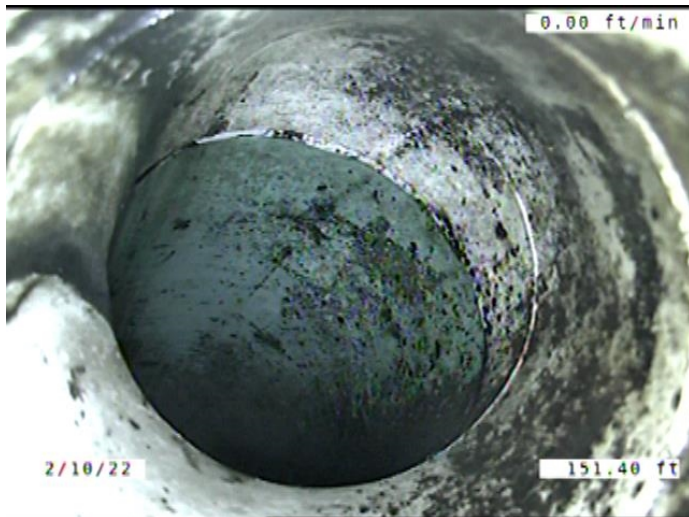
Code: **TF**  
Description: **Tap Factory**

Distance (ft): **151.4**  
Structural Grade: **0**  
O&M Grade: **0**  
Clock Start/From: **10**  
Clock To:  
1st Value: **4.000**  
2nd Value:  
Value Percent:  
Continuous Index:  
Within 8" of Joint: **YES**  
Remarks:

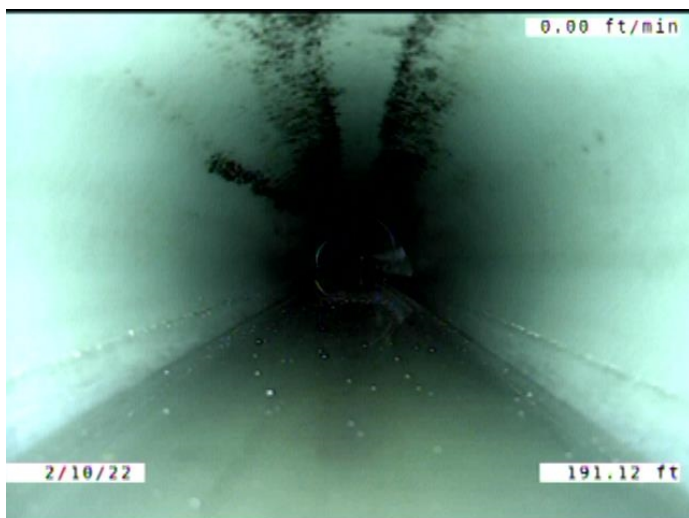
Code: **MWL**  
Description: **Miscellaneous Water Level**

Distance (ft): **191.1**  
Structural Grade: **0**  
O&M Grade: **0**  
Clock Start/From:  
Clock To:  
1st Value:  
2nd Value:  
Value Percent: **15.000**  
Continuous Index:  
Within 8" of Joint: **NO**  
Remarks:

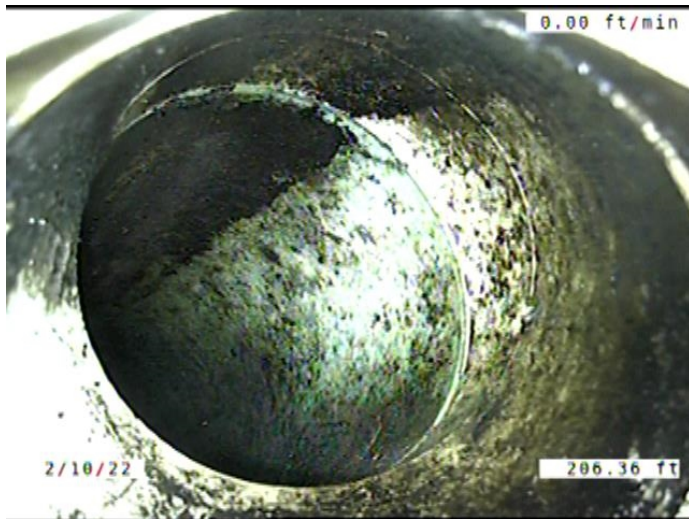
Code: **TF**  
Description: **Tap Factory**

Distance (ft): **206.4**  
Structural Grade: **0**  
O&M Grade: **0**  
Clock Start/From: **10**  
Clock To:  
1st Value: **4.000**  
2nd Value:  
Value Percent:  
Continuous Index:  
Within 8" of Joint: **YES**  
Remarks:

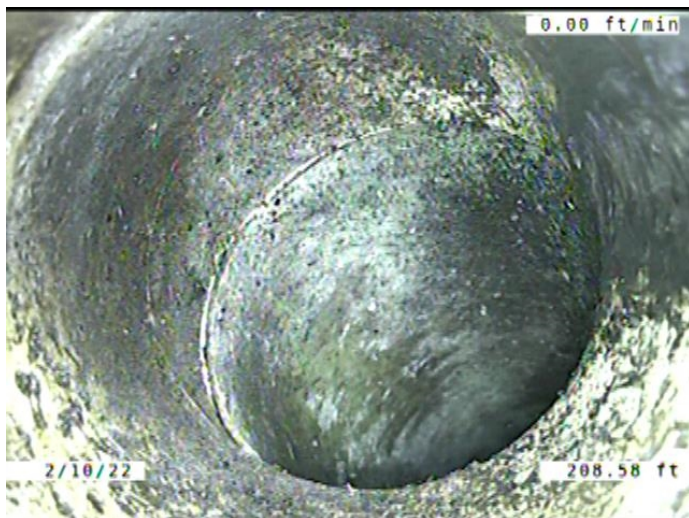
Code: **TF**  
Description: **Tap Factory**

Distance (ft): **208.6**  
Structural Grade: **0**  
O&M Grade: **0**  
Clock Start/From: **2**  
Clock To:  
1st Value: **4.000**  
2nd Value:  
Value Percent:  
Continuous Index:  
Within 8" of Joint: **YES**  
Remarks:

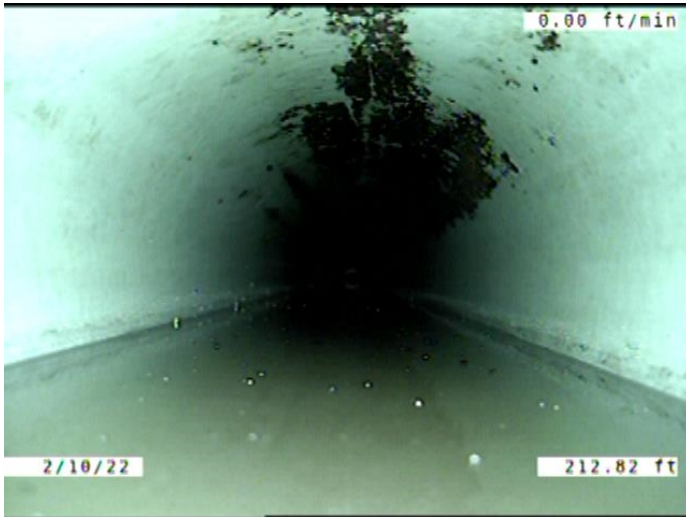
Code: **MWL**  
 Description: **Miscellaneous Water Level**

Distance (ft): **212.8**  
 Structural Grade: **0**  
 O&M Grade: **0**  
 Clock Start/From:  
 Clock To:  
 1st Value:  
 2nd Value:  
 Value Percent: **25.000**  
 Continuous Index:  
 Within 8" of Joint: **NO**  
 Remarks:

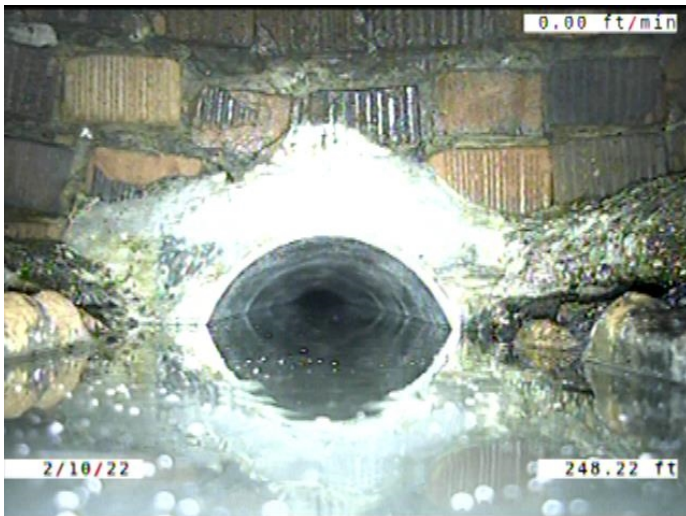
Code: **DSF**  
 Description: **Deposits Settled Fine**

Distance (ft): **248.2**  
 Structural Grade: **0**  
 O&M Grade: **2**  
 Clock Start/From: **5**  
 Clock To: **7**  
 1st Value:  
 2nd Value:  
 Value Percent: **5.000**  
 Continuous Index: **F01**  
 Within 8" of Joint: **YES**  
 Remarks:

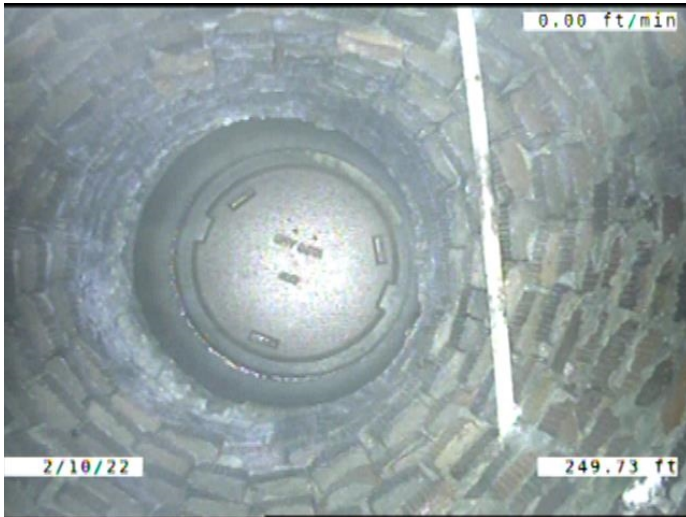
Code:	<b>AMH</b>
Description:	<b>Manhole</b>
Distance (ft):	<b>249.7</b>
Structural Grade:	<b>0</b>
O&M Grade:	<b>0</b>
Clock Start/From:	
Clock To:	
1st Value:	
2nd Value:	
Value Percent:	
Continuous Index:	
Within 8" of Joint:	<b>NO</b>
Remarks:	<b>M-707-026</b>
