Profile/Photo Observation Report

Date:	02/12/2022	Weather:		Coding:	PACP 7.0
Pipe Length (ft):	228.4	Owner:	City of Hobart	Pre Clean:	Heavy Cleaning
P.O.#:	YES502259	Surveyor:	S. Bucklin	PSR:	P-707-030-031
Customer:	City of Hobart	Clean Date:	02/10/2022	Shape:	C

Street:	South Lincoln Street	Flow Control:	Not Controlled
City:	Hobart, IN	Year Renewed:	
Location:	Local rural streets with light traffic, t	Tape/Media #:	
Purpose:	Routine Assessment	Dia/Height:	8"
Use:	Sanitary Sewage Pipe	Material:	PVC
Drain Area:		Lining:	None
Category:	NA		
Comment:			
Location Details:		Direction of Survey:	Upstream
US MH:	M-707-031	DS MH:	M-707-030
		Total Length Surveyed (ft):	228.4

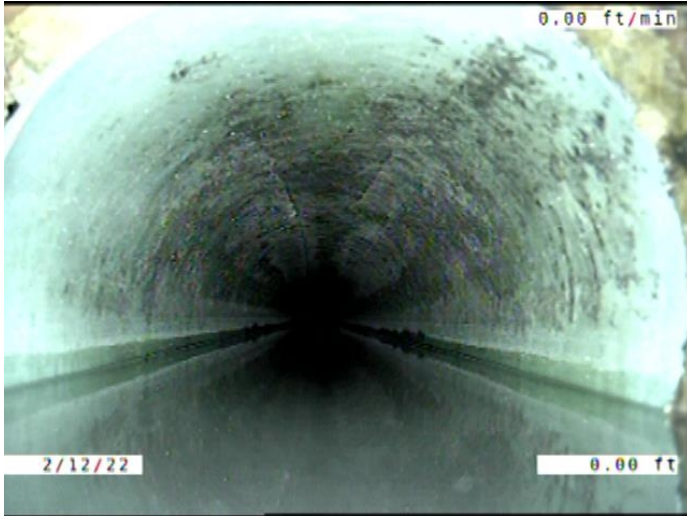
Code:	MWL
Description:	Miscellaneous Water Level
Distance (ft):	.0
Structural Grade:	0
O&M Grade:	0
Clock Start/From:	
Clock To:	
1st Value:	
2nd Value:	
Value Percent:	25.000
Continuous Index:	
Within 8" of Joint:	NO
Remarks:

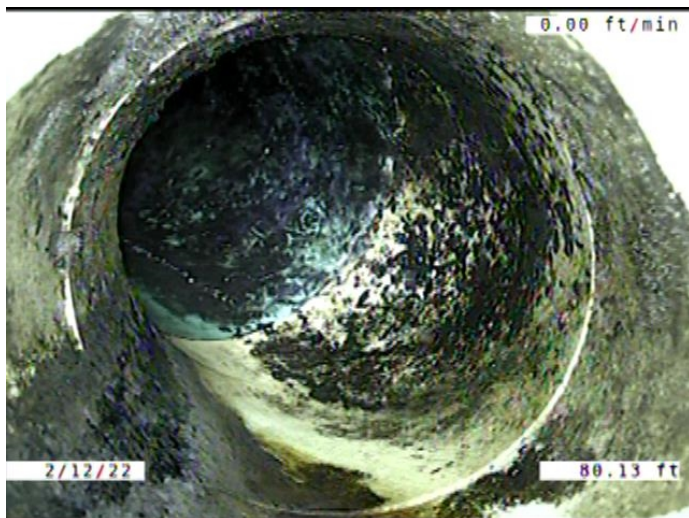
Code: **TF**
Description: **Tap Factory**

Distance (ft): **80.1**
Structural Grade: **0**
O&M Grade: **0**
Clock Start/From: **10**
Clock To:
1st Value: **4.000**
2nd Value:
Value Percent:
Continuous Index:
Within 8" of Joint: **YES**
Remarks:

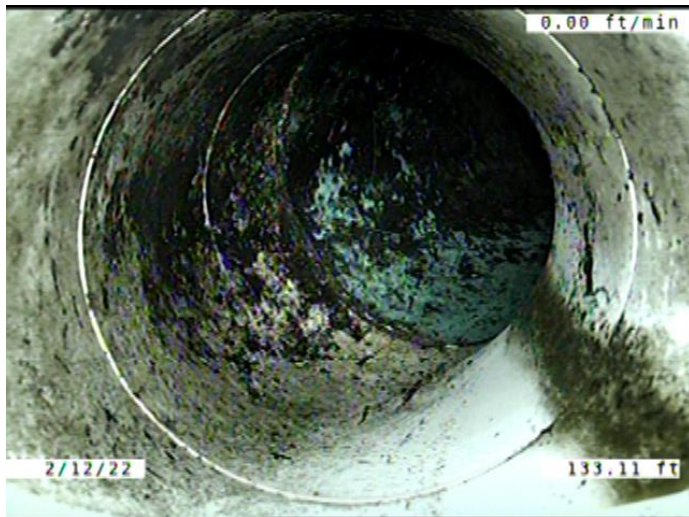
Code: **TF**
 Description: **Tap Factory**

Distance (ft): **133.1**
 Structural Grade: **0**
 O&M Grade: **0**
 Clock Start/From: **2**
 Clock To:
 1st Value: **4.000**
 2nd Value:
 Value Percent:
 Continuous Index:
 Within 8" of Joint: **YES**
 Remarks:

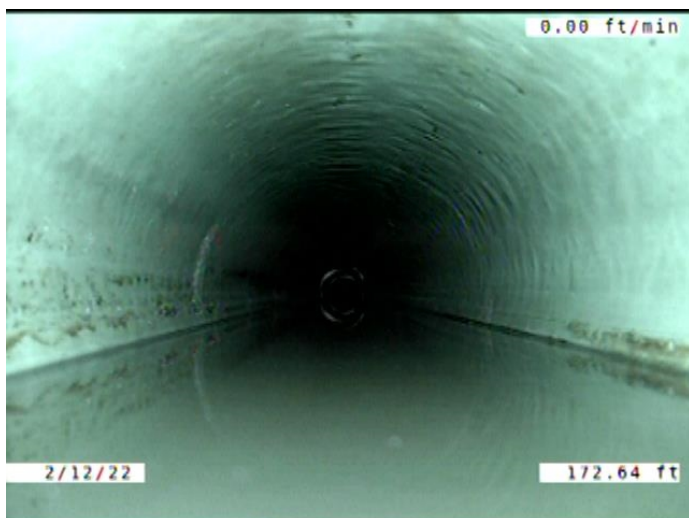
Code: **MWLS**
 Description: **Miscellaneous Water Level Sag**

Distance (ft): **172.6**
 Structural Grade: **2**
 O&M Grade: **0**
 Clock Start/From:
 Clock To:
 1st Value:
 2nd Value:
 Value Percent: **20.000**
 Continuous Index: **S01**
 Within 8" of Joint: **NO**
 Remarks:
