Profile/Photo Observation Report

Street:	LINCOLN ST	Flow Control:	Not Controlled
City:	Hobart, IN	Year Renewed:	
Location:	Light Highway	Tape/Media #:	
Purpose:	Maintenance Related	Dia/Height:	8"
Use:	Sanitary	Material:	VCP
Drain Area:	NA	Lining:	Cured in Place
Category:	NA		
Comment:	heavy sludge at 3'.-flow incorrect.		
Location Details:		Direction of Survey:	Upstream
US MH:	M-707-032	DS MH:	M-707-031
		Total Length Surveyed (ft):	4.5

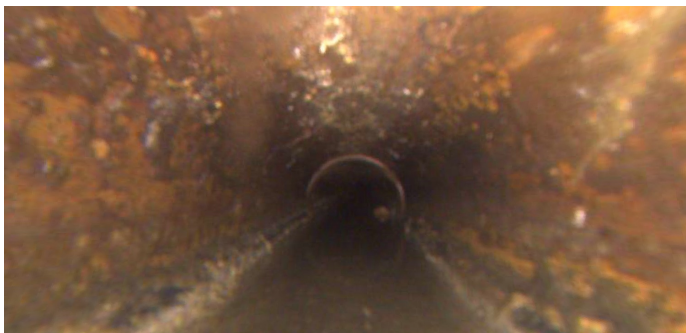
Code: **AMH**
Description: **Manhole**

Distance (ft): **.0**
Structural Grade: **0**
O&M Grade: **0**
Clock Start/From:
Clock To:
1st Value:
2nd Value:
Value Percent:
Continuous Index:
Within 8" of Joint: **NO**
Remarks: **M-707-031**

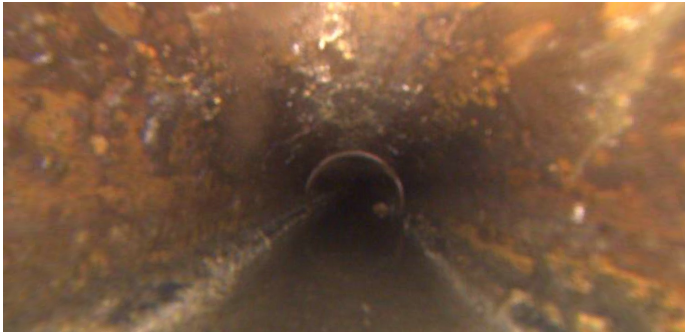
Code:	MWL
Description:	Water Level

Distance (ft):	.0
Structural Grade:	0
O&M Grade:	0
Clock Start/From:	
Clock To:	
1st Value:	
2nd Value:	
Value Percent:	10.000
Continuous Index:	
Within 8" of Joint:	NO
Remarks:

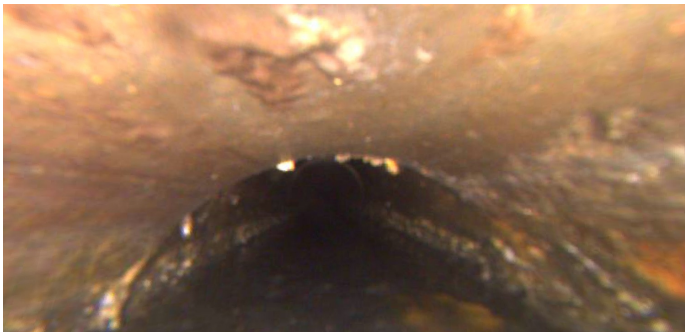
Code:	MSA
Description:	Abandoned Survey

Distance (ft):	4.5
Structural Grade:	0
O&M Grade:	0
Clock Start/From:	
Clock To:	
1st Value:	
2nd Value:	
Value Percent:	
Continuous Index:	
Within 8" of Joint:	NO
Remarks:	debris under water
