Profile/Photo Observation Report

Street:	STATE ST	Flow Control:	Not Controlled
City:	Hobart, IN	Year Renewed:	
Location:	Light Highway	Tape/Media #:	
Purpose:	Maintenance Related	Dia/Height:	12"
Use:	Sanitary	Material:	PVC
Drain Area:	NA	Lining:	Cured in Place
Category:	NA		
Comment:	flow incorrect.

Location Details:		Direction of Survey:	Downstream
US MH:	M-707-037	DS MH:	M-707-079
		Total Length Surveyed (ft):	245.8

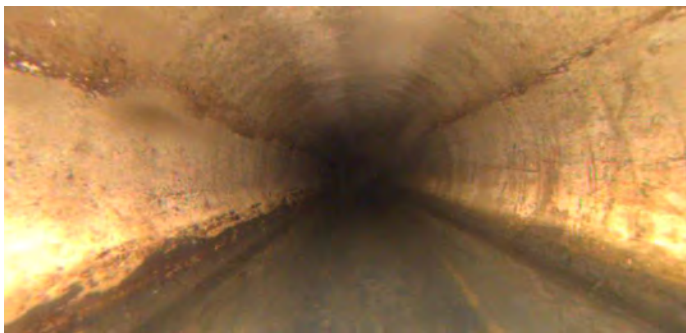
Code: **AMH**
Description: **Manhole**

Distance (ft): **.0**
Structural Grade: **0**
O&M Grade: **0**
Clock Start/From:
Clock To:
1st Value:
2nd Value:
Value Percent:
Continuous Index:
Within 8" of Joint: **NO**
Remarks: **M-707-037**

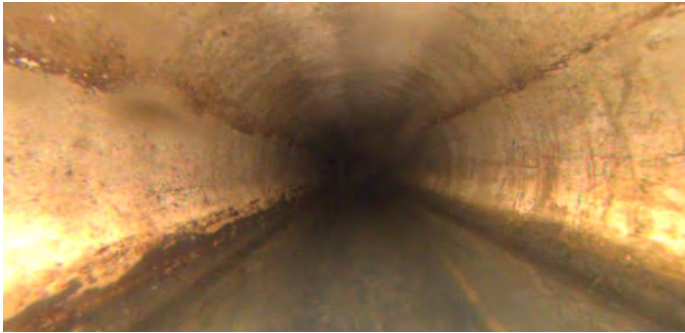
Code:	MWL
Description:	Water Level

Distance (ft):	.0
Structural Grade:	0
O&M Grade:	0
Clock Start/From:	
Clock To:	
1st Value:	
2nd Value:	
Value Percent:	20.000
Continuous Index:	
Within 8" of Joint:	NO
Remarks:

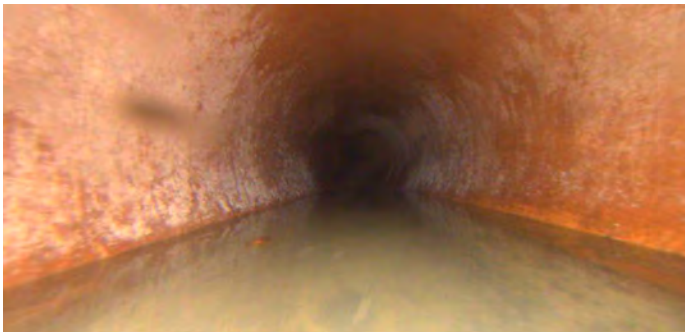
Code:	MMC
Description:	Material Change

Distance (ft):	8.9
Structural Grade:	0
O&M Grade:	0
Clock Start/From:	
Clock To:	
1st Value:	
2nd Value:	
Value Percent:	
Continuous Index:	
Within 8" of Joint:	NO
Remarks:	VCP

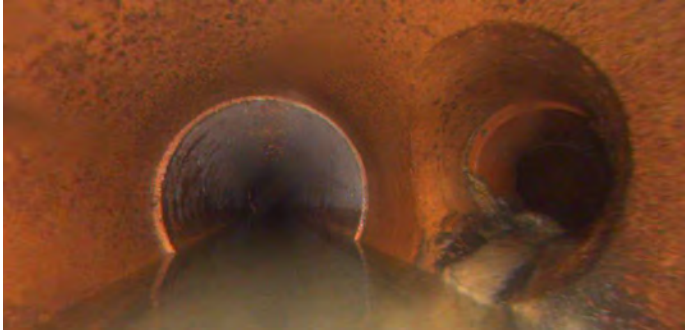
Code: **TF**
Description: **Tap Factory**

Distance (ft): **30.5**
Structural Grade: **0**
O&M Grade: **0**
Clock Start/From: **3**
Clock To:
1st Value: **4.000**
2nd Value:
Value Percent:
Continuous Index:
Within 8" of Joint:
Remarks:

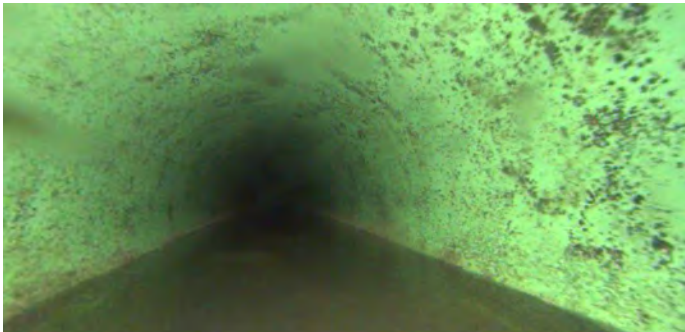
Code: **MMC**
Description: **Material Change**

Distance (ft): **100.3**
Structural Grade: **0**
O&M Grade: **0**
Clock Start/From:
Clock To:
1st Value:
2nd Value:
Value Percent:
Continuous Index:
Within 8" of Joint: **NO**
Remarks: **PVC**

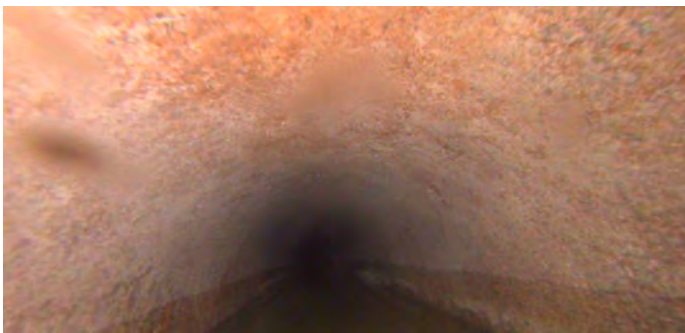
Code: **MMC**
Description: **Material Change**

Distance (ft): **125.5**
Structural Grade: **0**
O&M Grade: **0**
Clock Start/From:
Clock To:
1st Value:
2nd Value:
Value Percent:
Continuous Index:
Within 8" of Joint: **NO**
Remarks: **vcp**

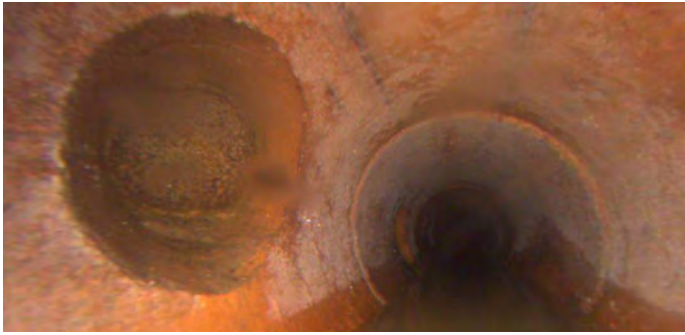
Code: **TFC**
Description: **Tap Factory Capped**

Distance (ft): **161.3**
Structural Grade: **0**
O&M Grade: **0**
Clock Start/From: **9**
Clock To:
1st Value: **4.000**
2nd Value:
Value Percent:
Continuous Index:
Within 8" of Joint:
Remarks:

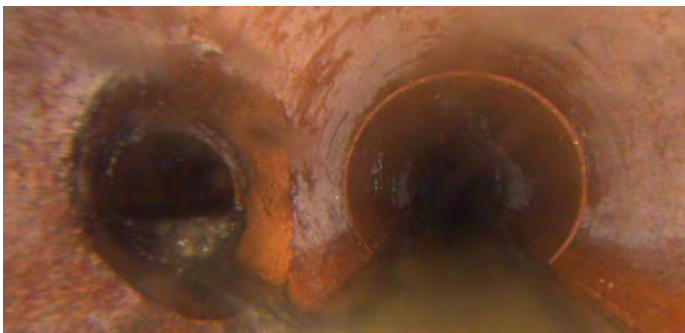
Code: **TFA**
Description: **Tap Factory Active**

Distance (ft): **163.4**
Structural Grade: **0**
O&M Grade: **0**
Clock Start/From: **9**
Clock To:
1st Value: **4.000**
2nd Value:
Value Percent:
Continuous Index:
Within 8" of Joint:
Remarks:

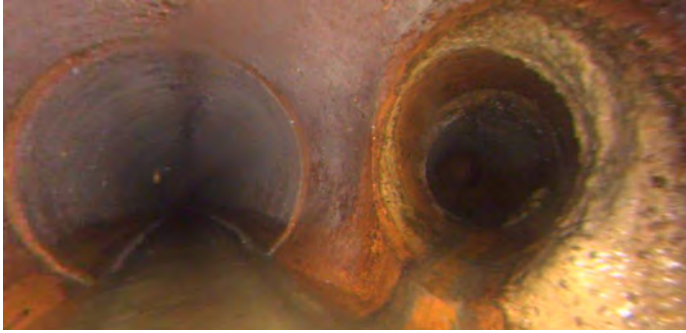
Code: **TF**
Description: **Tap Factory**

Distance (ft): **213.4**
Structural Grade: **0**
O&M Grade: **0**
Clock Start/From: **3**
Clock To:
1st Value: **4.000**
2nd Value:
Value Percent:
Continuous Index:
Within 8" of Joint:
Remarks:

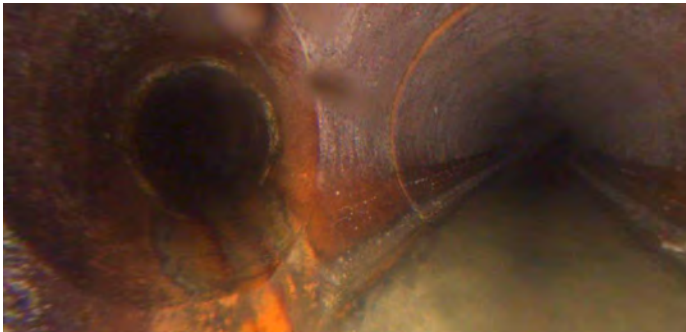
Code: **TF**
Description: **Tap Factory**

Distance (ft): **227.8**
Structural Grade: **0**
O&M Grade: **0**
Clock Start/From: **9**
Clock To:
1st Value: **4.000**
2nd Value:
Value Percent:
Continuous Index:
Within 8" of Joint:
Remarks:
