## Profile/Photo Observation Report

Street:	<b>Capitol</b>	Flow Control:	<b>Not Controlled</b>
City:	<b>Hobart, IN</b>	Year Renewed:	
Location:	<b>Light Highway</b>	Tape/Media #:	
Purpose:	<b>Maintenance Related</b>	Dia/Height:	<b>12"</b>
Use:	<b>Sanitary</b>	Material:	<b>PVC</b>
Drain Area:	<b>NA</b>	Lining:	<b>Cured in Place</b>
Category:	<b>NA</b>		
Comment:	<b>flow incorrect.</b>

Location Details:		Direction of Survey:	<b>Downstream</b>
US MH:	<b>M-707-037</b>	DS MH:	<b>M-707-079</b>
		Total Length Surveyed (ft):	<b>245.8</b>

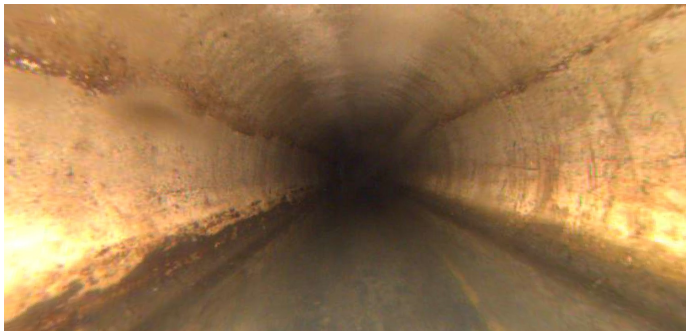
Code: **AMH**  
Description: **Manhole**

Distance (ft): **.0**  
Structural Grade: **0**  
O&M Grade: **0**  
Clock Start/From:  
Clock To:  
1st Value:  
2nd Value:  
Value Percent:  
Continuous Index:  
Within 8" of Joint: **NO**  
Remarks: **M-707-037**

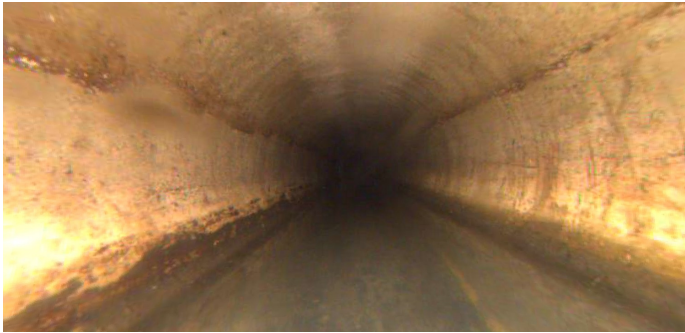
Code:	<b>MWL</b>
Description:	<b>Water Level</b>

Distance (ft):	<b>.0</b>
Structural Grade:	<b>0</b>
O&M Grade:	<b>0</b>
Clock Start/From:	
Clock To:	
1st Value:	
2nd Value:	
Value Percent:	<b>20.000</b>
Continuous Index:	
Within 8" of Joint:	<b>NO</b>
Remarks:

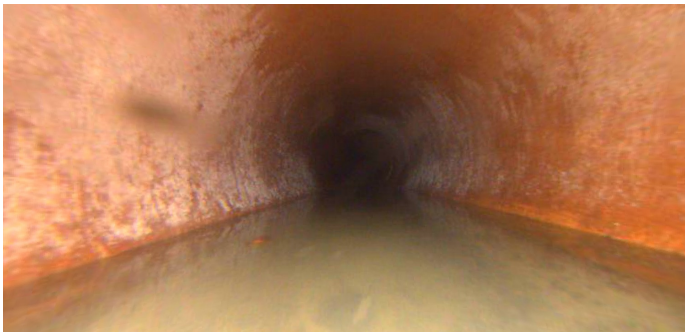
Code:	<b>MMC</b>
Description:	<b>Material Change</b>

Distance (ft):	<b>8.9</b>
Structural Grade:	<b>0</b>
O&M Grade:	<b>0</b>
Clock Start/From:	
Clock To:	
1st Value:	
2nd Value:	
Value Percent:	
Continuous Index:	
Within 8" of Joint:	<b>NO</b>
Remarks:	<b>VCP</b>

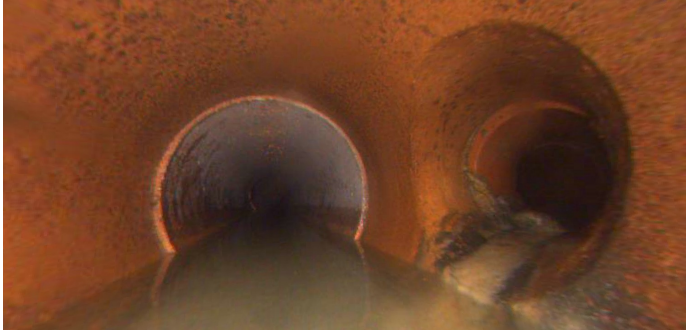
Code: **TF**  
Description: **Tap Factory**

Distance (ft): **30.5**  
Structural Grade: **0**  
O&M Grade: **0**  
Clock Start/From: **3**  
Clock To:  
1st Value: **4.000**  
2nd Value:  
Value Percent:  
Continuous Index:  
Within 8" of Joint:  
Remarks:

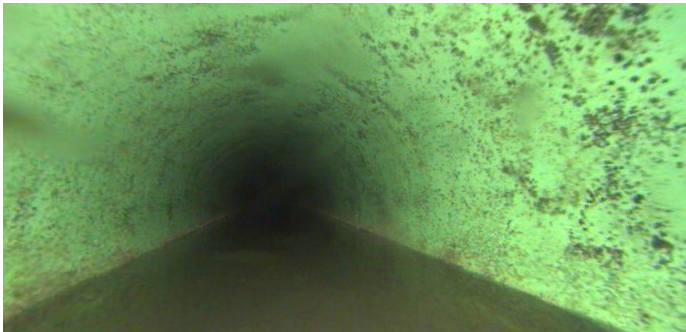
Code: **MMC**  
Description: **Material Change**

Distance (ft): **100.3**  
Structural Grade: **0**  
O&M Grade: **0**  
Clock Start/From:  
Clock To:  
1st Value:  
2nd Value:  
Value Percent:  
Continuous Index:  
Within 8" of Joint: **NO**  
Remarks: **PVC**

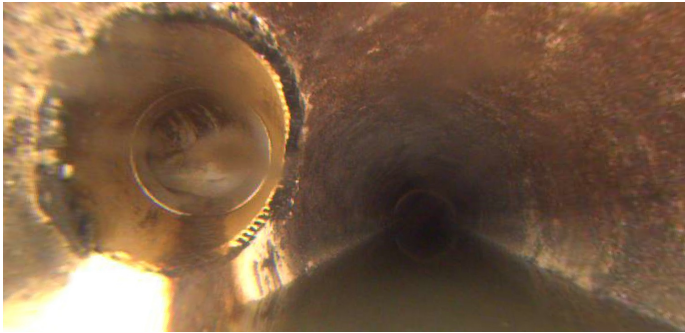
Code: **TB**  
Description: **Tap Break-in**

Distance (ft): **120.3**  
Structural Grade: **0**  
O&M Grade: **0**  
Clock Start/From: **9**  
Clock To:  
1st Value: **4.000**  
2nd Value:  
Value Percent:  
Continuous Index:  
Within 8" of Joint:  
Remarks:

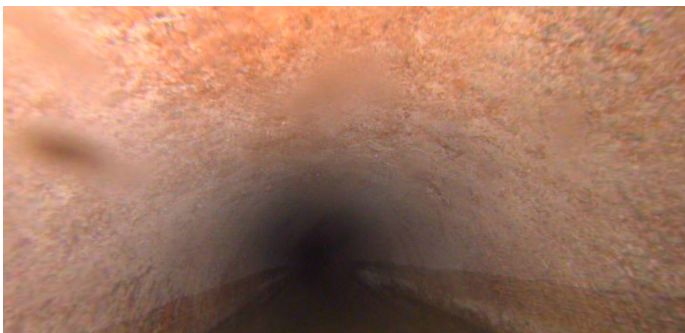
Code: **MMC**  
Description: **Material Change**

Distance (ft): **125.5**  
Structural Grade: **0**  
O&M Grade: **0**  
Clock Start/From:  
Clock To:  
1st Value:  
2nd Value:  
Value Percent:  
Continuous Index:  
Within 8" of Joint: **NO**  
Remarks: **vcp**

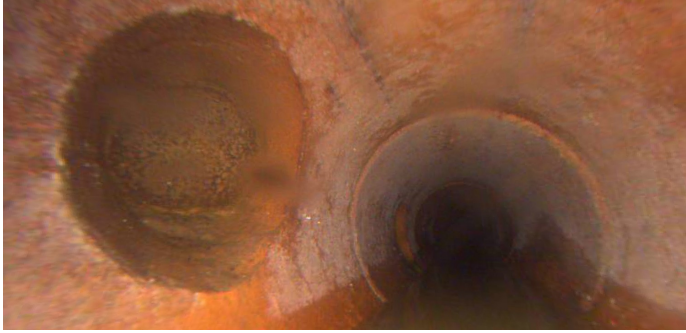
Code: **TFC**  
Description: **Tap Factory Capped**

Distance (ft): **161.3**  
Structural Grade: **0**  
O&M Grade: **0**  
Clock Start/From: **9**  
Clock To:  
1st Value: **4.000**  
2nd Value:  
Value Percent:  
Continuous Index:  
Within 8" of Joint:  
Remarks:

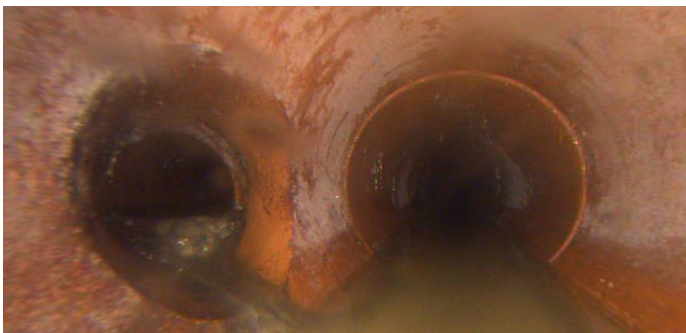
Code: **TFA**  
Description: **Tap Factory Active**

Distance (ft): **163.4**  
Structural Grade: **0**  
O&M Grade: **0**  
Clock Start/From: **9**  
Clock To:  
1st Value: **4.000**  
2nd Value:  
Value Percent:  
Continuous Index:  
Within 8" of Joint:  
Remarks:

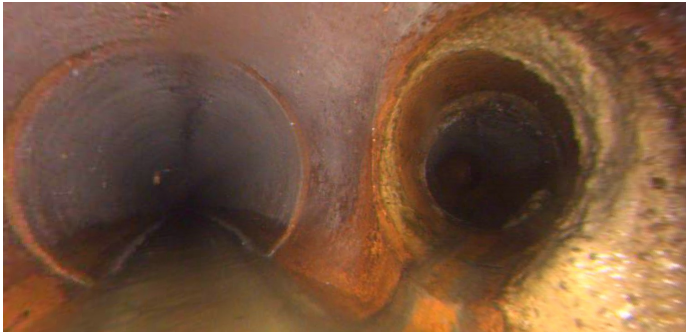
Code: **TF**  
Description: **Tap Factory**

Distance (ft): **213.4**  
Structural Grade: **0**  
O&M Grade: **0**  
Clock Start/From: **3**  
Clock To:  
1st Value: **4.000**  
2nd Value:  
Value Percent:  
Continuous Index:  
Within 8" of Joint:  
Remarks:

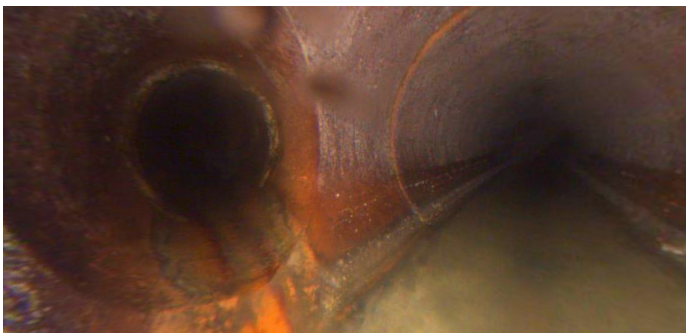
Code: **TF**  
Description: **Tap Factory**

Distance (ft): **227.8**  
Structural Grade: **0**  
O&M Grade: **0**  
Clock Start/From: **9**  
Clock To:  
1st Value: **4.000**  
2nd Value:  
Value Percent:  
Continuous Index:  
Within 8" of Joint:  
Remarks:

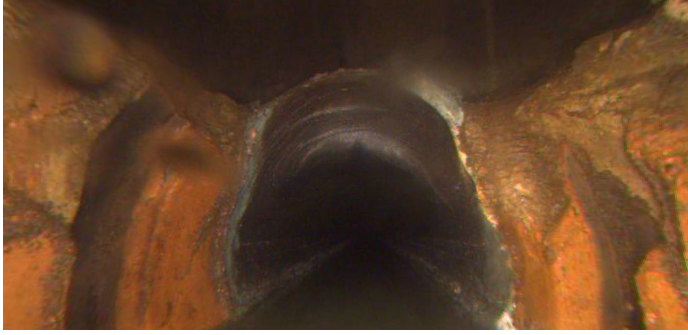
Code:	<b>AMH</b>
Description:	<b>Manhole</b>
Distance (ft):	<b>245.8</b>
Structural Grade:	<b>0</b>
O&M Grade:	<b>0</b>
Clock Start/From:	
Clock To:	
1st Value:	
2nd Value:	
Value Percent:	
Continuous Index:	
Within 8" of Joint:	<b>NO</b>
Remarks:	<b>M-707-079</b>
