Profile/Photo Observation Report

Street:	STATE ST	Flow Control:	Not Controlled
City:	Hobart, IN	Year Renewed:	
Location:	Light Highway	Tape/Media #:	
Purpose:	Maintenance Related	Dia/Height:	12"
Use:	Sanitary	Material:	VCP
Drain Area:	NA	Lining:	Cured in Place
Category:	NA		
Comment:	flow incorrect.

Location Details:		Direction of Survey:	Downstream
US MH:	M-707-039	DS MH:	M-707-038
		Total Length Surveyed (ft):	333.4

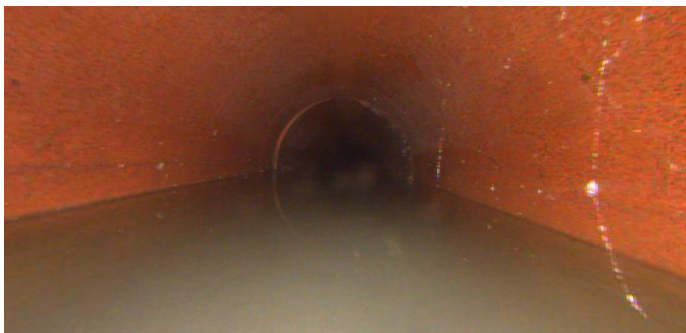
Code: **AMH**
Description: **Manhole**

Distance (ft): **.0**
Structural Grade: **0**
O&M Grade: **0**
Clock Start/From:
Clock To:
1st Value:
2nd Value:
Value Percent:
Continuous Index:
Within 8" of Joint: **NO**
Remarks: **M-707-039**

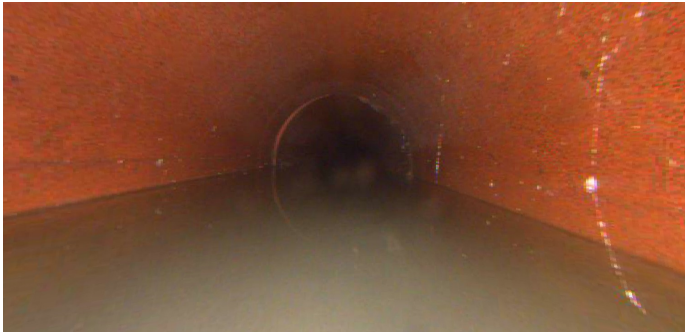
Code:	MWL
Description:	Water Level

Distance (ft):	.0
Structural Grade:	0
O&M Grade:	0
Clock Start/From:	
Clock To:	
1st Value:	
2nd Value:	
Value Percent:	5.000
Continuous Index:	
Within 8" of Joint:	NO
Remarks:

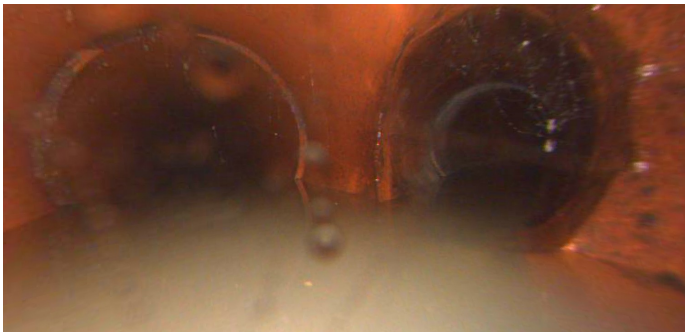
Code:	TFA
Description:	Tap Factory Active

Distance (ft):	58.7
Structural Grade:	0
O&M Grade:	0
Clock Start/From:	3
Clock To:	
1st Value:	4.000
2nd Value:	
Value Percent:	
Continuous Index:	
Within 8" of Joint:	
Remarks:

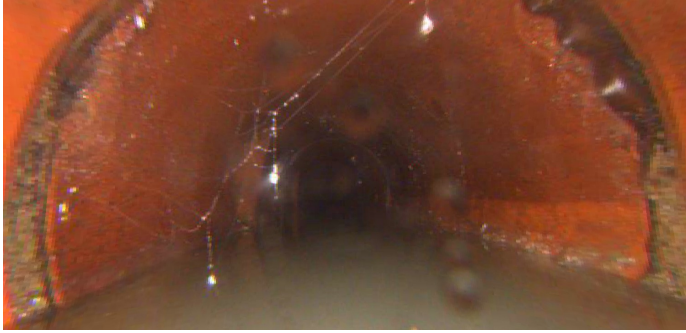
Code: **RFJ**
Description: **Roots Fine Joint**

Distance (ft): **72.0**
Structural Grade: **0**
O&M Grade: **1**
Clock Start/From: **7**
Clock To: **5**
1st Value:
2nd Value:
Value Percent:
Continuous Index:
Within 8" of Joint: **YES**
Remarks:

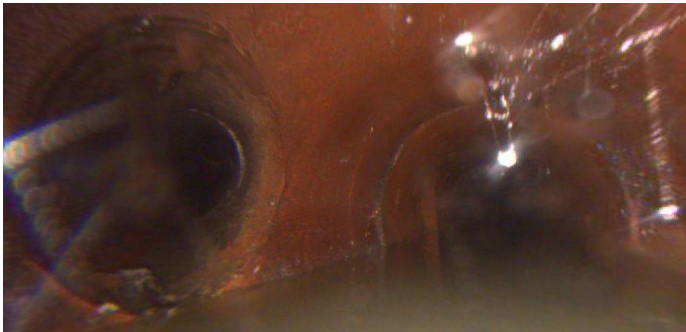
Code: **TF**
Description: **Tap Factory**

Distance (ft): **73.1**
Structural Grade: **0**
O&M Grade: **0**
Clock Start/From: **9**
Clock To:
1st Value: **4.000**
2nd Value:
Value Percent:
Continuous Index:
Within 8" of Joint:
Remarks:

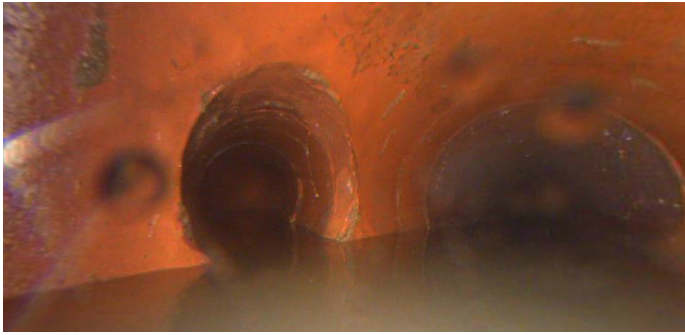
Code: **TFA**
Description: **Tap Factory Active**

Distance (ft): **75.1**
Structural Grade: **0**
O&M Grade: **0**
Clock Start/From: **9**
Clock To:
1st Value: **4.000**
2nd Value:
Value Percent:
Continuous Index:
Within 8" of Joint:
Remarks:

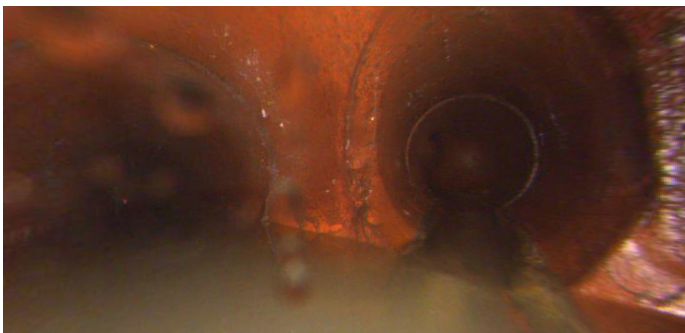
Code: **TFA**
Description: **Tap Factory Active**

Distance (ft): **144.6**
Structural Grade: **0**
O&M Grade: **0**
Clock Start/From: **3**
Clock To:
1st Value: **4.000**
2nd Value:
Value Percent:
Continuous Index:
Within 8" of Joint:
Remarks:

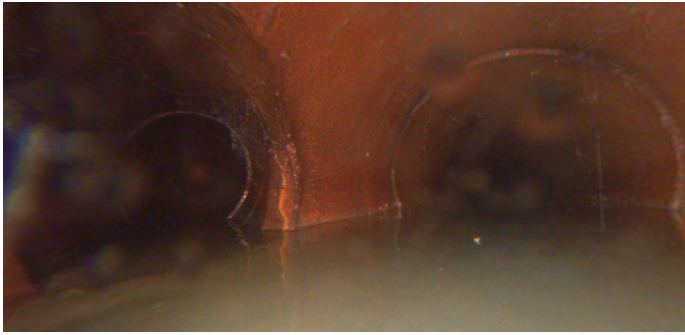
Code: **TFA**
Description: **Tap Factory Active**

Distance (ft): **152.8**
Structural Grade: **0**
O&M Grade: **0**
Clock Start/From: **9**
Clock To:
1st Value: **4.000**
2nd Value:
Value Percent:
Continuous Index:
Within 8" of Joint:
Remarks:

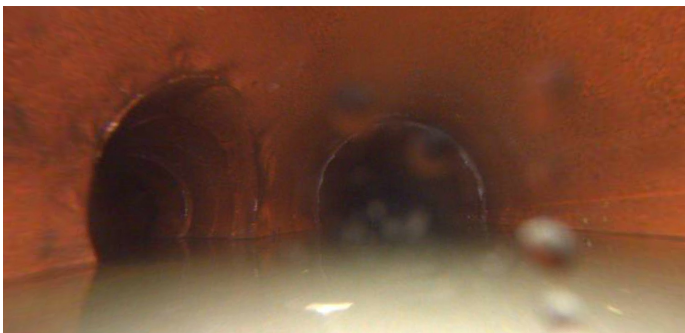
Code: **TFA**
Description: **Tap Factory Active**

Distance (ft): **195.0**
Structural Grade: **0**
O&M Grade: **0**
Clock Start/From: **9**
Clock To:
1st Value: **4.000**
2nd Value:
Value Percent:
Continuous Index:
Within 8" of Joint:
Remarks:

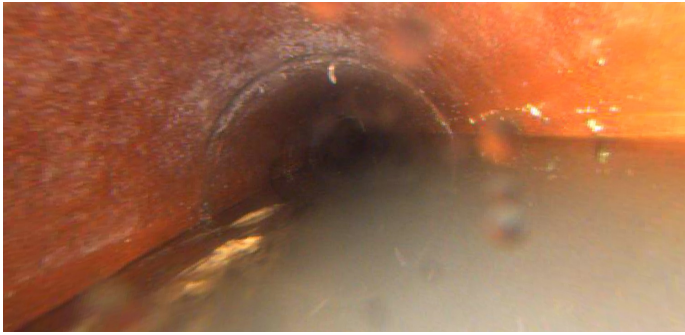
Code: **RFJ**
Description: **Roots Fine Joint**

Distance (ft): **271.9**
Structural Grade: **0**
O&M Grade: **1**
Clock Start/From: **11**
Clock To: **1**
1st Value:
2nd Value:
Value Percent:
Continuous Index:
Within 8" of Joint: **YES**
Remarks:

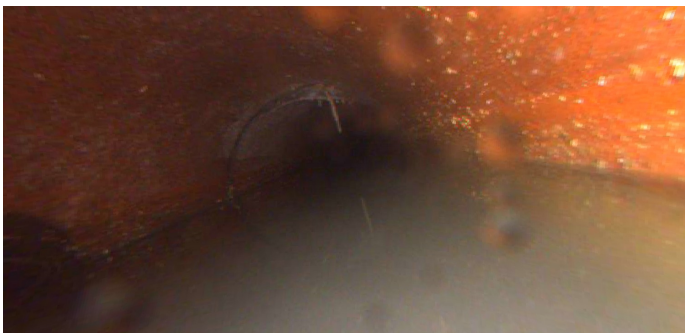
Code: **RFJ**
Description: **Roots Fine Joint**

Distance (ft): **273.5**
Structural Grade: **0**
O&M Grade: **1**
Clock Start/From: **12**
Clock To: **1**
1st Value:
2nd Value:
Value Percent:
Continuous Index:
Within 8" of Joint: **YES**
Remarks:

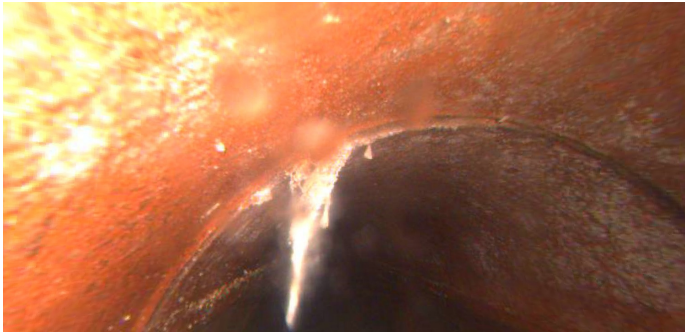
Code: **RFJ**
Description: **Roots Fine Joint**

Distance (ft): **288.9**
Structural Grade: **0**
O&M Grade: **1**
Clock Start/From: **11**
Clock To:
1st Value:
2nd Value:
Value Percent:
Continuous Index:
Within 8" of Joint: **YES**
Remarks:

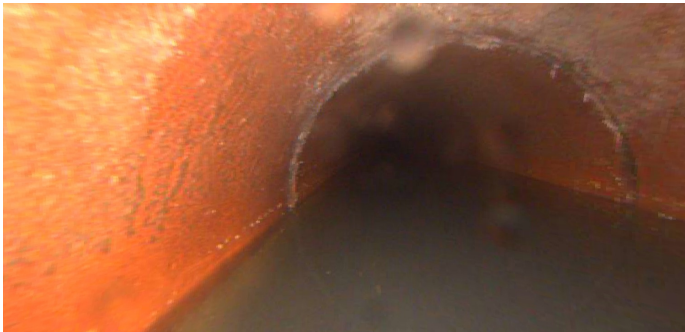
Code: **RFJ**
Description: **Roots Fine Joint**

Distance (ft): **300.5**
Structural Grade: **0**
O&M Grade: **1**
Clock Start/From: **11**
Clock To: **3**
1st Value:
2nd Value:
Value Percent:
Continuous Index:
Within 8" of Joint: **YES**
Remarks:

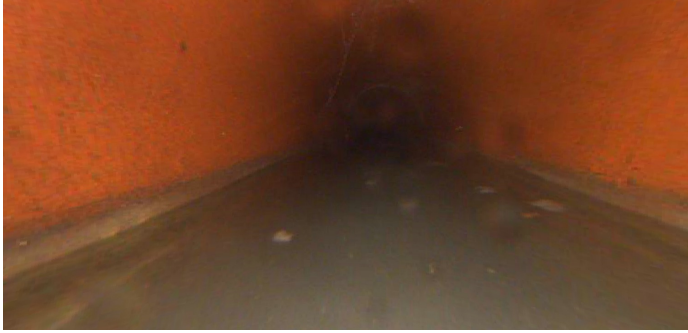
Code:	AMH
Description:	Manhole
Distance (ft):	333.4
Structural Grade:	0
O&M Grade:	0
Clock Start/From:	
Clock To:	
1st Value:	
2nd Value:	
Value Percent:	
Continuous Index:	
Within 8" of Joint:	NO
Remarks:	M-707-038
