## Profile/Photo Observation Report

Date:	<b>04/15/2018</b>	Weather:		Coding:	<b>PACP 6.0</b>
Pipe Length (ft):	<b>336.1</b>	Owner:	<b>NA</b>	Pre Clean:	<b>Not Known</b>
P.O.#:		Surveyor:	<b>Selasie Honu</b>	PSR:	<b>P-707-038-039</b>
Customer:		Clean Date:	<b>01/01/1900</b>	Shape:	<b>C</b>

Street:	<b>Capitol</b>	Flow Control:	<b>Not Controlled</b>
City:	<b>Hobart, IN</b>	Year Renewed:	
Location:	<b>Light Highway</b>	Tape/Media #:	
Purpose:	<b>Maintenance Related</b>	Dia/Height:	<b>12"</b>
Use:	<b>Sanitary</b>	Material:	<b>VCP</b>
Drain Area:	<b>NA</b>	Lining:	<b>Cured in Place</b>
Category:	<b>NA</b>		
Comment:	<b>flow incorrect.</b>

Location Details:		Direction of Survey:	<b>Downstream</b>
US MH:	<b>M-707-039</b>	DS MH:	<b>M-707-038</b>
		Total Length Surveyed (ft):	<b>333.4</b>

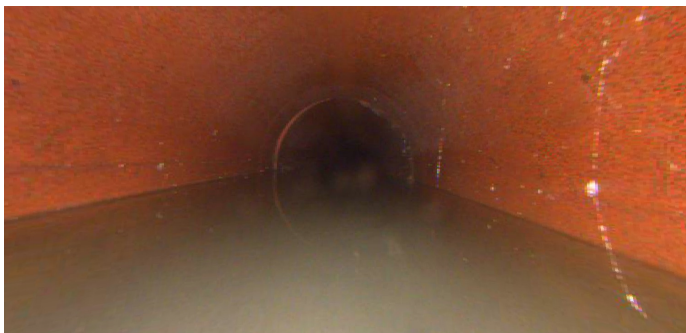
Code: **AMH**  
Description: **Manhole**

Distance (ft): **.0**  
Structural Grade: **0**  
O&M Grade: **0**  
Clock Start/From:  
Clock To:  
1st Value:  
2nd Value:  
Value Percent:  
Continuous Index:  
Within 8" of Joint: **NO**  
Remarks: **M-707-039**

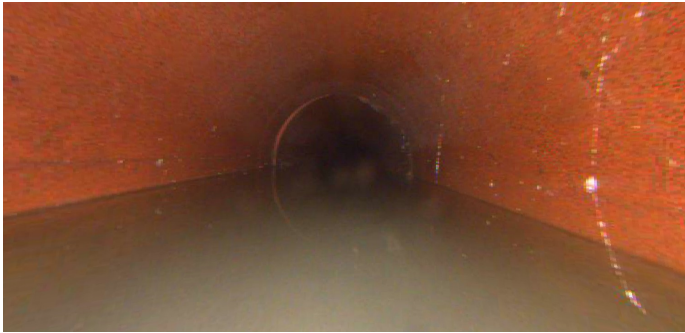
Code:	<b>MWL</b>
Description:	<b>Water Level</b>

Distance (ft):	<b>.0</b>
Structural Grade:	<b>0</b>
O&M Grade:	<b>0</b>
Clock Start/From:	
Clock To:	
1st Value:	
2nd Value:	
Value Percent:	<b>5.000</b>
Continuous Index:	
Within 8" of Joint:	<b>NO</b>
Remarks:

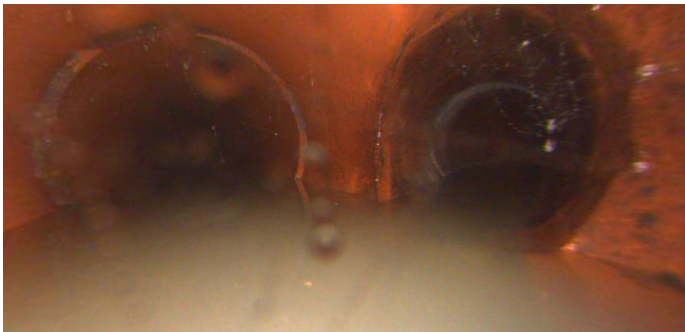
Code:	<b>TFA</b>
Description:	<b>Tap Factory Active</b>

Distance (ft):	<b>58.7</b>
Structural Grade:	<b>0</b>
O&M Grade:	<b>0</b>
Clock Start/From:	<b>3</b>
Clock To:	
1st Value:	<b>4.000</b>
2nd Value:	
Value Percent:	
Continuous Index:	
Within 8" of Joint:	
Remarks:

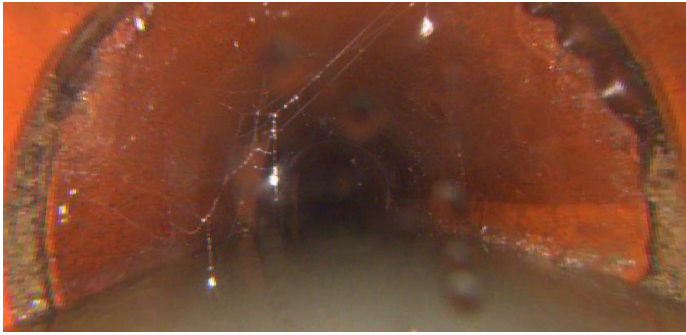
Code: **RFJ**  
Description: **Roots Fine Joint**

Distance (ft): **72.0**  
Structural Grade: **0**  
O&M Grade: **1**  
Clock Start/From: **7**  
Clock To: **5**  
1st Value:  
2nd Value:  
Value Percent:  
Continuous Index:  
Within 8" of Joint: **YES**  
Remarks:

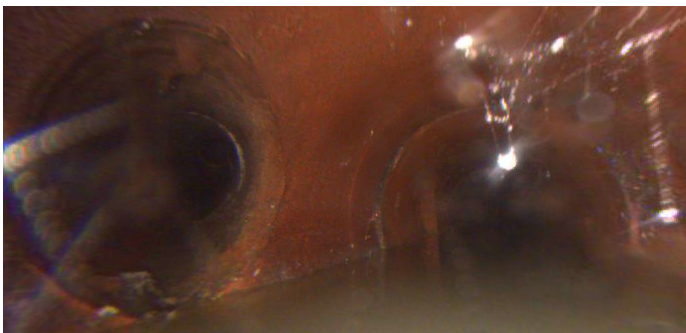
Code: **TF**  
Description: **Tap Factory**

Distance (ft): **73.1**  
Structural Grade: **0**  
O&M Grade: **0**  
Clock Start/From: **9**  
Clock To:  
1st Value: **4.000**  
2nd Value:  
Value Percent:  
Continuous Index:  
Within 8" of Joint:  
Remarks:

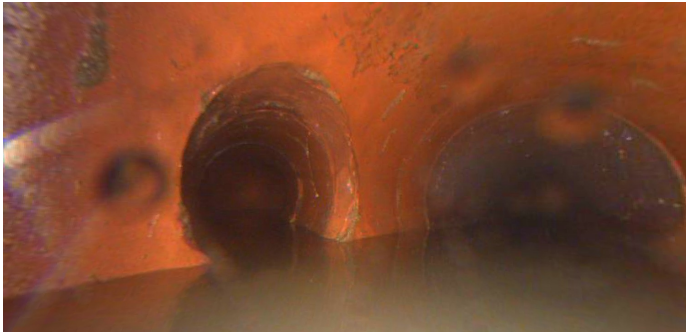
Code: **TFA**  
Description: **Tap Factory Active**

Distance (ft): **75.1**  
Structural Grade: **0**  
O&M Grade: **0**  
Clock Start/From: **9**  
Clock To:  
1st Value: **4.000**  
2nd Value:  
Value Percent:  
Continuous Index:  
Within 8" of Joint:  
Remarks:

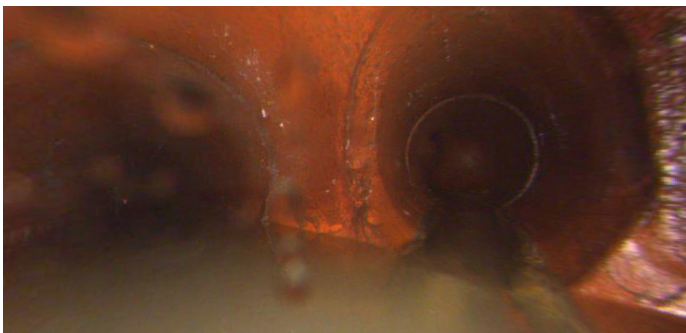
Code: **TFA**  
Description: **Tap Factory Active**

Distance (ft): **144.6**  
Structural Grade: **0**  
O&M Grade: **0**  
Clock Start/From: **3**  
Clock To:  
1st Value: **4.000**  
2nd Value:  
Value Percent:  
Continuous Index:  
Within 8" of Joint:  
Remarks:

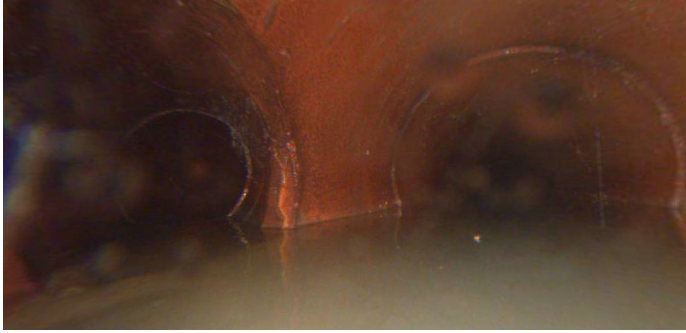
Code: **TFA**  
Description: **Tap Factory Active**

Distance (ft): **152.8**  
Structural Grade: **0**  
O&M Grade: **0**  
Clock Start/From: **9**  
Clock To:  
1st Value: **4.000**  
2nd Value:  
Value Percent:  
Continuous Index:  
Within 8" of Joint:  
Remarks:

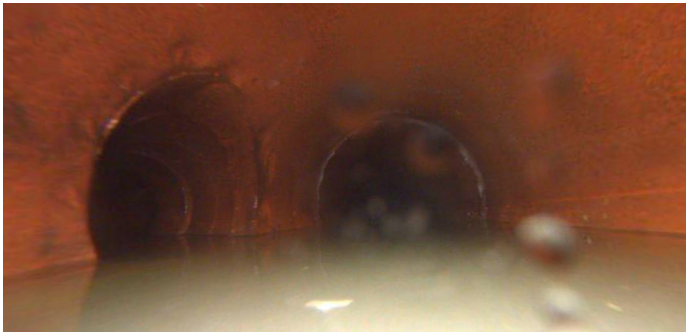
Code: **TFA**  
Description: **Tap Factory Active**

Distance (ft): **195.0**  
Structural Grade: **0**  
O&M Grade: **0**  
Clock Start/From: **9**  
Clock To:  
1st Value: **4.000**  
2nd Value:  
Value Percent:  
Continuous Index:  
Within 8" of Joint:  
Remarks:

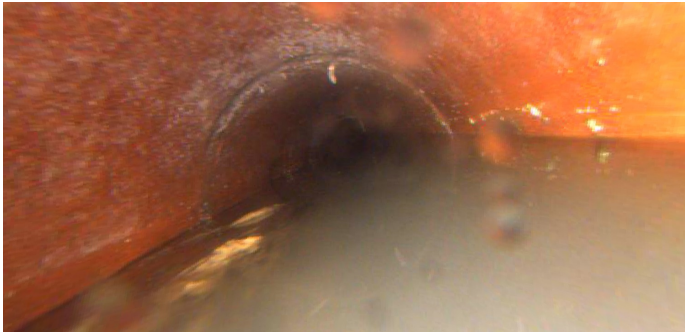
Code: **RFJ**  
Description: **Roots Fine Joint**

Distance (ft): **271.9**  
Structural Grade: **0**  
O&M Grade: **1**  
Clock Start/From: **11**  
Clock To: **1**  
1st Value:  
2nd Value:  
Value Percent:  
Continuous Index:  
Within 8" of Joint: **YES**  
Remarks:

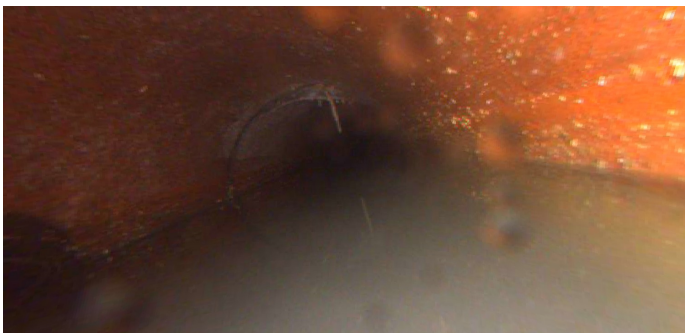
Code: **RFJ**  
Description: **Roots Fine Joint**

Distance (ft): **273.5**  
Structural Grade: **0**  
O&M Grade: **1**  
Clock Start/From: **12**  
Clock To: **1**  
1st Value:  
2nd Value:  
Value Percent:  
Continuous Index:  
Within 8" of Joint: **YES**  
Remarks:

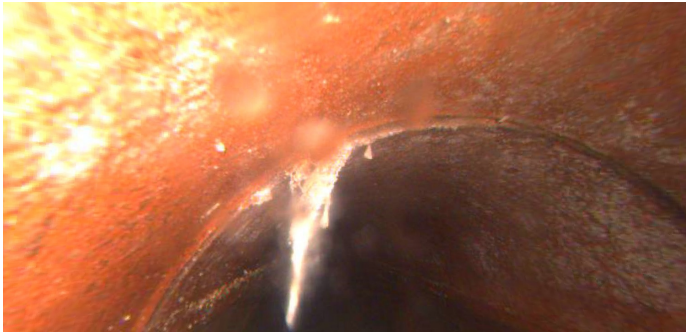
Code: **RFJ**  
Description: **Roots Fine Joint**

Distance (ft): **288.9**  
Structural Grade: **0**  
O&M Grade: **1**  
Clock Start/From: **11**  
Clock To:  
1st Value:  
2nd Value:  
Value Percent:  
Continuous Index:  
Within 8" of Joint: **YES**  
Remarks:

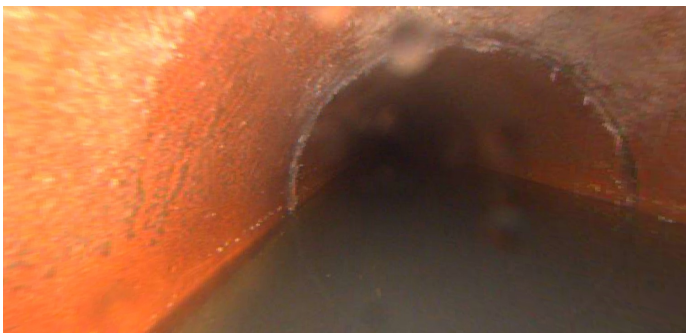
Code: **RFJ**  
Description: **Roots Fine Joint**

Distance (ft): **300.5**  
Structural Grade: **0**  
O&M Grade: **1**  
Clock Start/From: **11**  
Clock To: **3**  
1st Value:  
2nd Value:  
Value Percent:  
Continuous Index:  
Within 8" of Joint: **YES**  
Remarks:

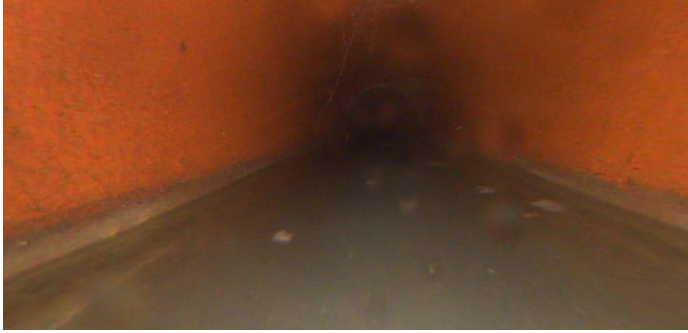
Code:	<b>AMH</b>
Description:	<b>Manhole</b>
Distance (ft):	<b>333.4</b>
Structural Grade:	<b>0</b>
O&M Grade:	<b>0</b>
Clock Start/From:	
Clock To:	
1st Value:	
2nd Value:	
Value Percent:	
Continuous Index:	
Within 8" of Joint:	<b>NO</b>
Remarks:	<b>M-707-038</b>
