## Profile/Photo Observation Report

Street:	<b>STATE ST</b>	Flow Control:	<b>Not Controlled</b>
City:	<b>Hobart, IN</b>	Year Renewed:	
Location:	<b>Light Highway</b>	Tape/Media #:	
Purpose:	<b>Maintenance Related</b>	Dia/Height:	<b>12"</b>
Use:	<b>Sanitary</b>	Material:	<b>VCP</b>
Drain Area:	<b>NA</b>	Lining:	<b>Cured in Place</b>
Category:	<b>NA</b>		
Comment:	<b>heavy silt at 2'.</b>

Location Details:		Direction of Survey:	<b>Downstream</b>
US MH:	<b>M-707-040</b>	DS MH:	<b>M-707-039</b>
		Total Length Surveyed (ft):	<b>3.4</b>

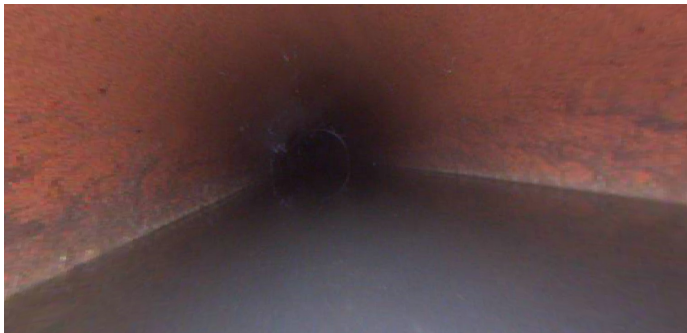
Code: **AMH**  
 Description: **Manhole**  
 Distance (ft): **.0**  
 Structural Grade: **0**  
 O&M Grade: **0**  
 Clock Start/From:  
 Clock To:  
 1st Value:  
 2nd Value:  
 Value Percent:  
 Continuous Index:  
 Within 8" of Joint: **NO**  
 Remarks: **M-707-040**

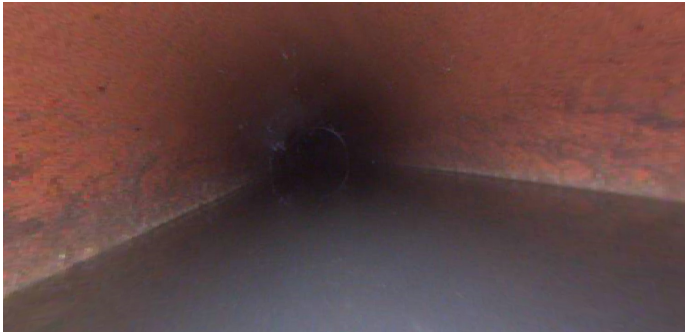
Code:	<b>MWL</b>
Description:	<b>Water Level</b>

Distance (ft):	<b>.0</b>
Structural Grade:	<b>0</b>
O&M Grade:	<b>0</b>
Clock Start/From:	
Clock To:	
1st Value:	
2nd Value:	
Value Percent:	<b>5.000</b>
Continuous Index:	
Within 8" of Joint:	<b>NO</b>
Remarks:
