## Profile/Photo Observation Report

Street:	<b>Capitol</b>	Flow Control:	<b>Not Controlled</b>
City:	<b>Hobart, IN</b>	Year Renewed:	
Location:	<b>Light Highway</b>	Tape/Media #:	
Purpose:	<b>Maintenance Related</b>	Dia/Height:	<b>12"</b>
Use:	<b>Sanitary</b>	Material:	<b>CP</b>
Drain Area:	<b>NA</b>	Lining:	<b>Cured in Place</b>
Category:	<b>NA</b>		
Comment:	<b>Reverse setup.</b>

Location Details:		Direction of Survey:	<b>Upstream</b>
US MH:	<b>M-707-040</b>	DS MH:	<b>M-707-039</b>
		Total Length Surveyed (ft):	<b>359.3</b>

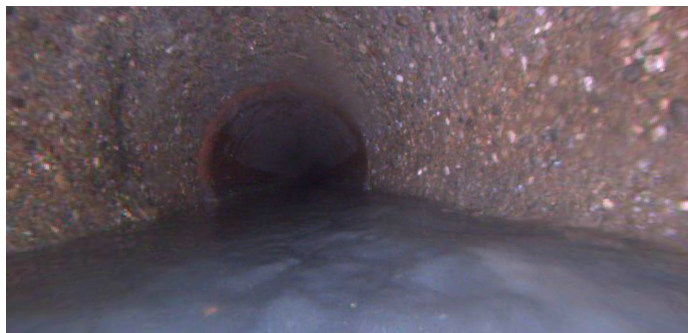
Code: **MWL**  
 Description: **Water Level**  
 Distance (ft): **.0**  
 Structural Grade: **0**  
 O&M Grade: **0**  
 Clock Start/From:  
 Clock To:  
 1st Value:  
 2nd Value:  
 Value Percent: **30.000**  
 Continuous Index:  
 Within 8" of Joint: **NO**  
 Remarks:

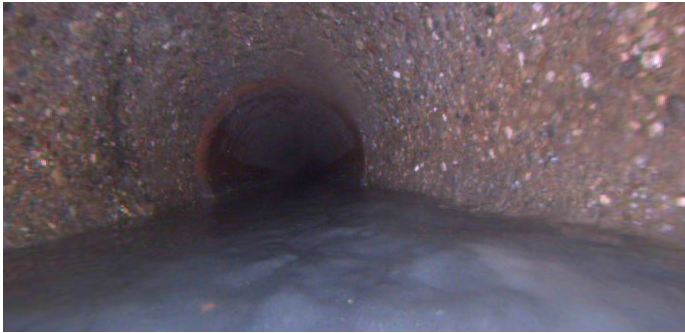
Code:	<b>SAP</b>
Description:	<b>Surface Aggregate Projecting</b>

Distance (ft):	<b>.0</b>
Structural Grade:	<b>3</b>
O&M Grade:	<b>0</b>
Clock Start/From:	<b>8</b>
Clock To:	<b>4</b>
1st Value:	
2nd Value:	
Value Percent:	
Continuous Index:	
Within 8" of Joint:	
Remarks:

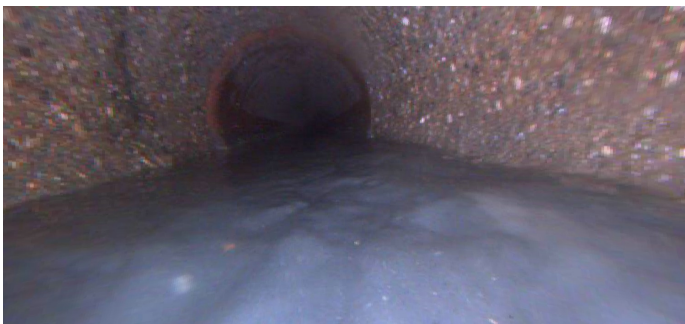
Code:	<b>AMH</b>
Description:	<b>Manhole</b>

Distance (ft):	<b>.0</b>
Structural Grade:	<b>0</b>
O&M Grade:	<b>0</b>
Clock Start/From:	
Clock To:	
1st Value:	
2nd Value:	
Value Percent:	
Continuous Index:	
Within 8" of Joint:	<b>NO</b>
Remarks:	<b>M-707-039</b>

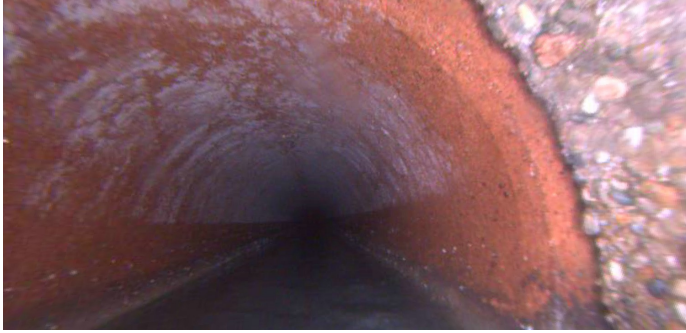
Code: **MMC**  
Description: **Material Change**

Distance (ft): **2.6**  
Structural Grade: **0**  
O&M Grade: **0**  
Clock Start/From:  
Clock To:  
1st Value:  
2nd Value:  
Value Percent:  
Continuous Index:  
Within 8" of Joint: **NO**  
Remarks: **vcp**

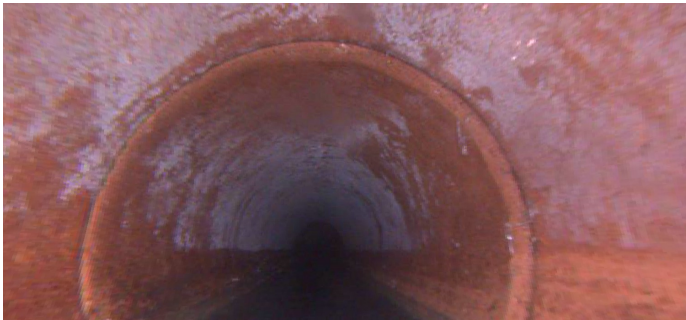
Code: **RFJ**  
Description: **Roots Fine Joint**

Distance (ft): **27.1**  
Structural Grade: **0**  
O&M Grade: **1**  
Clock Start/From: **2**  
Clock To:  
1st Value:  
2nd Value:  
Value Percent:  
Continuous Index:  
Within 8" of Joint: **YES**  
Remarks:

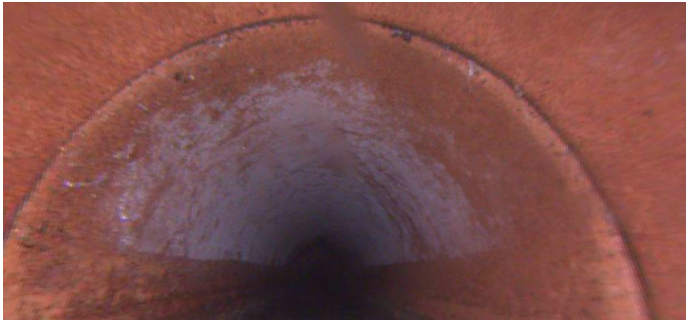
Code: **RFJ**  
Description: **Roots Fine Joint**

Distance (ft): **51.4**  
Structural Grade: **0**  
O&M Grade: **1**  
Clock Start/From: **11**  
Clock To: **1**  
1st Value:  
2nd Value:  
Value Percent:  
Continuous Index:  
Within 8" of Joint: **YES**  
Remarks:

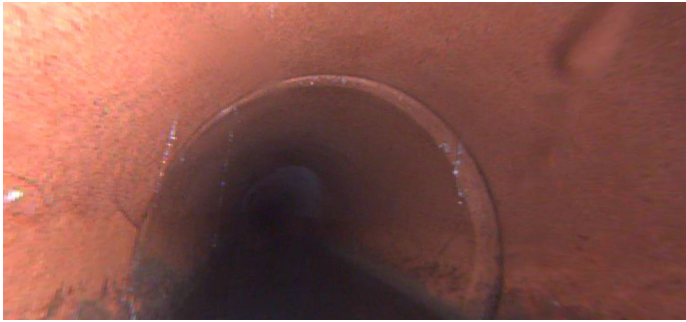
Code: **RFJ**  
Description: **Roots Fine Joint**

Distance (ft): **83.5**  
Structural Grade: **0**  
O&M Grade: **1**  
Clock Start/From: **12**  
Clock To: **2**  
1st Value:  
2nd Value:  
Value Percent:  
Continuous Index:  
Within 8" of Joint: **YES**  
Remarks:

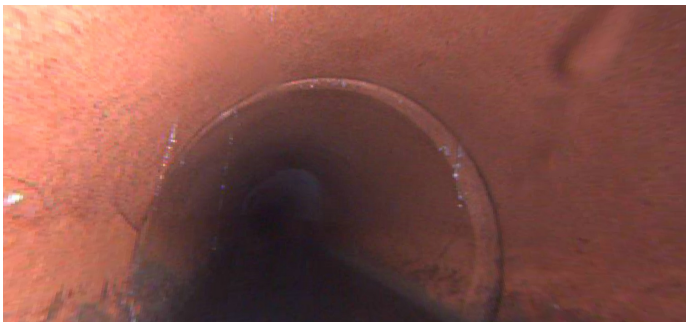
Code: **FL**  
Description: **Fracture Longitudinal**

Distance (ft): **83.5**  
Structural Grade: **3**  
O&M Grade: **0**  
Clock Start/From: **9**  
Clock To:  
1st Value:  
2nd Value:  
Value Percent:  
Continuous Index:  
Within 8" of Joint: **YES**  
Remarks:

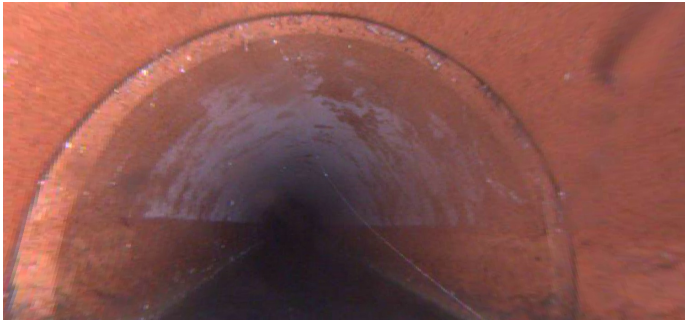
Code: **RFJ**  
Description: **Roots Fine Joint**

Distance (ft): **107.6**  
Structural Grade: **0**  
O&M Grade: **1**  
Clock Start/From: **12**  
Clock To: **3**  
1st Value:  
2nd Value:  
Value Percent:  
Continuous Index:  
Within 8" of Joint: **YES**  
Remarks:

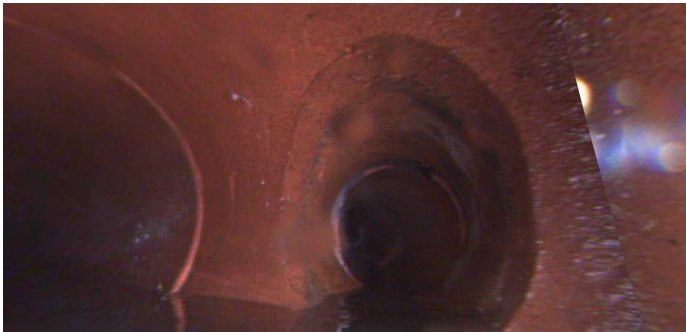
Code: **TFA**  
Description: **Tap Factory Active**

Distance (ft): **161.6**  
Structural Grade: **0**  
O&M Grade: **0**  
Clock Start/From: **9**  
Clock To:  
1st Value: **4.000**  
2nd Value:  
Value Percent:  
Continuous Index:  
Within 8" of Joint:  
Remarks:

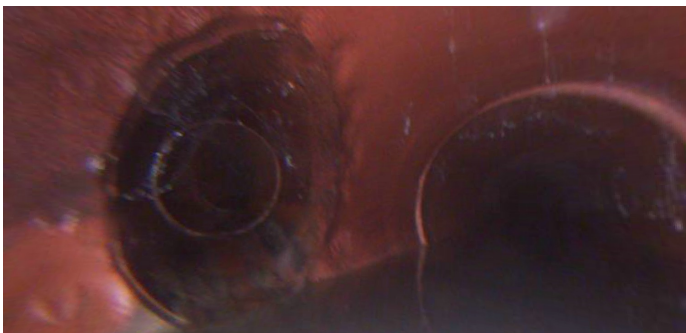
Code: **TF**  
Description: **Tap Factory**

Distance (ft): **212.2**  
Structural Grade: **0**  
O&M Grade: **0**  
Clock Start/From: **3**  
Clock To:  
1st Value: **4.000**  
2nd Value:  
Value Percent:  
Continuous Index:  
Within 8" of Joint:  
Remarks:

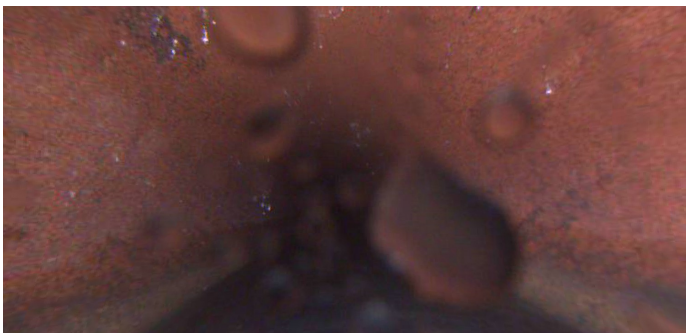
Code: **AMH**  
Description: **Manhole**

Distance (ft): **359.3**  
Structural Grade: **0**  
O&M Grade: **0**  
Clock Start/From:  
Clock To:  
1st Value:  
2nd Value:  
Value Percent:  
Continuous Index:  
Within 8" of Joint: **NO**  
Remarks: **M-707-040**
