Profile/Photo Observation Report

Date:	04/15/2018	Weather:		Coding:	PACP 6.0
Pipe Length (ft):	290.3	Owner:	NA	Pre Clean:	Not Known
P.O.#:		Surveyor:	Selasie Honu	PSR:	P-707-040-075
Customer:		Clean Date:	01/01/1900	Shape:	C

Street:	STATE ST	Flow Control:	Not Controlled
City:	Hobart, IN	Year Renewed:	
Location:	Light Highway	Tape/Media #:	
Purpose:	Maintenance Related	Dia/Height:	12"
Use:	Sanitary	Material:	VCP
Drain Area:	NA	Lining:	Cured in Place
Category:	NA		
Comment:	2nd attempt.

Location Details:		Direction of Survey:	Downstream
US MH:	M-707-040	DS MH:	M-707-075
		Total Length Surveyed (ft):	292.1

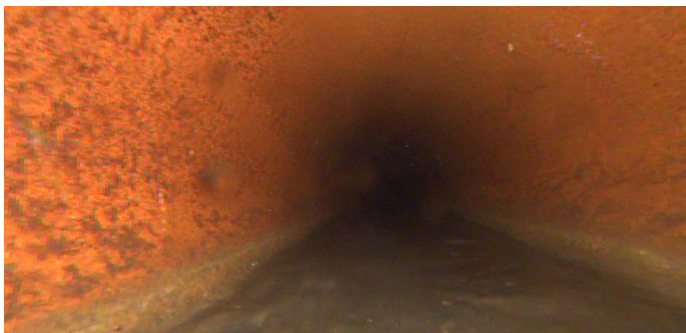
Code: **AMH**
Description: **Manhole**

Distance (ft): **.0**
Structural Grade: **0**
O&M Grade: **0**
Clock Start/From:
Clock To:
1st Value:
2nd Value:
Value Percent:
Continuous Index:
Within 8" of Joint: **NO**
Remarks: **M-707-040**

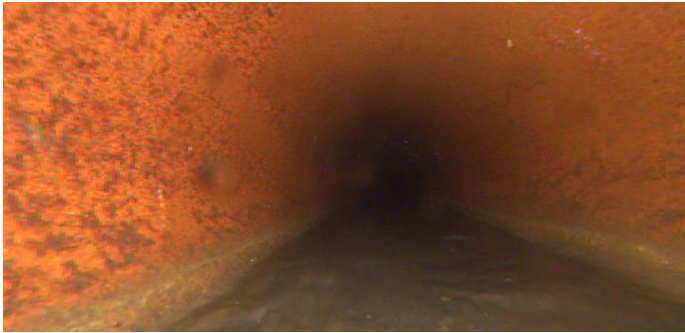
Code:	MWL
Description:	Water Level

Distance (ft):	.0
Structural Grade:	0
O&M Grade:	0
Clock Start/From:	
Clock To:	
1st Value:	
2nd Value:	
Value Percent:	5.000
Continuous Index:	
Within 8" of Joint:	NO
Remarks:

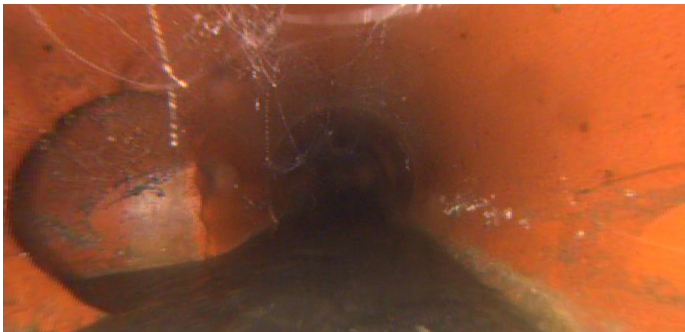
Code:	TF
Description:	Tap Factory

Distance (ft):	35.9
Structural Grade:	0
O&M Grade:	0
Clock Start/From:	9
Clock To:	
1st Value:	4.000
2nd Value:	
Value Percent:	
Continuous Index:	
Within 8" of Joint:	
Remarks:

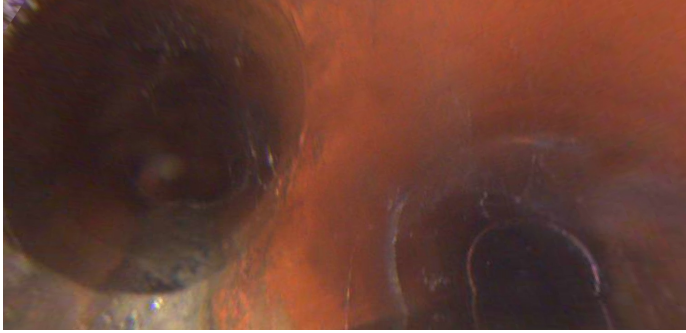
Code: **TFA**
Description: **Tap Factory Active**

Distance (ft): **39.1**
Structural Grade: **0**
O&M Grade: **0**
Clock Start/From: **3**
Clock To:
1st Value: **4.000**
2nd Value:
Value Percent:
Continuous Index:
Within 8" of Joint:
Remarks:

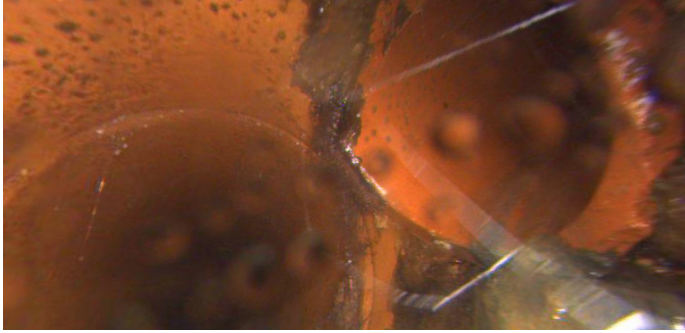
Code: **TBI**
Description: **Tap Break-in Intruding**

Distance (ft): **77.9**
Structural Grade: **0**
O&M Grade: **2**
Clock Start/From: **2**
Clock To:
1st Value: **4.000**
2nd Value: **1.000**
Value Percent:
Continuous Index:
Within 8" of Joint:
Remarks:

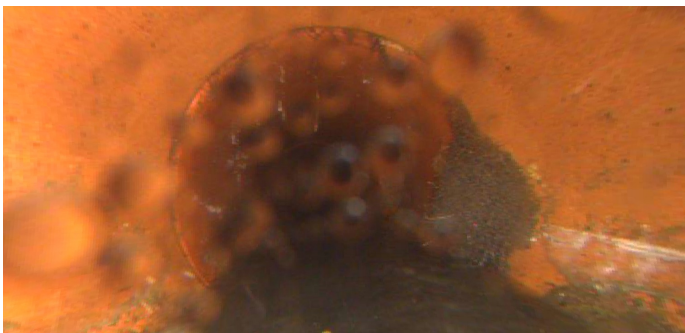
Code: **RMJ**
Description: **Roots Medium Joint**

Distance (ft): **176.6**
Structural Grade: **0**
O&M Grade: **3**
Clock Start/From: **7**
Clock To: **5**
1st Value:
2nd Value:
Value Percent: **20.000**
Continuous Index:
Within 8" of Joint: **YES**
Remarks:

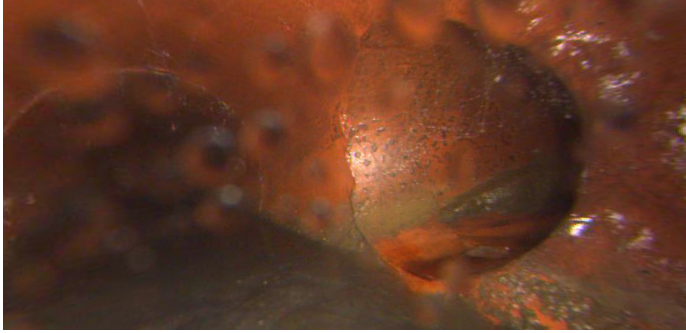
Code: **TFA**
Description: **Tap Factory Active**

Distance (ft): **178.2**
Structural Grade: **0**
O&M Grade: **0**
Clock Start/From: **3**
Clock To:
1st Value: **4.000**
2nd Value:
Value Percent:
Continuous Index:
Within 8" of Joint:
Remarks:

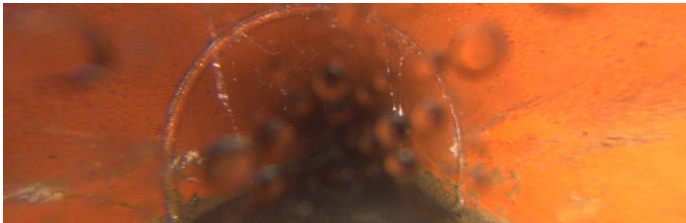
Code: **RFJ**
Description: **Roots Fine Joint**

Distance (ft): **179.1**
Structural Grade: **0**
O&M Grade: **1**
Clock Start/From: **7**
Clock To: **5**
1st Value:
2nd Value:
Value Percent:
Continuous Index:
Within 8" of Joint: **YES**
Remarks:

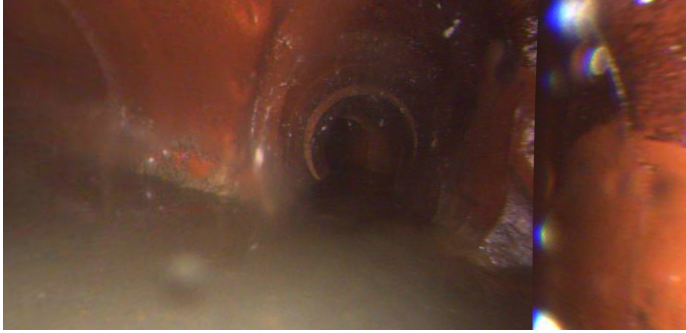
Code: **TFA**
Description: **Tap Factory Active**

Distance (ft): **187.1**
Structural Grade: **0**
O&M Grade: **0**
Clock Start/From: **9**
Clock To:
1st Value: **4.000**
2nd Value:
Value Percent:
Continuous Index:
Within 8" of Joint:
Remarks:

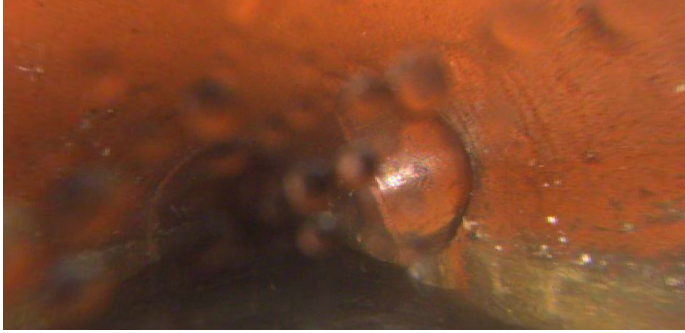
Code: **TF**
Description: **Tap Factory**

Distance (ft): **232.6**
Structural Grade: **0**
O&M Grade: **0**
Clock Start/From: **3**
Clock To:
1st Value: **4.000**
2nd Value:
Value Percent:
Continuous Index:
Within 8" of Joint:
Remarks:

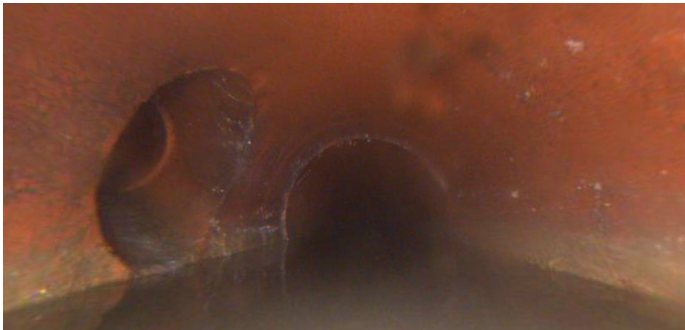
Code: **TF**
Description: **Tap Factory**

Distance (ft): **234.3**
Structural Grade: **0**
O&M Grade: **0**
Clock Start/From: **3**
Clock To:
1st Value: **4.000**
2nd Value:
Value Percent:
Continuous Index:
Within 8" of Joint:
Remarks:

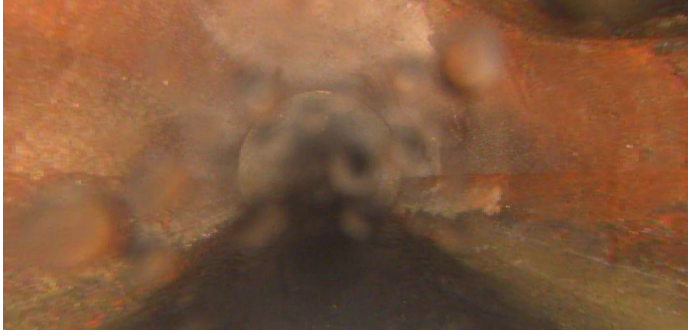
Code:	AMH
Description:	Manhole
Distance (ft):	292.1
Structural Grade:	0
O&M Grade:	0
Clock Start/From:	
Clock To:	
1st Value:	
2nd Value:	
Value Percent:	
Continuous Index:	
Within 8" of Joint:	NO
Remarks:	M-707-075
