Profile/Photo Observation Report

Date:	04/06/2018	Weather:		Coding:	PACP 6.0
Pipe Length (ft):	290.0	Owner:	NA	Pre Clean:	Not Known
P.O.#:		Surveyor:	Jen Costello	PSR:	P-707-045-046
Customer:		Clean Date:	01/01/1900	Shape:	C

Street:	E 13TH PL	Flow Control:	Not Controlled
City:	Hobart, IN	Year Renewed:	
Location:	Light Highway	Tape/Media #:	
Purpose:	Maintenance Related	Dia/Height:	8"
Use:	Sanitary	Material:	PVC
Drain Area:	NA	Lining:	Cured in Place
Category:	NA		
Comment:

Location Details:		Direction of Survey:	Downstream
US MH:	M-707-046	DS MH:	M-707-045
		Total Length Surveyed (ft):	284.8

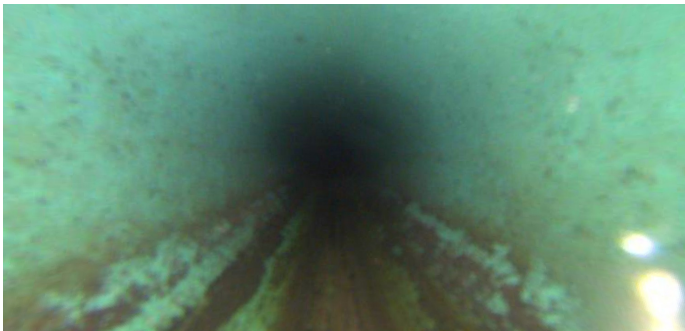
Code: **AMH**
Description: **Manhole**

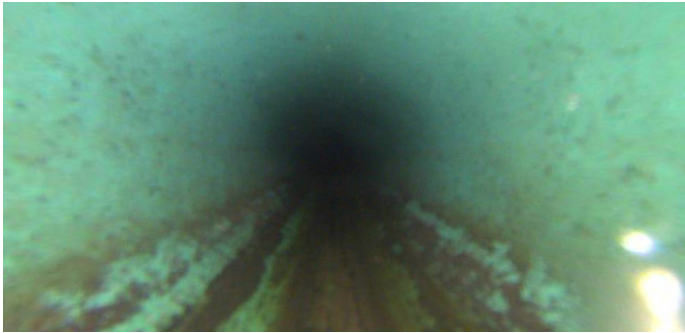
Code:	MWL
Description:	Water Level

Distance (ft):	.0
Structural Grade:	0
O&M Grade:	0
Clock Start/From:	
Clock To:	
1st Value:	
2nd Value:	
Value Percent:	5.000
Continuous Index:	
Within 8" of Joint:	NO
Remarks:

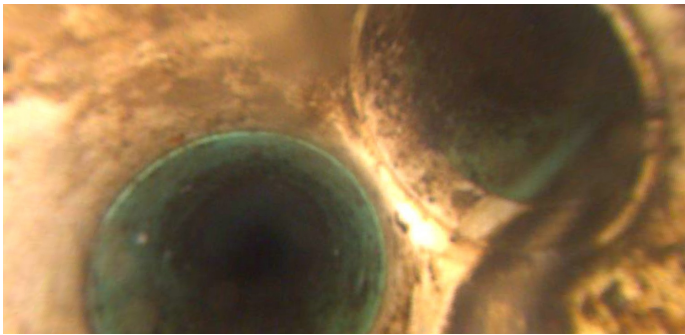
Code:	TF
Description:	Tap Factory

Distance (ft):	9.1
Structural Grade:	0
O&M Grade:	0
Clock Start/From:	2
Clock To:	
1st Value:	4.000
2nd Value:	
Value Percent:	
Continuous Index:	
Within 8" of Joint:	
Remarks:

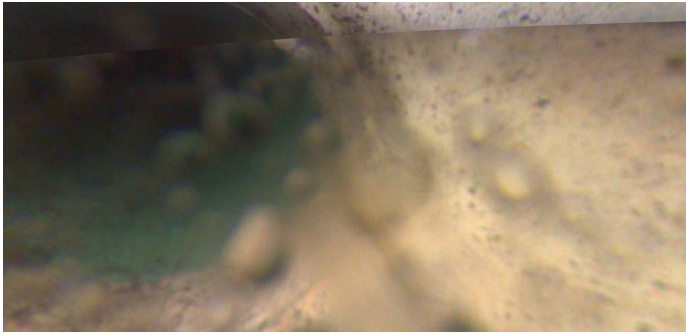
Code: **TF**
Description: **Tap Factory**

Distance (ft): **56.9**
Structural Grade: **0**
O&M Grade: **0**
Clock Start/From: **11**
Clock To:
1st Value: **4.000**
2nd Value:
Value Percent:
Continuous Index:
Within 8" of Joint:
Remarks:

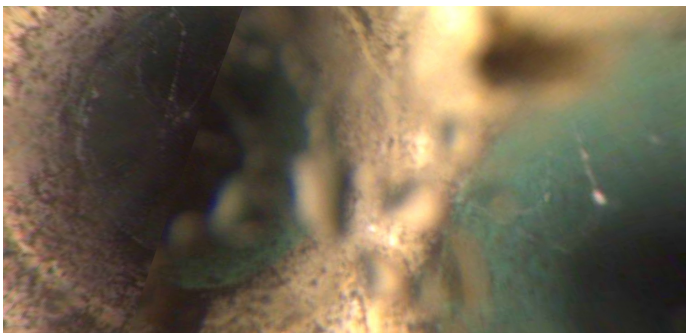
Code: **TF**
Description: **Tap Factory**

Distance (ft): **143.9**
Structural Grade: **0**
O&M Grade: **0**
Clock Start/From: **9**
Clock To:
1st Value: **4.000**
2nd Value:
Value Percent:
Continuous Index:
Within 8" of Joint:
Remarks:

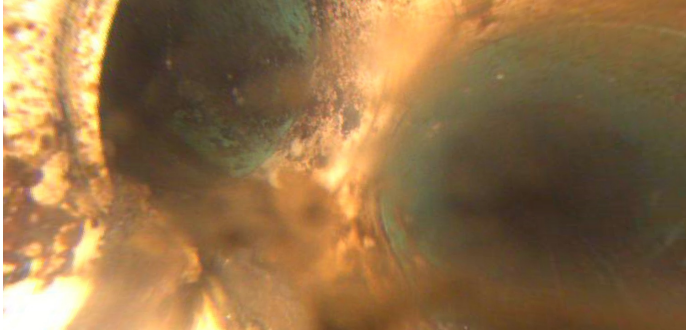
Code: **TF**
Description: **Tap Factory**

Distance (ft): **191.5**
Structural Grade: **0**
O&M Grade: **0**
Clock Start/From: **2**
Clock To:
1st Value: **4.000**
2nd Value:
Value Percent:
Continuous Index:
Within 8" of Joint:
Remarks:

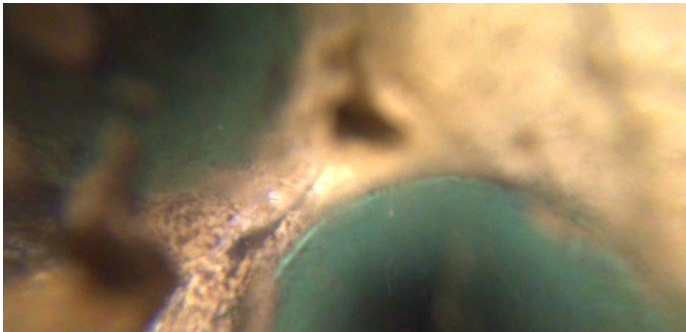
Code: **TF**
Description: **Tap Factory**

Distance (ft): **214.2**
Structural Grade: **0**
O&M Grade: **0**
Clock Start/From: **11**
Clock To:
1st Value: **4.000**
2nd Value:
Value Percent:
Continuous Index:
Within 8" of Joint:
Remarks:

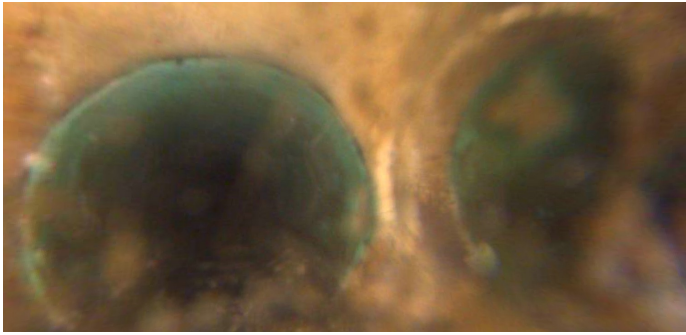
Code: **TF**
Description: **Tap Factory**

Distance (ft): **268.6**
Structural Grade: **0**
O&M Grade: **0**
Clock Start/From: **3**
Clock To:
1st Value: **4.000**
2nd Value:
Value Percent:
Continuous Index:
Within 8" of Joint:
Remarks:

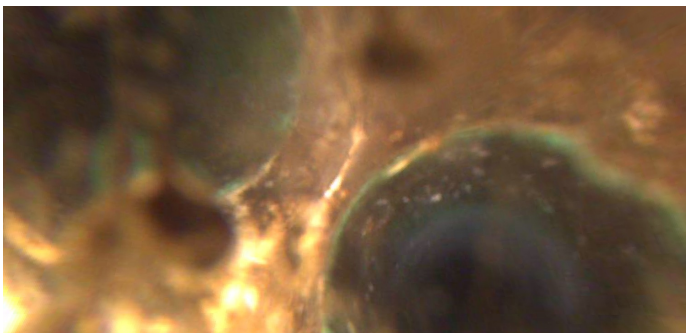
Code: **TF**
Description: **Tap Factory**

Distance (ft): **274.4**
Structural Grade: **0**
O&M Grade: **0**
Clock Start/From: **10**
Clock To:
1st Value: **4.000**
2nd Value:
Value Percent:
Continuous Index:
Within 8" of Joint:
Remarks:

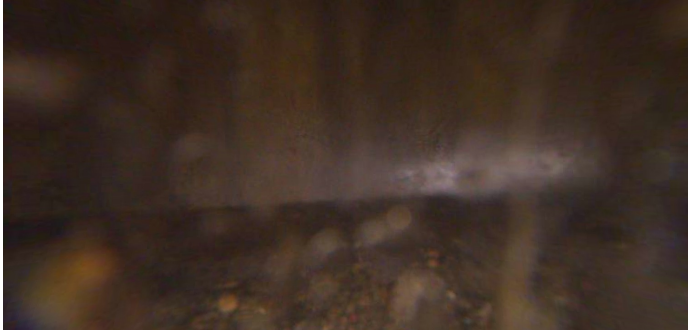
Code:	AMH
Description:	Manhole
Distance (ft):	283.4
Structural Grade:	0
O&M Grade:	0
Clock Start/From:	
Clock To:	
1st Value:	
2nd Value:	
Value Percent:	
Continuous Index:	
Within 8" of Joint:	NO
Remarks:	M-707-045
