Profile/Photo Observation Report

Street:	13th	Flow Control:	Not Controlled
City:	Hobart, IN	Year Renewed:	
Location:	Light Highway	Tape/Media #:	
Purpose:	Maintenance Related	Dia/Height:	8"
Use:	Sanitary	Material:	PVC
Drain Area:	NA	Lining:	Cured in Place
Category:	NA		
Comment:

Location Details:		Direction of Survey:	Downstream
US MH:	M-707-046	DS MH:	M-707-045
		Total Length Surveyed (ft):	284.8

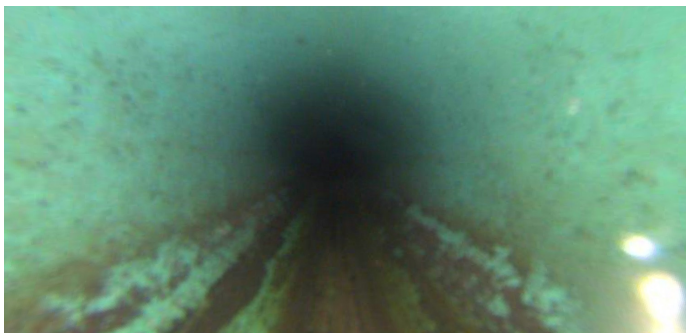
Code: **AMH**
Description: **Manhole**

Distance (ft): **.0**
Structural Grade: **0**
O&M Grade: **0**
Clock Start/From:
Clock To:
1st Value:
2nd Value:
Value Percent:
Continuous Index:
Within 8" of Joint: **NO**
Remarks: **M-707-046**

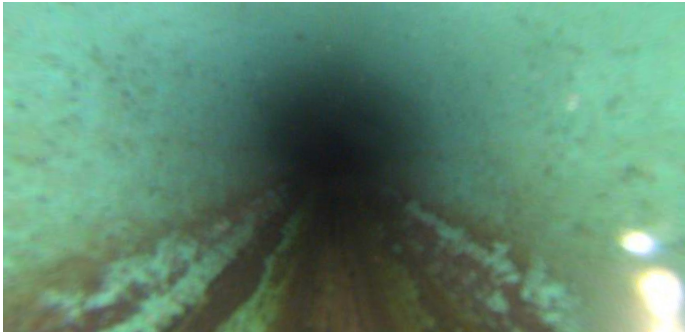
Code:	MWL
Description:	Water Level

Distance (ft):	.0
Structural Grade:	0
O&M Grade:	0
Clock Start/From:	
Clock To:	
1st Value:	
2nd Value:	
Value Percent:	5.000
Continuous Index:	
Within 8" of Joint:	NO
Remarks:

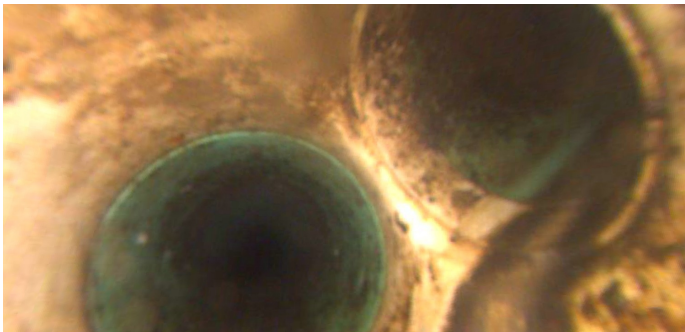
Code:	TF
Description:	Tap Factory

Distance (ft):	9.1
Structural Grade:	0
O&M Grade:	0
Clock Start/From:	2
Clock To:	
1st Value:	4.000
2nd Value:	
Value Percent:	
Continuous Index:	
Within 8" of Joint:	
Remarks:

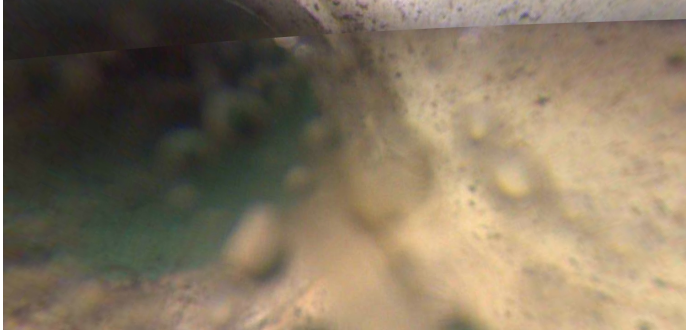
Code: **TF**
Description: **Tap Factory**

Distance (ft): **56.9**
Structural Grade: **0**
O&M Grade: **0**
Clock Start/From: **11**
Clock To:
1st Value: **4.000**
2nd Value:
Value Percent:
Continuous Index:
Within 8" of Joint:
Remarks:

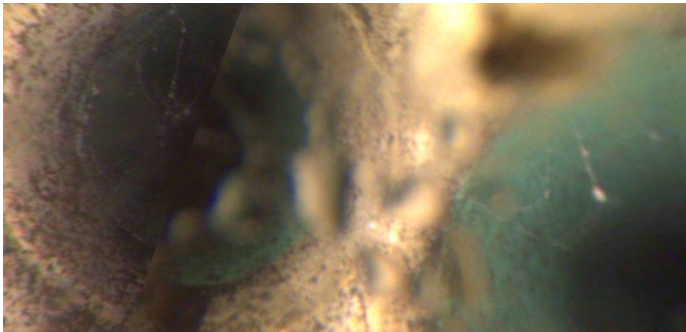
Code: **TF**
Description: **Tap Factory**

Distance (ft): **143.9**
Structural Grade: **0**
O&M Grade: **0**
Clock Start/From: **9**
Clock To:
1st Value: **4.000**
2nd Value:
Value Percent:
Continuous Index:
Within 8" of Joint:
Remarks:

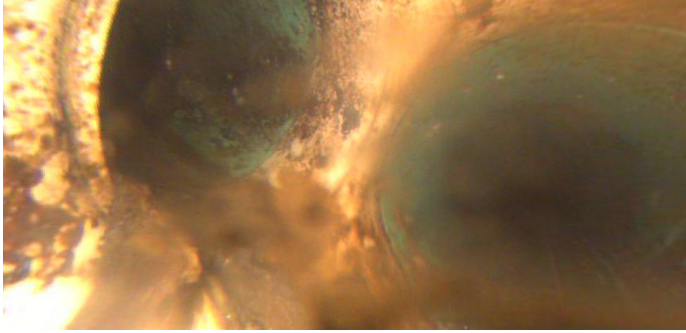
Code: **TF**
Description: **Tap Factory**

Distance (ft): **191.5**
Structural Grade: **0**
O&M Grade: **0**
Clock Start/From: **2**
Clock To:
1st Value: **4.000**
2nd Value:
Value Percent:
Continuous Index:
Within 8" of Joint:
Remarks:

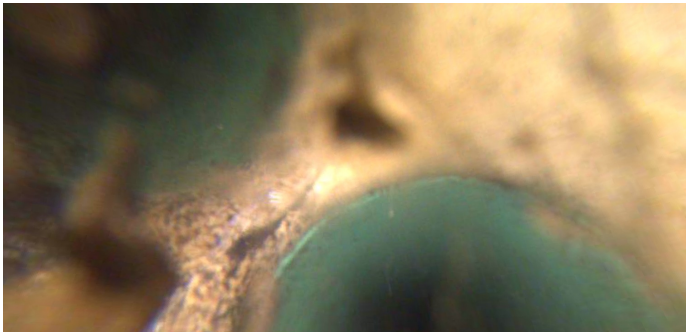
Code: **TF**
Description: **Tap Factory**

Distance (ft): **214.2**
Structural Grade: **0**
O&M Grade: **0**
Clock Start/From: **11**
Clock To:
1st Value: **4.000**
2nd Value:
Value Percent:
Continuous Index:
Within 8" of Joint:
Remarks:

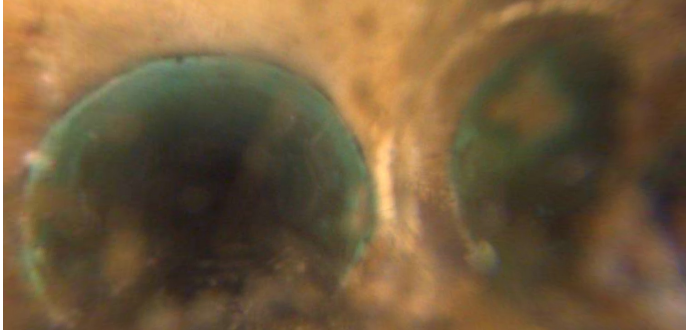
Code: **TF**
Description: **Tap Factory**

Distance (ft): **268.6**
Structural Grade: **0**
O&M Grade: **0**
Clock Start/From: **3**
Clock To:
1st Value: **4.000**
2nd Value:
Value Percent:
Continuous Index:
Within 8" of Joint:
Remarks:

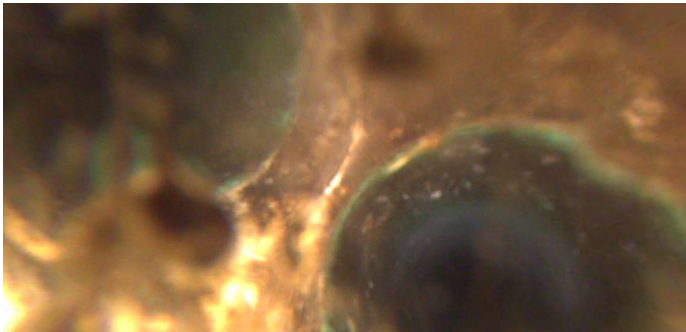
Code: **TF**
Description: **Tap Factory**

Distance (ft): **274.4**
Structural Grade: **0**
O&M Grade: **0**
Clock Start/From: **10**
Clock To:
1st Value: **4.000**
2nd Value:
Value Percent:
Continuous Index:
Within 8" of Joint:
Remarks:

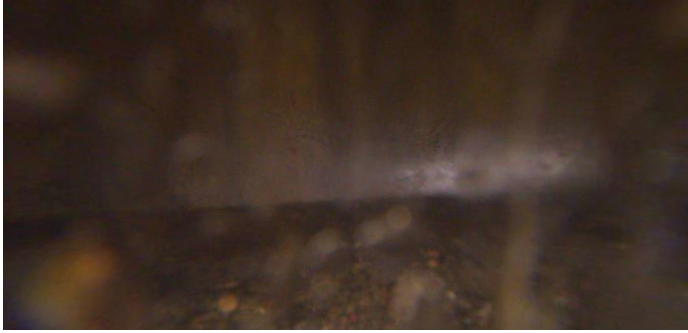
Code:	AMH
Description:	Manhole
Distance (ft):	283.4
Structural Grade:	0
O&M Grade:	0
Clock Start/From:	
Clock To:	
1st Value:	
2nd Value:	
Value Percent:	
Continuous Index:	
Within 8" of Joint:	NO
Remarks:	M-707-045
