Profile/Photo Observation Report

Street:	FLEMING ST & E 13TH PL	Flow Control:	Not Controlled
City:	Hobart, IN	Year Renewed:	
Location:	Light Highway	Tape/Media #:	
Purpose:	Maintenance Related	Dia/Height:	8"
Use:	Sanitary	Material:	PVC
Drain Area:	NA	Lining:	Cured in Place
Category:	NA		
Comment:	Flow direction wrong.

Location Details:		Direction of Survey:	Upstream
US MH:	M-707-047	DS MH:	M-707-046
		Total Length Surveyed (ft):	32.2

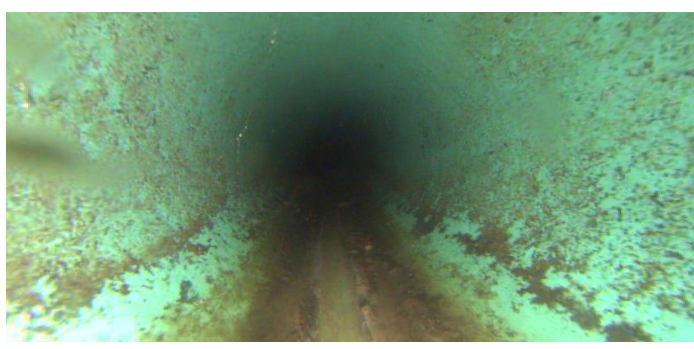
Code: **AMH**
Description: **Manhole**

Distance (ft): **.0**
Structural Grade: **0**
O&M Grade: **0**
Clock Start/From:
Clock To:
1st Value:
2nd Value:
Value Percent:
Continuous Index:
Within 8" of Joint: **NO**
Remarks: **M-707-046**

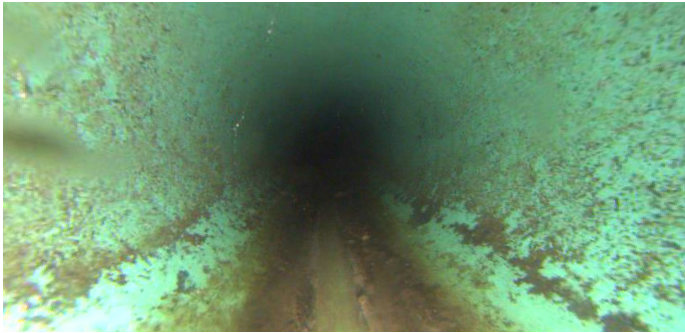
Code:	MWL
Description:	Water Level

Distance (ft):	.0
Structural Grade:	0
O&M Grade:	0
Clock Start/From:	
Clock To:	
1st Value:	
2nd Value:	
Value Percent:	5.000
Continuous Index:	
Within 8" of Joint:	NO
Remarks:

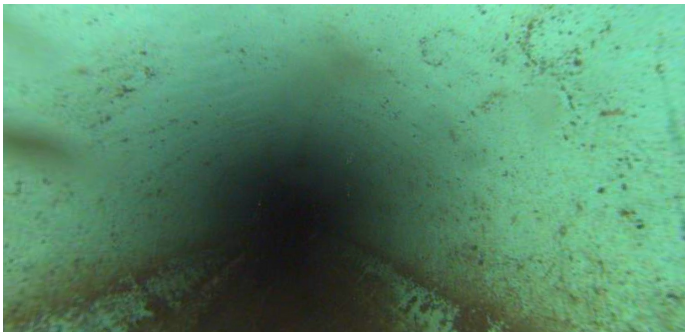
Code:	MSA
Description:	Abandoned Survey

Distance (ft):	32.2
Structural Grade:	0
O&M Grade:	0
Clock Start/From:	
Clock To:	
1st Value:	
2nd Value:	
Value Percent:	
Continuous Index:	
Within 8" of Joint:	NO
Remarks:	UNKNOWN
