Profile/Photo Observation Report

Street:	13th	Flow Control:	Not Controlled
City:	Hobart, IN	Year Renewed:	
Location:	Light Highway	Tape/Media #:	
Purpose:	Maintenance Related	Dia/Height:	8"
Use:	Sanitary	Material:	PVC
Drain Area:	NA	Lining:	Cured in Place
Category:	NA		
Comment:	Flow direction wrong.

Location Details:		Direction of Survey:	Upstream
US MH:	M-707-047	DS MH:	M-707-046
		Total Length Surveyed (ft):	32.2

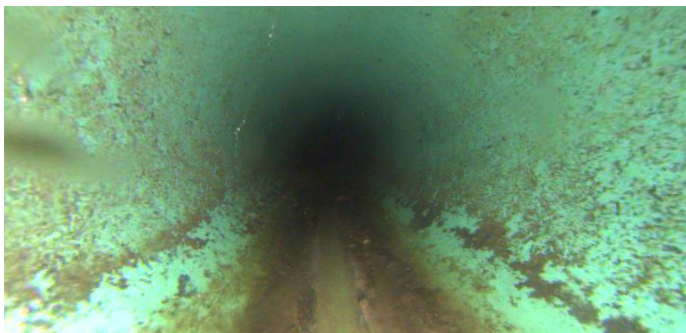
Code: **AMH**
Description: **Manhole**

Distance (ft): **.0**
Structural Grade: **0**
O&M Grade: **0**
Clock Start/From:
Clock To:
1st Value:
2nd Value:
Value Percent:
Continuous Index:
Within 8" of Joint: **NO**
Remarks: **M-707-046**

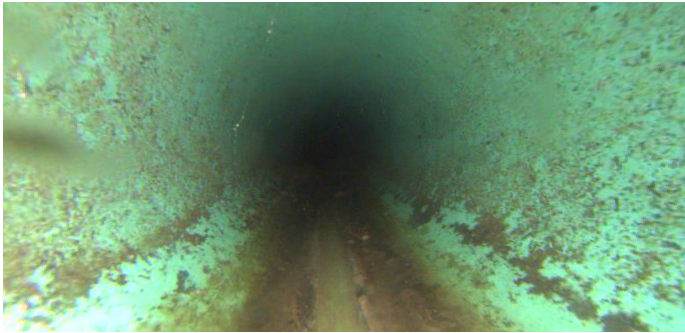
Code:	MWL
Description:	Water Level

Distance (ft):	.0
Structural Grade:	0
O&M Grade:	0
Clock Start/From:	
Clock To:	
1st Value:	
2nd Value:	
Value Percent:	5.000
Continuous Index:	
Within 8" of Joint:	NO
Remarks:

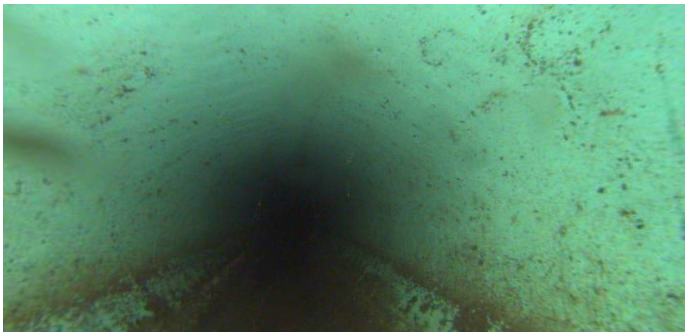
Code:	MSA
Description:	Abandoned Survey

Distance (ft):	32.2
Structural Grade:	0
O&M Grade:	0
Clock Start/From:	
Clock To:	
1st Value:	
2nd Value:	
Value Percent:	
Continuous Index:	
Within 8" of Joint:	NO
Remarks:	UNKNOWN
