Profile/Photo Observation Report

Date:	04/06/2018	Weather:		Coding:	PACP 6.0
Pipe Length (ft):	310.3	Owner:	NA	Pre Clean:	Not Known
P.O.#:		Surveyor:	Jen Costello	PSR:	P-707-046-047
Customer:		Clean Date:	01/01/1900	Shape:	C

Street:	FLEMING ST & E 13TH PL	Flow Control:	Not Controlled
City:	Hobart, IN	Year Renewed:	
Location:	Light Highway	Tape/Media #:	
Purpose:	Maintenance Related	Dia/Height:	8"
Use:	Sanitary	Material:	PVC
Drain Area:	NA	Lining:	Cured in Place
Category:	NA		
Comment:	Flow direction wrong. Reverse setup.		
Location Details:		Direction of Survey:	Downstream
US MH:	M-707-047	DS MH:	M-707-046
		Total Length Surveyed (ft):	305.0

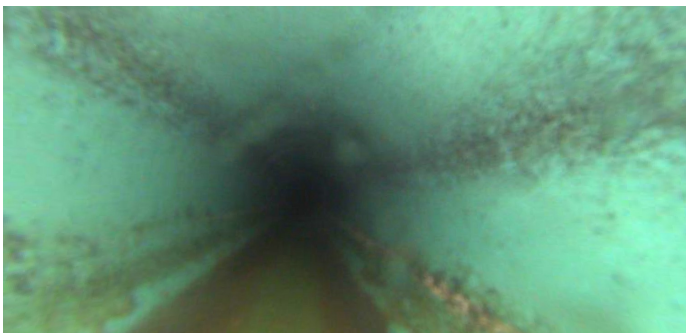
Code: **DAGS**
Description: **Deposits Attached Grease**

Distance (ft): **33.0**
Structural Grade: **0**
O&M Grade: **2**
Clock Start/From: **7**
Clock To: **5**
1st Value:
2nd Value:
Value Percent: **5.000**
Continuous Index: **F01**
Within 8" of Joint: **NO**
Remarks:

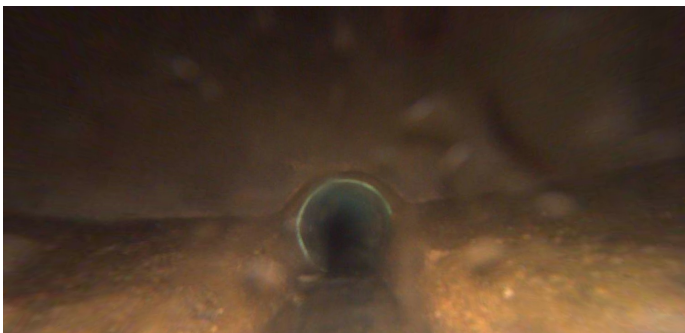
Code: **AMH**
Description: **Manhole**

Distance (ft): **305.0**
Structural Grade: **0**
O&M Grade: **0**
Clock Start/From:
Clock To:
1st Value:
2nd Value:
Value Percent:
Continuous Index:
Within 8" of Joint: **NO**
Remarks: **M-707-046**
