Profile/Photo Observation Report

Street:	FLEMING ST & E 13TH PL	Flow Control:	Not Controlled
City:	Hobart, IN	Year Renewed:	
Location:	Light Highway	Tape/Media #:	
Purpose:	Maintenance Related	Dia/Height:	8"
Use:	Sanitary	Material:	PVC
Drain Area:	NA	Lining:	Cured in Place
Category:	NA		
Comment:

Location Details:		Direction of Survey:	Downstream
US MH:	M-707-047	DS MH:	M-707-048
		Total Length Surveyed (ft):	247.7

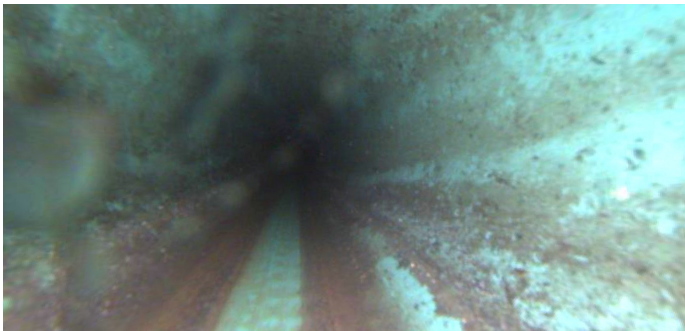
Code: **AMH**
Description: **Manhole**

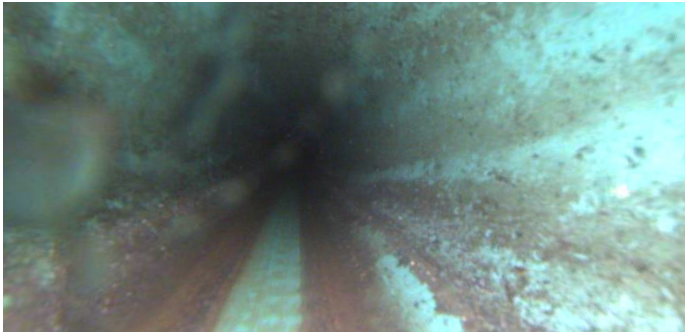
Code:	MWL
Description:	Water Level

Distance (ft):	.0
Structural Grade:	0
O&M Grade:	0
Clock Start/From:	
Clock To:	
1st Value:	
2nd Value:	
Value Percent:	5.000
Continuous Index:	
Within 8" of Joint:	NO
Remarks:

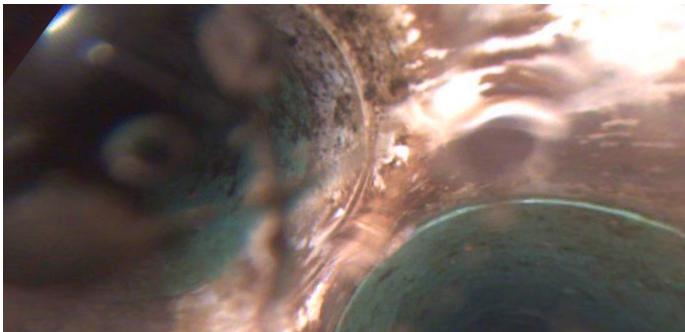
Code:	TF
Description:	Tap Factory

Distance (ft):	40.5
Structural Grade:	0
O&M Grade:	0
Clock Start/From:	10
Clock To:	
1st Value:	4.000
2nd Value:	
Value Percent:	
Continuous Index:	
Within 8" of Joint:	
Remarks:

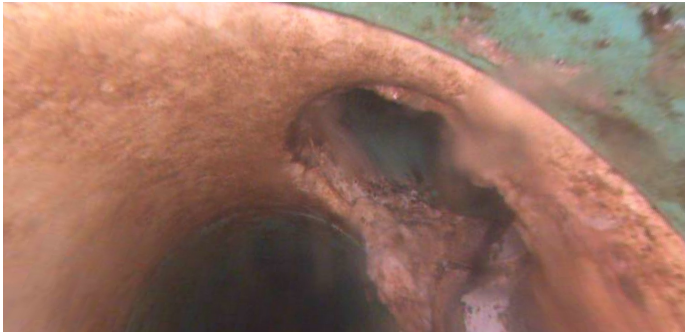
Code: **TFD**
Description: **Tap Factory Defective**

Distance (ft): **126.0**
Structural Grade: **0**
O&M Grade: **2**
Clock Start/From: **10**
Clock To:
1st Value: **4.000**
2nd Value:
Value Percent:
Continuous Index:
Within 8" of Joint:
Remarks: **DAGS**

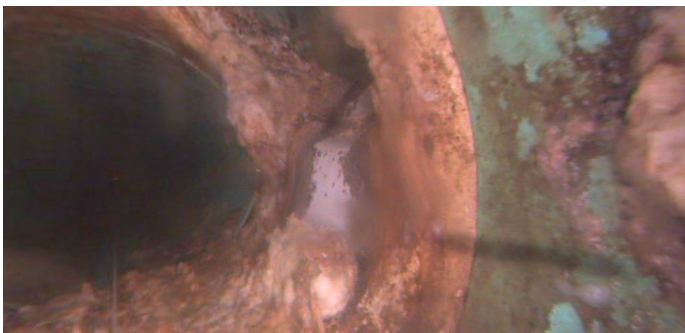
Code: **DAGS**
Description: **Deposits Attached Grease**

Distance (ft): **126.0**
Structural Grade: **0**
O&M Grade: **2**
Clock Start/From: **8**
Clock To: **10**
1st Value:
2nd Value:
Value Percent: **5.000**
Continuous Index:
Within 8" of Joint: **NO**
Remarks:

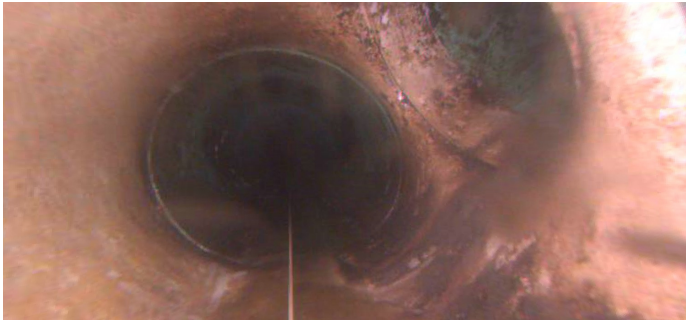
Code: **TF**
Description: **Tap Factory**

Distance (ft): **222.2**
Structural Grade: **0**
O&M Grade: **0**
Clock Start/From: **10**
Clock To:
1st Value: **4.000**
2nd Value:
Value Percent:
Continuous Index:
Within 8" of Joint:
Remarks:

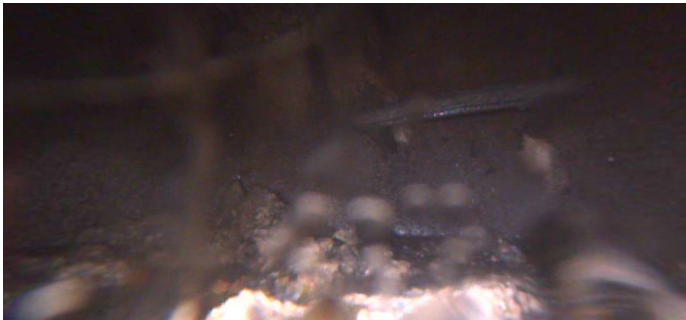
Code: **AMH**
Description: **Manhole**

Distance (ft): **247.7**
Structural Grade: **0**
O&M Grade: **0**
Clock Start/From:
Clock To:
1st Value:
2nd Value:
Value Percent:
Continuous Index:
Within 8" of Joint: **NO**
Remarks: **M-707-048**
