Profile/Photo Observation Report

Street:	Fkeming	Flow Control:	Not Controlled
City:	Hobart, IN	Year Renewed:	
Location:	Parking Lot	Tape/Media #:	
Purpose:	Maintenance Related	Dia/Height:	8"
Use:	Sanitary	Material:	PVC
Drain Area:	NA	Lining:	Cured in Place
Category:	NA		
Comment:

Location Details:		Direction of Survey:	Downstream
US MH:	M-707-049	DS MH:	M-707-047
		Total Length Surveyed (ft):	147.8

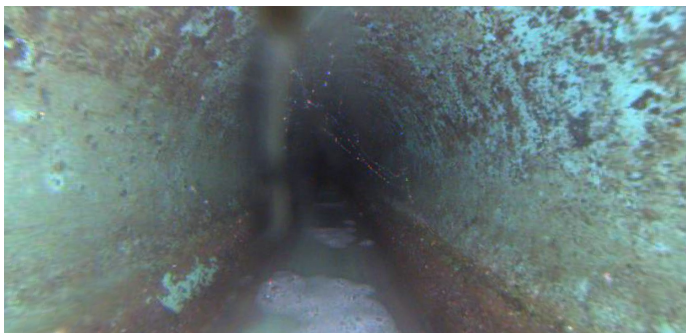
Code: **AMH**
Description: **Manhole**

Distance (ft): **.0**
Structural Grade: **0**
O&M Grade: **0**
Clock Start/From:
Clock To:
1st Value:
2nd Value:
Value Percent:
Continuous Index:
Within 8" of Joint: **NO**
Remarks: **M-707-049**

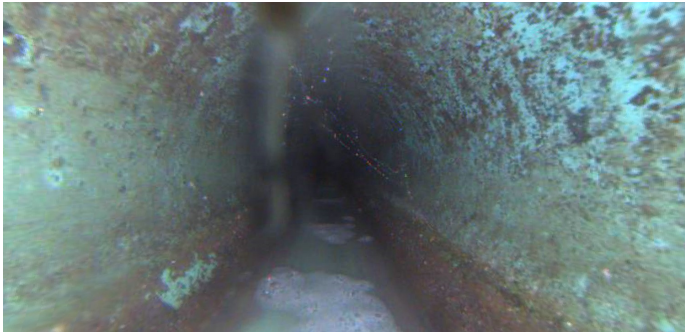
Code:	MWL
Description:	Water Level

Distance (ft):	.0
Structural Grade:	0
O&M Grade:	0
Clock Start/From:	
Clock To:	
1st Value:	
2nd Value:	
Value Percent:	5.000
Continuous Index:	
Within 8" of Joint:	NO
Remarks:

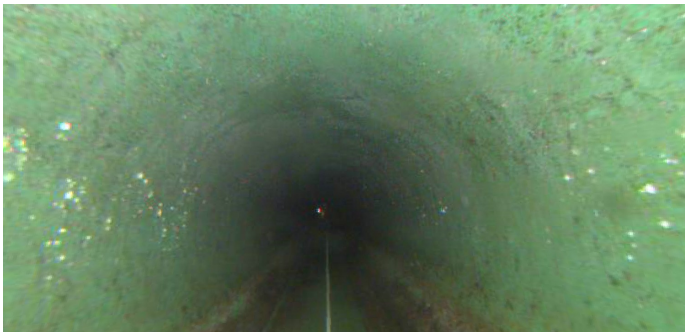
Code:	MGO
Description:	General Observation

Distance (ft):	19.0
Structural Grade:	0
O&M Grade:	0
Clock Start/From:	
Clock To:	
1st Value:	
2nd Value:	
Value Percent:	
Continuous Index:	
Within 8" of Joint:	NO
Remarks:	REAR CAMERA

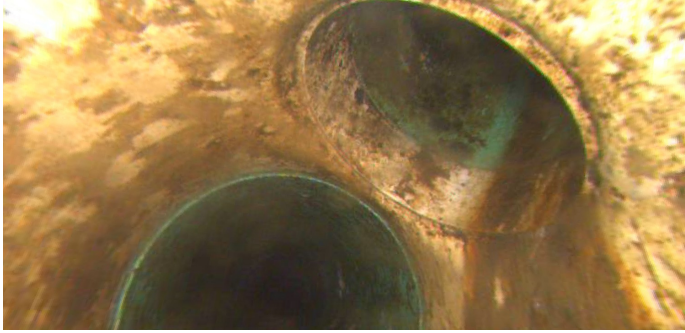
Code: **TF**
Description: **Tap Factory**

Distance (ft): **63.2**
Structural Grade: **0**
O&M Grade: **0**
Clock Start/From: **11**
Clock To:
1st Value: **4.000**
2nd Value:
Value Percent:
Continuous Index:
Within 8" of Joint:
Remarks:

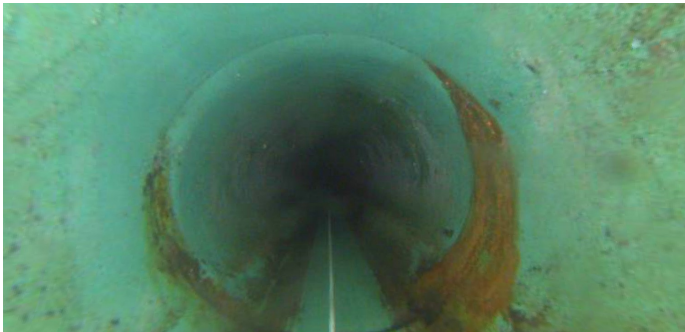
Code: **IW**
Description: **Infil Weeper**

Distance (ft): **114.0**
Structural Grade: **0**
O&M Grade: **2**
Clock Start/From: **8**
Clock To: **4**
1st Value:
2nd Value:
Value Percent:
Continuous Index:
Within 8" of Joint: **YES**
Remarks:

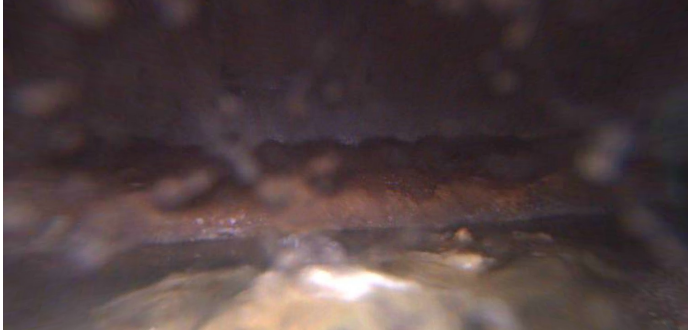
Code:	AMH
Description:	Manhole
Distance (ft):	147.8
Structural Grade:	0
O&M Grade:	0
Clock Start/From:	
Clock To:	
1st Value:	
2nd Value:	
Value Percent:	
Continuous Index:	
Within 8" of Joint:	NO
Remarks:	M-707-047
