## Profile/Photo Observation Report

Date:	<b>04/07/2018</b>	Weather:		Coding:	<b>PACP 6.0</b>
Pipe Length (ft):	<b>262.8</b>	Owner:	<b>NA</b>	Pre Clean:	<b>Not Known</b>
P.O.#:		Surveyor:	<b>Jen Costello</b>	PSR:	<b>P-707-050-051</b>
Customer:		Clean Date:	<b>01/01/1900</b>	Shape:	<b>C</b>

Location Details:		Direction of Survey:	<b>Upstream</b>
US MH:	<b>M-707-050</b>	DS MH:	<b>M-707-051</b>
		Total Length Surveyed (ft):	<b>256.7</b>

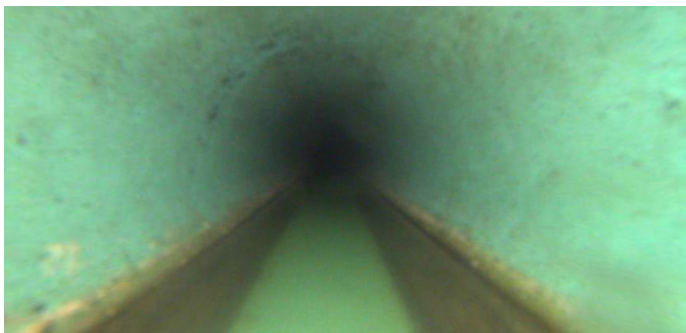
Code: **AMH**  
Description: **Manhole**

Distance (ft): **.0**  
Structural Grade: **0**  
O&M Grade: **0**  
Clock Start/From:  
Clock To:  
1st Value:  
2nd Value:  
Value Percent:  
Continuous Index:  
Within 8" of Joint: **NO**  
Remarks: **M-707-051**

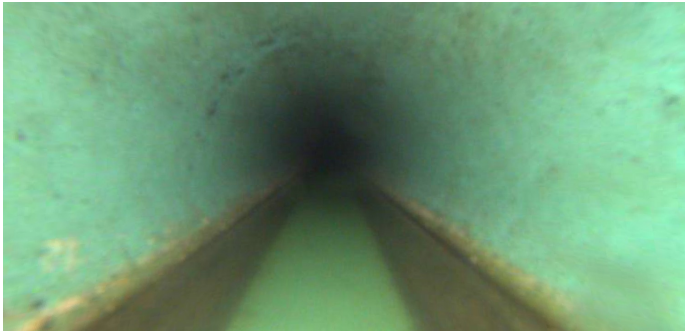
Code:	<b>MWL</b>
Description:	<b>Water Level</b>

Distance (ft):	<b>.0</b>
Structural Grade:	<b>0</b>
O&M Grade:	<b>0</b>
Clock Start/From:	
Clock To:	
1st Value:	
2nd Value:	
Value Percent:	<b>10.000</b>
Continuous Index:	
Within 8" of Joint:	<b>NO</b>
Remarks:

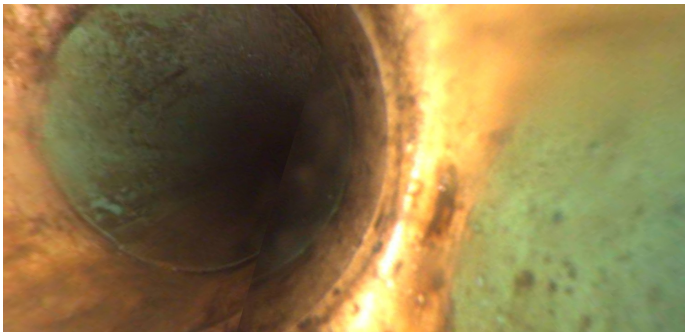
Code:	<b>TF</b>
Description:	<b>Tap Factory</b>

Distance (ft):	<b>53.4</b>
Structural Grade:	<b>0</b>
O&M Grade:	<b>0</b>
Clock Start/From:	<b>10</b>
Clock To:	
1st Value:	<b>4.000</b>
2nd Value:	
Value Percent:	
Continuous Index:	
Within 8" of Joint:	
Remarks:

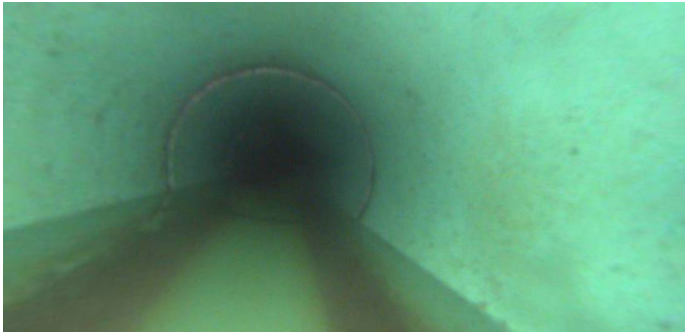
Code: **MWL**  
Description: **Water Level**

Distance (ft): **65.0**  
Structural Grade: **0**  
O&M Grade: **0**  
Clock Start/From:  
Clock To:  
1st Value:  
2nd Value:  
Value Percent: **40.000**  
Continuous Index:  
Within 8" of Joint: **NO**  
Remarks:

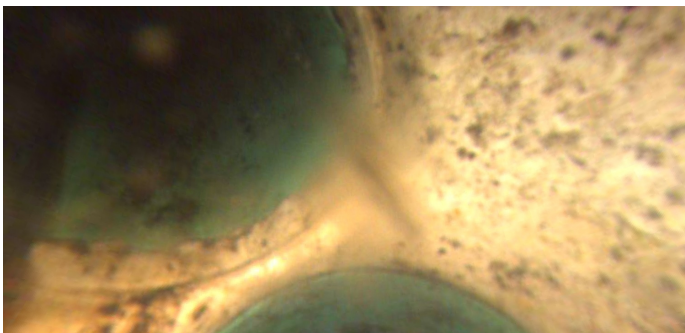
Code: **TF**  
Description: **Tap Factory**

Distance (ft): **140.3**  
Structural Grade: **0**  
O&M Grade: **0**  
Clock Start/From: **11**  
Clock To:  
1st Value: **4.000**  
2nd Value:  
Value Percent:  
Continuous Index:  
Within 8" of Joint:  
Remarks:

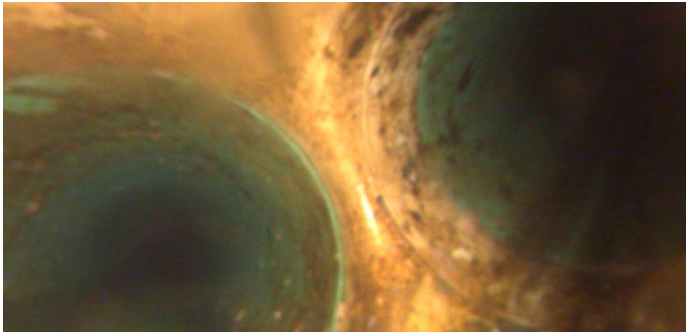
Code: **TF**  
Description: **Tap Factory**

Distance (ft): **155.4**  
Structural Grade: **0**  
O&M Grade: **0**  
Clock Start/From: **2**  
Clock To:  
1st Value: **4.000**  
2nd Value:  
Value Percent:  
Continuous Index:  
Within 8" of Joint:  
Remarks:

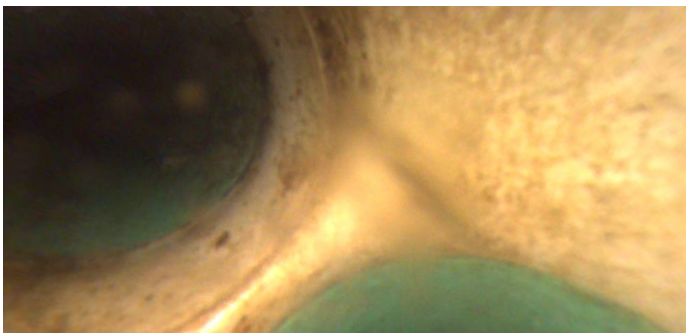
Code: **TF**  
Description: **Tap Factory**

Distance (ft): **197.0**  
Structural Grade: **0**  
O&M Grade: **0**  
Clock Start/From: **10**  
Clock To:  
1st Value: **4.000**  
2nd Value:  
Value Percent:  
Continuous Index:  
Within 8" of Joint:  
Remarks:

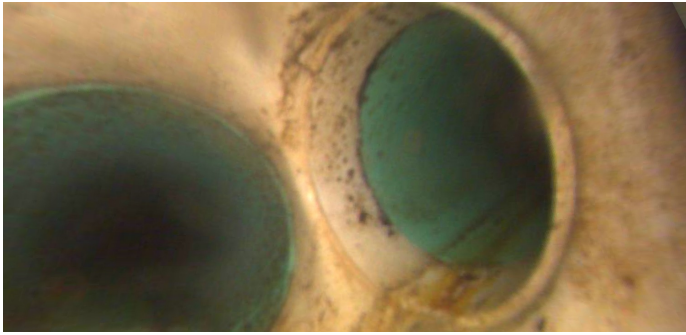
Code: **TF**  
Description: **Tap Factory**

Distance (ft): **215.8**  
Structural Grade: **0**  
O&M Grade: **0**  
Clock Start/From: **3**  
Clock To:  
1st Value: **4.000**  
2nd Value:  
Value Percent:  
Continuous Index:  
Within 8" of Joint:  
Remarks:

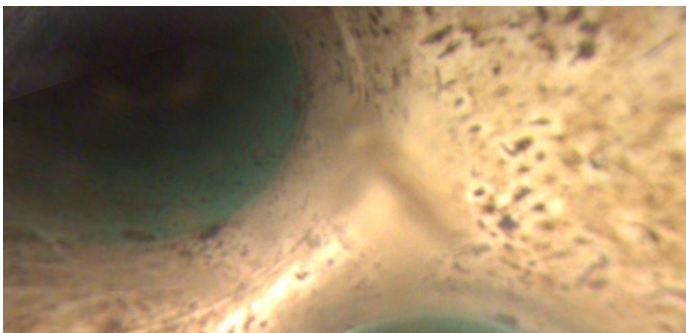
Code: **TF**  
Description: **Tap Factory**

Distance (ft): **252.8**  
Structural Grade: **0**  
O&M Grade: **0**  
Clock Start/From: **10**  
Clock To:  
1st Value: **4.000**  
2nd Value:  
Value Percent:  
Continuous Index:  
Within 8" of Joint:  
Remarks:

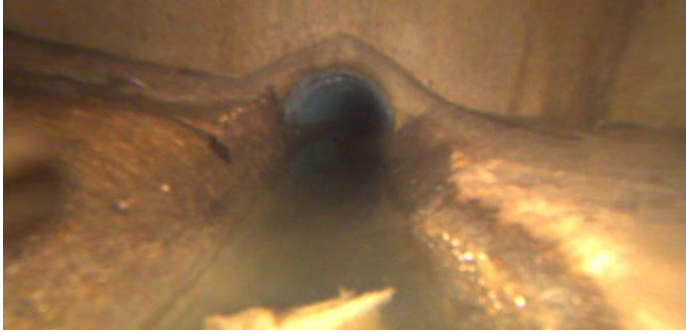
Code:	<b>AMH</b>
Description:	<b>Manhole</b>
Distance (ft):	<b>256.7</b>
Structural Grade:	<b>0</b>
O&M Grade:	<b>0</b>
Clock Start/From:	
Clock To:	
1st Value:	
2nd Value:	
Value Percent:	
Continuous Index:	
Within 8" of Joint:	<b>NO</b>
Remarks:	<b>M-707-050</b>
