Profile/Photo Observation Report

Date:	04/07/2018	Weather:		Coding:	PACP 6.0
Pipe Length (ft):	143.8	Owner:	NA	Pre Clean:	Not Known
P.O.#:		Surveyor:	Jen Costello	PSR:	P-707-070-051
Customer:		Clean Date:	01/01/1900	Shape:	C

Street:	13th	Flow Control:	Not Controlled
City:	Hobart, IN	Year Renewed:	
Location:	Easement/Right of Way	Tape/Media #:	
Purpose:	Maintenance Related	Dia/Height:	8"
Use:	Sanitary	Material:	PVC
Drain Area:	NA	Lining:	Cured in Place
Category:	NA		
Comment:	Flow direction wrong.

Location Details:		Direction of Survey:	Downstream
US MH:	M-707-051	DS MH:	M-707-070
		Total Length Surveyed (ft):	141.2

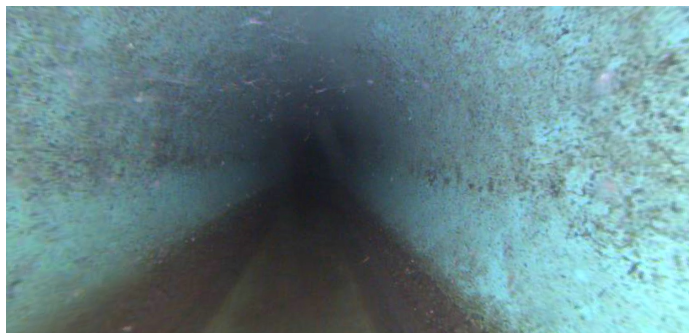
Code: **AMH**
Description: **Manhole**

Distance (ft): **.0**
Structural Grade: **0**
O&M Grade: **0**
Clock Start/From:
Clock To:
1st Value:
2nd Value:
Value Percent:
Continuous Index:
Within 8" of Joint: **NO**
Remarks: **M-707-051**

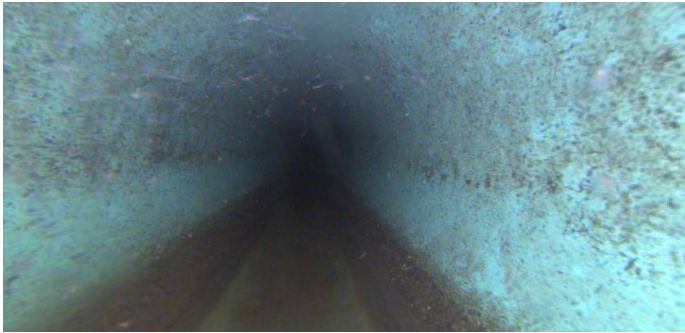
Code:	MWL
Description:	Water Level

Distance (ft):	.0
Structural Grade:	0
O&M Grade:	0
Clock Start/From:	
Clock To:	
1st Value:	
2nd Value:	
Value Percent:	5.000
Continuous Index:	
Within 8" of Joint:	NO
Remarks:

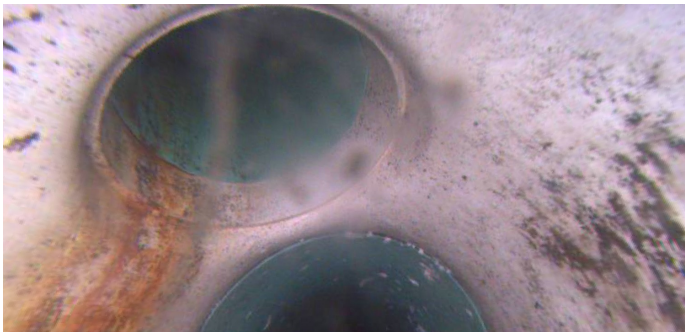
Code:	TF
Description:	Tap Factory

Distance (ft):	36.5
Structural Grade:	0
O&M Grade:	0
Clock Start/From:	12
Clock To:	
1st Value:	4.000
2nd Value:	
Value Percent:	
Continuous Index:	
Within 8" of Joint:	
Remarks:

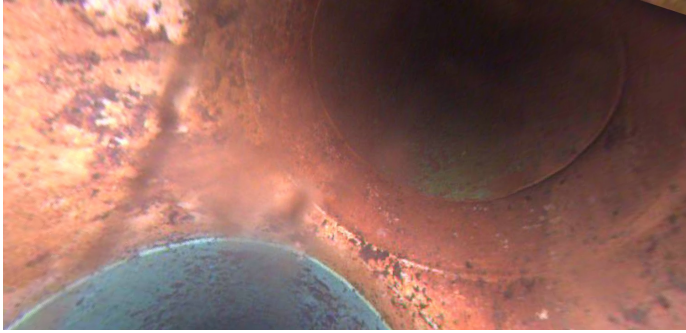
Code: **TF**
Description: **Tap Factory**

Distance (ft): **90.1**
Structural Grade: **0**
O&M Grade: **0**
Clock Start/From: **1**
Clock To:
1st Value: **4.000**
2nd Value:
Value Percent:
Continuous Index:
Within 8" of Joint:
Remarks:

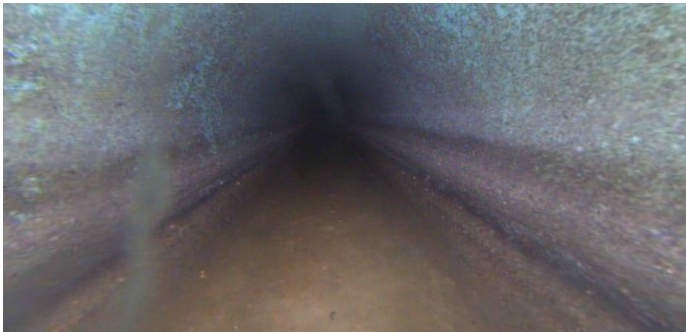
Code: **MWL**
Description: **Water Level**

Distance (ft): **129.1**
Structural Grade: **0**
O&M Grade: **0**
Clock Start/From:
Clock To:
1st Value:
2nd Value:
Value Percent: **10.000**
Continuous Index:
Within 8" of Joint: **NO**
Remarks:

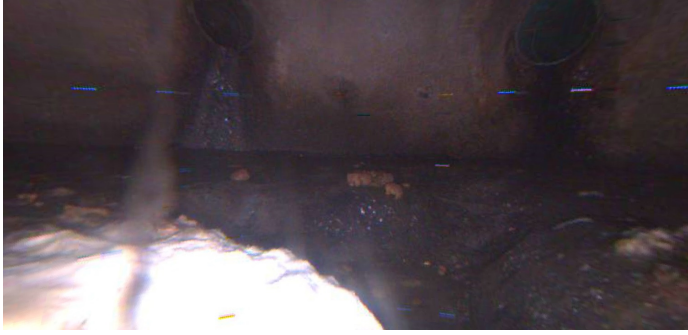
Code:	AMH
Description:	Manhole
Distance (ft):	141.2
Structural Grade:	0
O&M Grade:	0
Clock Start/From:	
Clock To:	
1st Value:	
2nd Value:	
Value Percent:	
Continuous Index:	
Within 8" of Joint:	NO
Remarks:	M-707-070
