Profile/Photo Observation Report

Street:	E 13TH ST	Flow Control:	Not Controlled
City:	Hobart, IN	Year Renewed:	
Location:	Easement/Right of Way	Tape/Media #:	
Purpose:	Maintenance Related	Dia/Height:	8"
Use:	Sanitary	Material:	PVC
Drain Area:	NA	Lining:	Cured in Place
Category:	NA		
Comment:	Flow direction wrong.

Location Details:		Direction of Survey:	Upstream
US MH:	M-707-052	DS MH:	M-707-051
		Total Length Surveyed (ft):	151.7

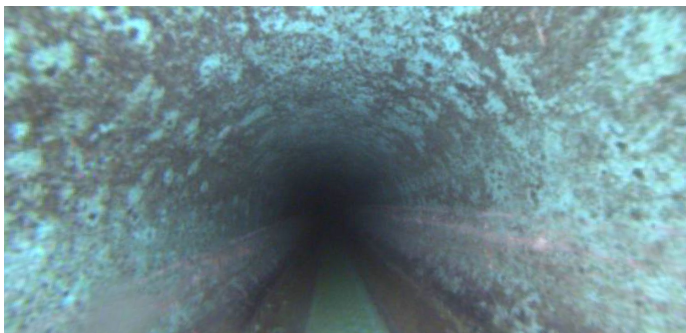
Code: **AMH**
Description: **Manhole**

Distance (ft): **.0**
Structural Grade: **0**
O&M Grade: **0**
Clock Start/From:
Clock To:
1st Value:
2nd Value:
Value Percent:
Continuous Index:
Within 8" of Joint: **NO**
Remarks: **M-707-051**

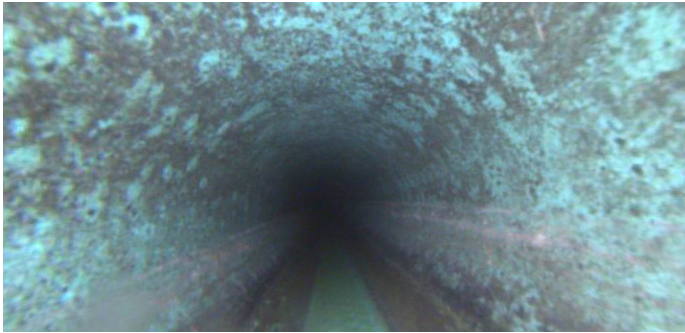
Code:	MWL
Description:	Water Level

Distance (ft):	.0
Structural Grade:	0
O&M Grade:	0
Clock Start/From:	
Clock To:	
1st Value:	
2nd Value:	
Value Percent:	5.000
Continuous Index:	
Within 8" of Joint:	NO
Remarks:

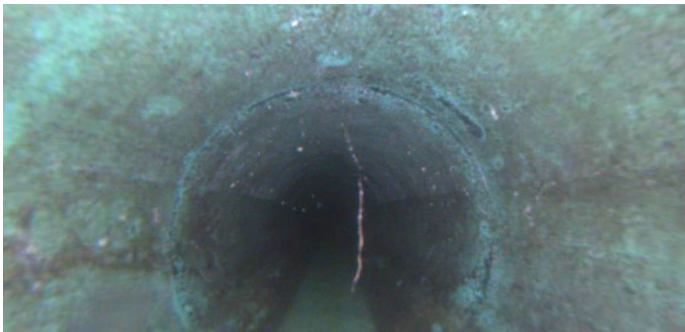
Code:	RFJ
Description:	Roots Fine Joint

Distance (ft):	16.0
Structural Grade:	0
O&M Grade:	1
Clock Start/From:	12
Clock To:	
1st Value:	
2nd Value:	
Value Percent:	
Continuous Index:	
Within 8" of Joint:	YES
Remarks:

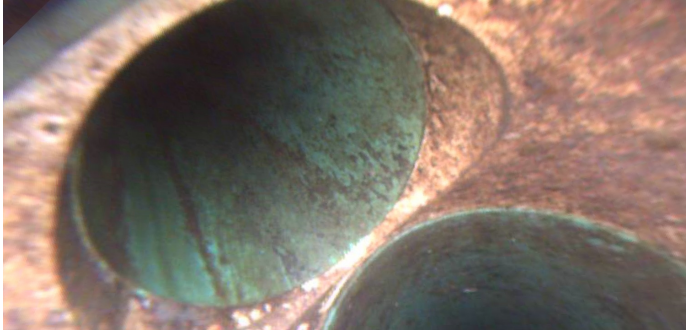
Code: **TF**
Description: **Tap Factory**

Distance (ft): **61.5**
Structural Grade: **0**
O&M Grade: **0**
Clock Start/From: **10**
Clock To:
1st Value: **4.000**
2nd Value:
Value Percent:
Continuous Index:
Within 8" of Joint:
Remarks:

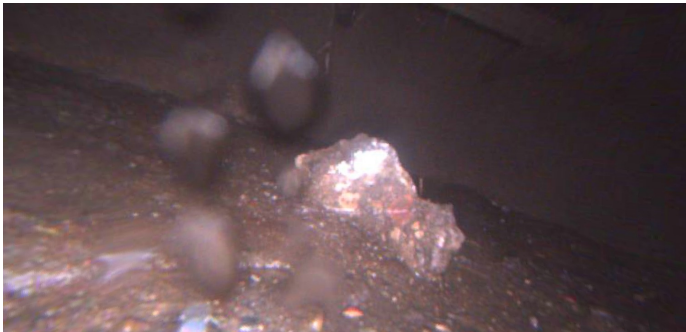
Code: **AMH**
Description: **Manhole**

Distance (ft): **151.7**
Structural Grade: **0**
O&M Grade: **0**
Clock Start/From:
Clock To:
1st Value:
2nd Value:
Value Percent:
Continuous Index:
Within 8" of Joint: **NO**
Remarks: **M-707-052**
