## Profile/Photo Observation Report

Street:	<b>13th</b>	Flow Control:	<b>Not Controlled</b>
City:	<b>Hobart, IN</b>	Year Renewed:	
Location:	<b>Easement/Right of Way</b>	Tape/Media #:	
Purpose:	<b>Maintenance Related</b>	Dia/Height:	<b>8"</b>
Use:	<b>Sanitary</b>	Material:	<b>PVC</b>
Drain Area:	<b>NA</b>	Lining:	<b>Cured in Place</b>
Category:	<b>NA</b>		
Comment:	<b>Flow direction wrong.</b>

Location Details:		Direction of Survey:	<b>Upstream</b>
US MH:	<b>M-707-052</b>	DS MH:	<b>M-707-051</b>
		Total Length Surveyed (ft):	<b>151.7</b>

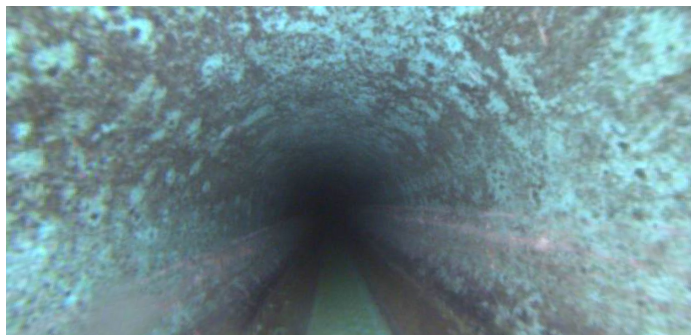
Code: **AMH**  
 Description: **Manhole**  
 Distance (ft): **.0**  
 Structural Grade: **0**  
 O&M Grade: **0**  
 Clock Start/From:  
 Clock To:  
 1st Value:  
 2nd Value:  
 Value Percent:  
 Continuous Index:  
 Within 8" of Joint: **NO**  
 Remarks: **M-707-051**

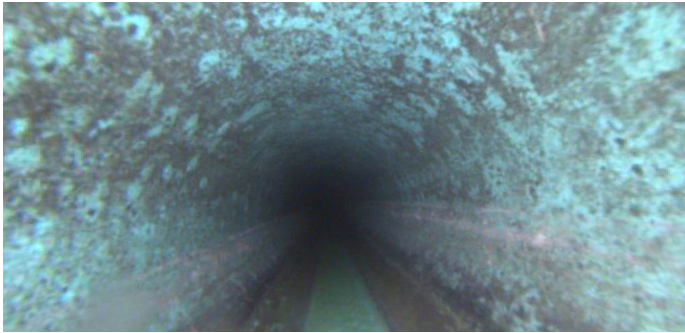
Code:	<b>MWL</b>
Description:	<b>Water Level</b>

Distance (ft):	<b>.0</b>
Structural Grade:	<b>0</b>
O&M Grade:	<b>0</b>
Clock Start/From:	
Clock To:	
1st Value:	
2nd Value:	
Value Percent:	<b>5.000</b>
Continuous Index:	
Within 8" of Joint:	<b>NO</b>
Remarks:

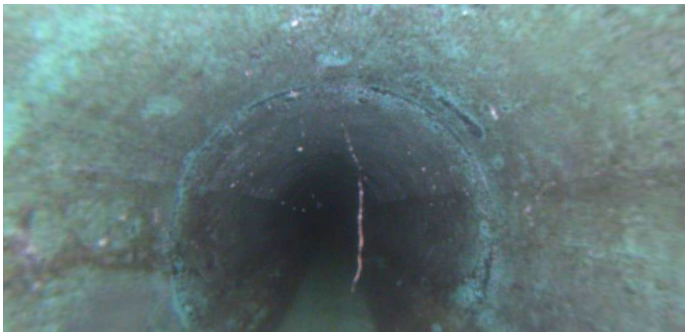
Code:	<b>RFJ</b>
Description:	<b>Roots Fine Joint</b>

Distance (ft):	<b>16.0</b>
Structural Grade:	<b>0</b>
O&M Grade:	<b>1</b>
Clock Start/From:	<b>12</b>
Clock To:	
1st Value:	
2nd Value:	
Value Percent:	
Continuous Index:	
Within 8" of Joint:	<b>YES</b>
Remarks:

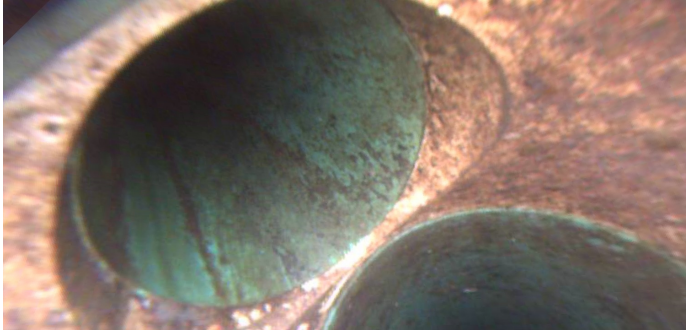
Code: **TF**  
Description: **Tap Factory**

Distance (ft): **61.5**  
Structural Grade: **0**  
O&M Grade: **0**  
Clock Start/From: **10**  
Clock To:  
1st Value: **4.000**  
2nd Value:  
Value Percent:  
Continuous Index:  
Within 8" of Joint:  
Remarks:

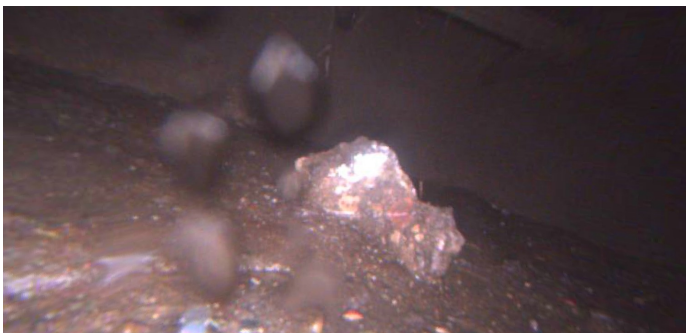
Code: **AMH**  
Description: **Manhole**

Distance (ft): **151.7**  
Structural Grade: **0**  
O&M Grade: **0**  
Clock Start/From:  
Clock To:  
1st Value:  
2nd Value:  
Value Percent:  
Continuous Index:  
Within 8" of Joint: **NO**  
Remarks: **M-707-052**
