## Profile/Photo Observation Report

Date:	<b>04/04/2018</b>	Weather:		Coding:	<b>PACP 6.0</b>
Pipe Length (ft):	<b>144.4</b>	Owner:	<b>NA</b>	Pre Clean:	<b>No Pre-Cleaning</b>
P.O.#:		Surveyor:	<b>Jen Costello</b>	PSR:	<b>P-707-052-053</b>
Customer:		Clean Date:	<b>01/01/1900</b>	Shape:	<b>C</b>

Street:	<b>FOXCROFT STREET</b>	Flow Control:	<b>Not Controlled</b>
City:	<b>Hobart, IN</b>	Year Renewed:	
Location:	<b>Yard</b>	Tape/Media #:	
Purpose:	<b>Routine Assessment</b>	Dia/Height:	<b>8"</b>
Use:	<b>Sanitary</b>	Material:	<b>PVC</b>
Drain Area:	<b>NA</b>	Lining:	
Category:	<b>NA</b>		
Comment:	<b>Flow direction is marked wrong.</b>		
Location Details:		Direction of Survey:	<b>Upstream</b>
US MH:	<b>M-707-053</b>	DS MH:	<b>M-707-052</b>
		Total Length Surveyed (ft):	<b>92.5</b>

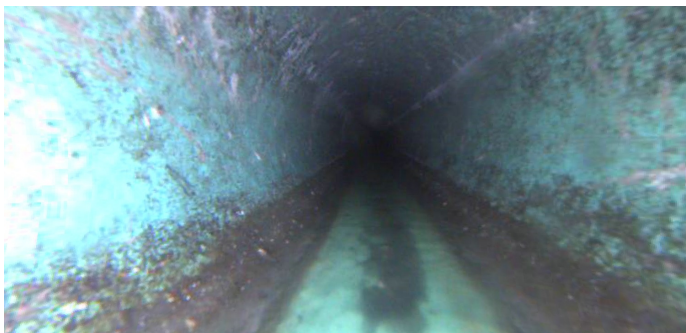
Code: **AMH**  
Description: **Manhole**

Distance (ft): **.0**  
Structural Grade: **0**  
O&M Grade: **0**  
Clock Start/From:  
Clock To:  
1st Value:  
2nd Value:  
Value Percent:  
Continuous Index:  
Within 8" of Joint: **NO**  
Remarks: **M-707-052**

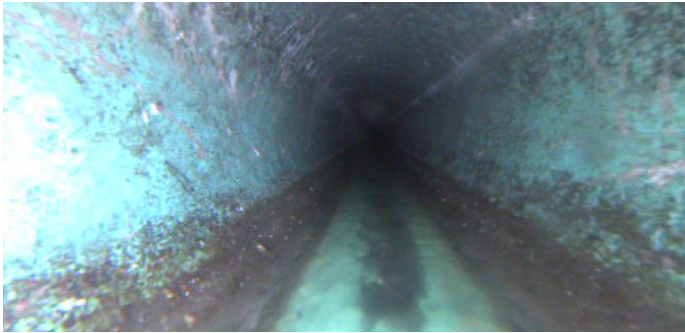
Code:	<b>MWL</b>
Description:	<b>Water Level</b>

Distance (ft):	<b>.0</b>
Structural Grade:	<b>0</b>
O&M Grade:	<b>0</b>
Clock Start/From:	
Clock To:	
1st Value:	
2nd Value:	
Value Percent:	<b>5.000</b>
Continuous Index:	
Within 8" of Joint:	<b>NO</b>
Remarks:

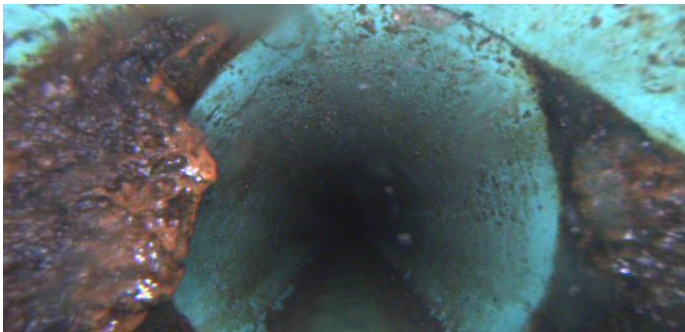
Code:	<b>DAE</b>
Description:	<b>Deposits Attached Encrustation</b>

Distance (ft):	<b>24.6</b>
Structural Grade:	<b>0</b>
O&M Grade:	<b>3</b>
Clock Start/From:	<b>8</b>
Clock To:	<b>4</b>
1st Value:	
2nd Value:	
Value Percent:	<b>20.000</b>
Continuous Index:	
Within 8" of Joint:	<b>YES</b>
Remarks:

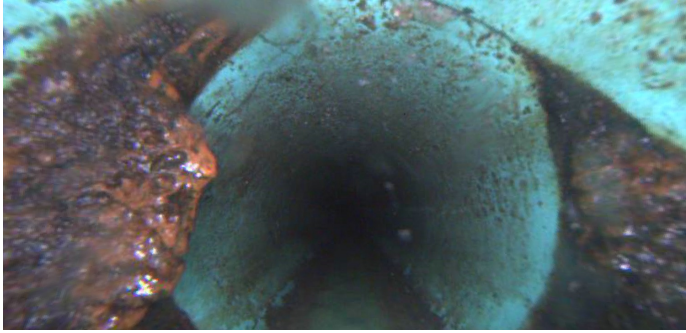
Code: **IW**  
Description: **Infil Weeper**

Distance (ft): **24.6**  
Structural Grade: **0**  
O&M Grade: **2**  
Clock Start/From: **8**  
Clock To: **4**  
1st Value:  
2nd Value:  
Value Percent:  
Continuous Index:  
Within 8" of Joint: **YES**  
Remarks:

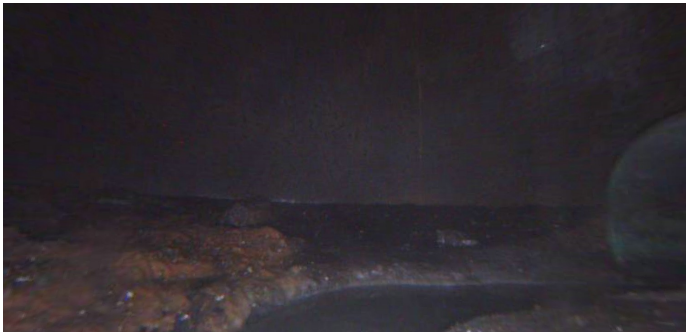
Code: **AMH**  
Description: **Manhole**

Distance (ft): **92.5**  
Structural Grade: **0**  
O&M Grade: **0**  
Clock Start/From:  
Clock To:  
1st Value:  
2nd Value:  
Value Percent:  
Continuous Index:  
Within 8" of Joint: **NO**  
Remarks: **M-707-053**
