## Profile/Photo Observation Report

Street:	<b>FLEMING ST &amp; E 13TH ST</b>	Flow Control:	<b>Not Controlled</b>
City:	<b>Hobart, IN</b>	Year Renewed:	
Location:	<b>Light Highway</b>	Tape/Media #:	
Purpose:	<b>Maintenance Related</b>	Dia/Height:	<b>12"</b>
Use:	<b>Sanitary</b>	Material:	<b>PVC</b>
Drain Area:	<b>NA</b>	Lining:	<b>Cured in Place</b>
Category:	<b>NA</b>		
Comment:

Location Details:		Direction of Survey:	<b>Downstream</b>
US MH:	<b>M-707-055</b>	DS MH:	<b>M-707-049</b>
		Total Length Surveyed (ft):	<b>149.7</b>

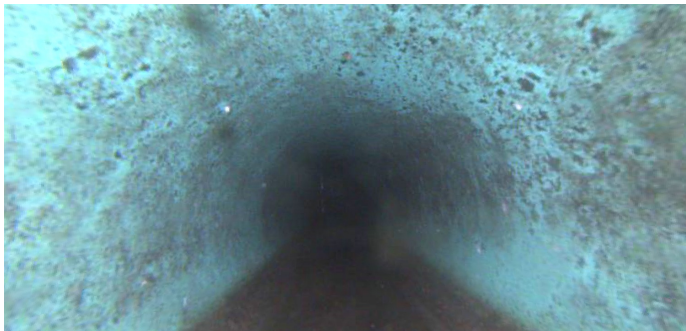
Code: **AMH**  
Description: **Manhole**

Distance (ft): **.0**  
Structural Grade: **0**  
O&M Grade: **0**  
Clock Start/From:  
Clock To:  
1st Value:  
2nd Value:  
Value Percent:  
Continuous Index:  
Within 8" of Joint: **NO**  
Remarks: **M-707-055**

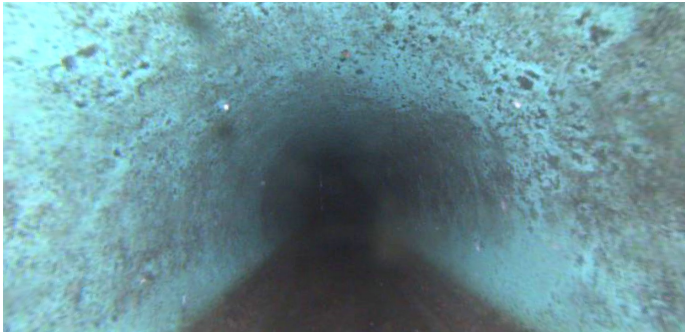
Code:	<b>MWL</b>
Description:	<b>Water Level</b>

Distance (ft):	<b>.0</b>
Structural Grade:	<b>0</b>
O&M Grade:	<b>0</b>
Clock Start/From:	
Clock To:	
1st Value:	
2nd Value:	
Value Percent:	<b>5.000</b>
Continuous Index:	
Within 8" of Joint:	<b>NO</b>
Remarks:

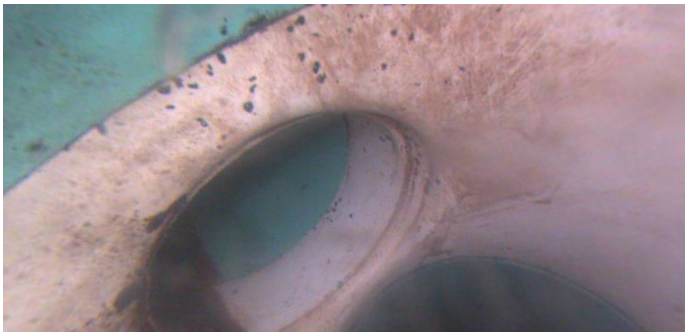
Code:	<b>TF</b>
Description:	<b>Tap Factory</b>

Distance (ft):	<b>105.8</b>
Structural Grade:	<b>0</b>
O&M Grade:	<b>0</b>
Clock Start/From:	<b>2</b>
Clock To:	
1st Value:	<b>4.000</b>
2nd Value:	
Value Percent:	
Continuous Index:	
Within 8" of Joint:	
Remarks:

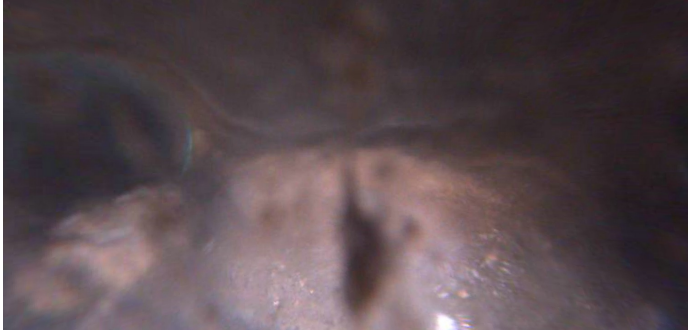
Code:	AMH
Description:	Manhole
Distance (ft):	149.7
Structural Grade:	0
O&M Grade:	0
Clock Start/From:	
Clock To:	
1st Value:	
2nd Value:	
Value Percent:	
Continuous Index:	
Within 8" of Joint:	NO
Remarks:	M-707-049
