Profile/Photo Observation Report

Date:	04/05/2018	Weather:		Coding:	PACP 6.0
Pipe Length (ft):	270.2	Owner:	NA	Pre Clean:	Not Known
P.O.#:		Surveyor:	Jen Costello	PSR:	P-707-054-055
Customer:		Clean Date:	01/01/1900	Shape:	C

Street:	13th	Flow Control:	Not Controlled
City:	Hobart, IN	Year Renewed:	
Location:	Light Highway	Tape/Media #:	
Purpose:	Maintenance Related	Dia/Height:	12"
Use:	Sanitary	Material:	PVC
Drain Area:	NA	Lining:	Cured in Place
Category:	NA		
Comment:	Flow direction wrong.

Location Details:		Direction of Survey:	Downstream
US MH:	M-707-055	DS MH:	M-707-054
		Total Length Surveyed (ft):	267.2

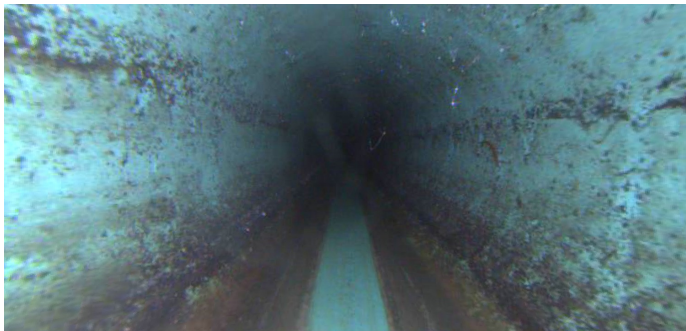
Code: **AMH**
Description: **Manhole**

Distance (ft): **.0**
Structural Grade: **0**
O&M Grade: **0**
Clock Start/From:
Clock To:
1st Value:
2nd Value:
Value Percent:
Continuous Index:
Within 8" of Joint: **NO**
Remarks: **M-707-055**

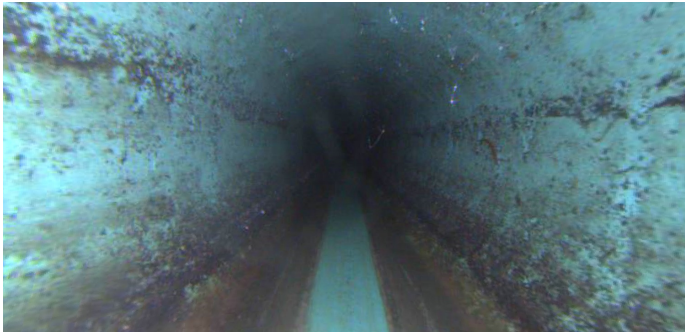
Code:	MWL
Description:	Water Level

Distance (ft):	.0
Structural Grade:	0
O&M Grade:	0
Clock Start/From:	
Clock To:	
1st Value:	
2nd Value:	
Value Percent:	5.000
Continuous Index:	
Within 8" of Joint:	NO
Remarks:

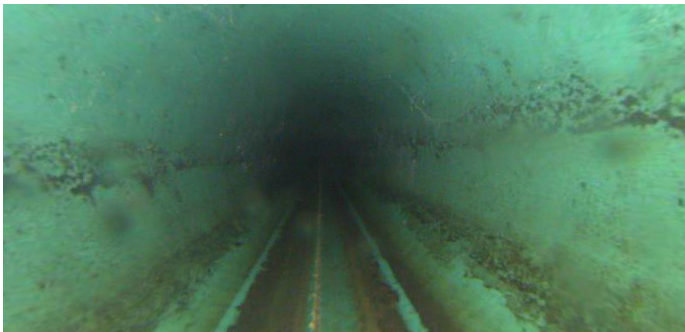
Code:	MGO
Description:	General Observation

Distance (ft):	30.8
Structural Grade:	0
O&M Grade:	0
Clock Start/From:	
Clock To:	
1st Value:	
2nd Value:	
Value Percent:	
Continuous Index:	
Within 8" of Joint:	NO
Remarks:	REAR CAMERA

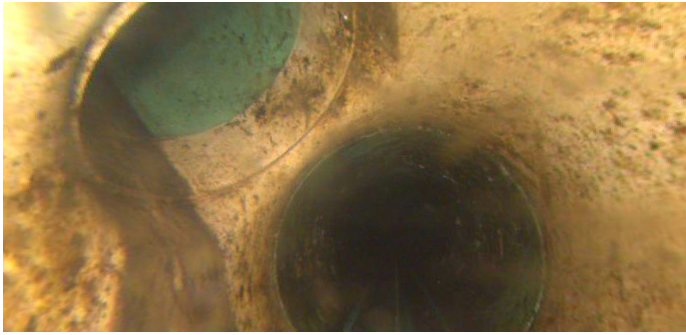
Code: **TFA**
Description: **Tap Factory Active**

Distance (ft): **75.5**
Structural Grade: **0**
O&M Grade: **0**
Clock Start/From: **1**
Clock To:
1st Value: **4.000**
2nd Value:
Value Percent:
Continuous Index:
Within 8" of Joint:
Remarks:

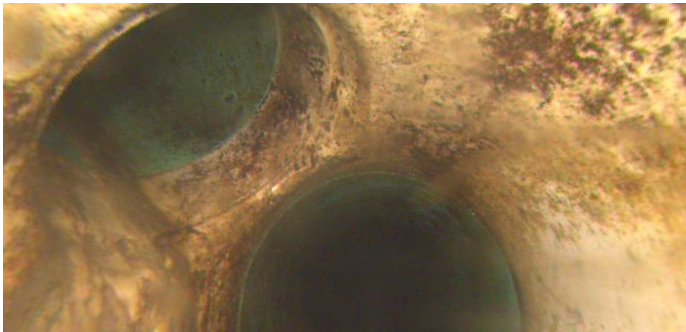
Code: **TF**
Description: **Tap Factory**

Distance (ft): **149.2**
Structural Grade: **0**
O&M Grade: **0**
Clock Start/From: **1**
Clock To:
1st Value: **4.000**
2nd Value:
Value Percent:
Continuous Index:
Within 8" of Joint:
Remarks:

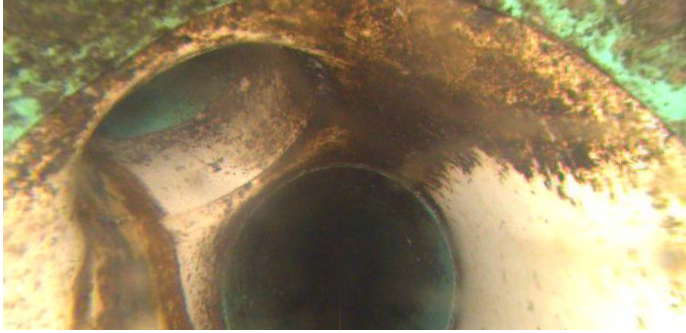
Code: **TF**
Description: **Tap Factory**

Distance (ft): **184.8**
Structural Grade: **0**
O&M Grade: **0**
Clock Start/From: **1**
Clock To:
1st Value: **4.000**
2nd Value:
Value Percent:
Continuous Index:
Within 8" of Joint:
Remarks:

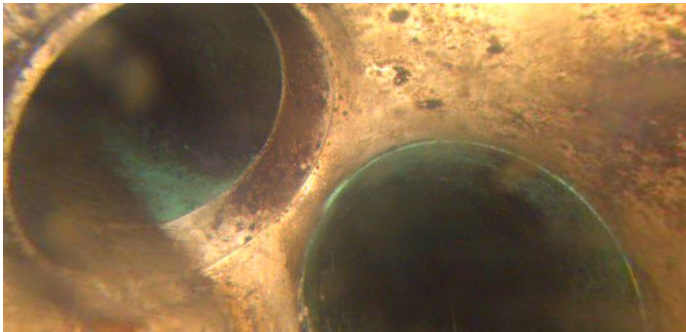
Code: **TF**
Description: **Tap Factory**

Distance (ft): **263.6**
Structural Grade: **0**
O&M Grade: **0**
Clock Start/From: **2**
Clock To:
1st Value: **4.000**
2nd Value:
Value Percent:
Continuous Index:
Within 8" of Joint:
Remarks:

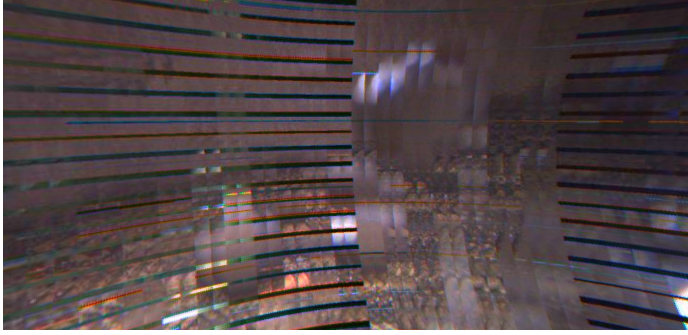
Code:	AMH
Description:	Manhole
Distance (ft):	267.2
Structural Grade:	0
O&M Grade:	0
Clock Start/From:	
Clock To:	
1st Value:	
2nd Value:	
Value Percent:	
Continuous Index:	
Within 8" of Joint:	NO
Remarks:	M-707-054
