Profile/Photo Observation Report

Street:	FLEMING ST & E 13TH ST	Flow Control:	Not Controlled
City:	Hobart, IN	Year Renewed:	
Location:	Light Highway	Tape/Media #:	
Purpose:	Maintenance Related	Dia/Height:	12"
Use:	Sanitary	Material:	PVC
Drain Area:	NA	Lining:	Cured in Place
Category:	NA		
Comment:

Location Details:		Direction of Survey:	Upstream
US MH:	M-707-056	DS MH:	M-707-055
		Total Length Surveyed (ft):	144.6

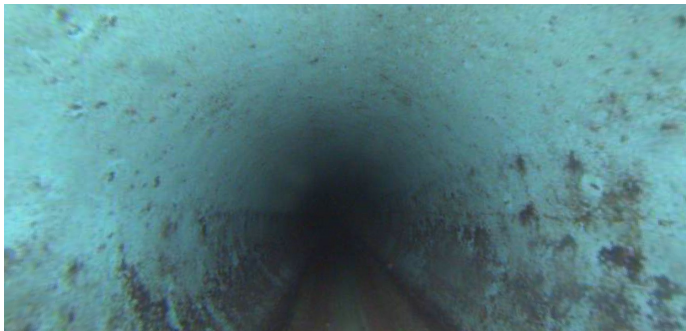
Code: **AMH**
Description: **Manhole**

Distance (ft): **.0**
Structural Grade: **0**
O&M Grade: **0**
Clock Start/From:
Clock To:
1st Value:
2nd Value:
Value Percent:
Continuous Index:
Within 8" of Joint: **NO**
Remarks: **M-707-055**

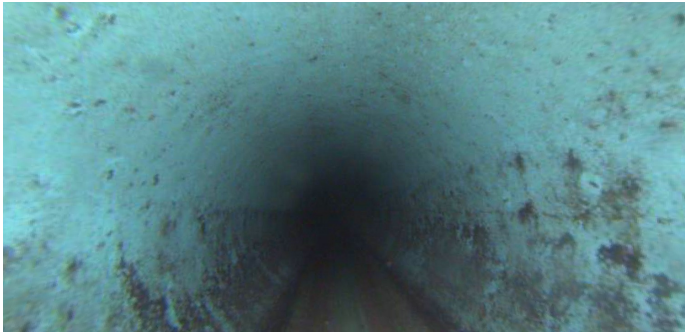
Code:	MWL
Description:	Water Level

Distance (ft):	.0
Structural Grade:	0
O&M Grade:	0
Clock Start/From:	
Clock To:	
1st Value:	
2nd Value:	
Value Percent:	5.000
Continuous Index:	
Within 8" of Joint:	NO
Remarks:

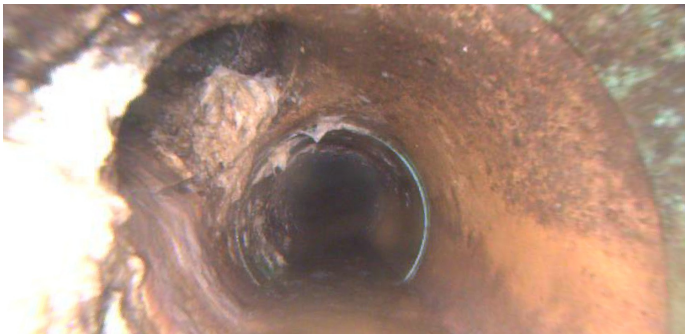
Code:	DAGS
Description:	Deposits Attached Grease

Distance (ft):	23.3
Structural Grade:	0
O&M Grade:	2
Clock Start/From:	7
Clock To:	10
1st Value:	
2nd Value:	
Value Percent:	5.000
Continuous Index:	
Within 8" of Joint:	NO
Remarks:

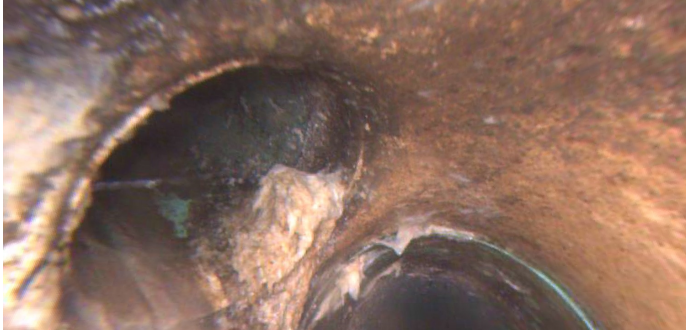
Code: **TF**
Description: **Tap Factory**

Distance (ft): **23.5**
Structural Grade: **0**
O&M Grade: **0**
Clock Start/From: **10**
Clock To:
1st Value: **4.000**
2nd Value:
Value Percent:
Continuous Index:
Within 8" of Joint:
Remarks:

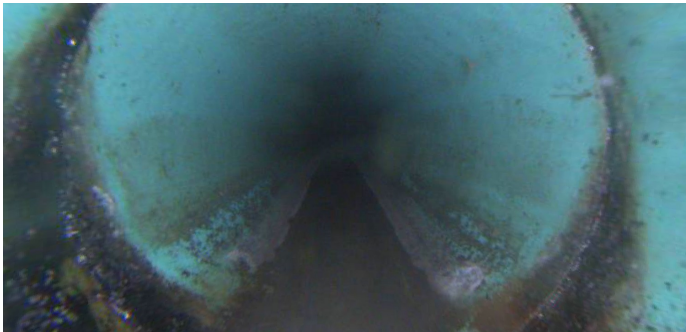
Code: **IW**
Description: **Infil Weeper**

Distance (ft): **47.9**
Structural Grade: **0**
O&M Grade: **2**
Clock Start/From: **8**
Clock To: **4**
1st Value:
2nd Value:
Value Percent:
Continuous Index:
Within 8" of Joint: **YES**
Remarks:

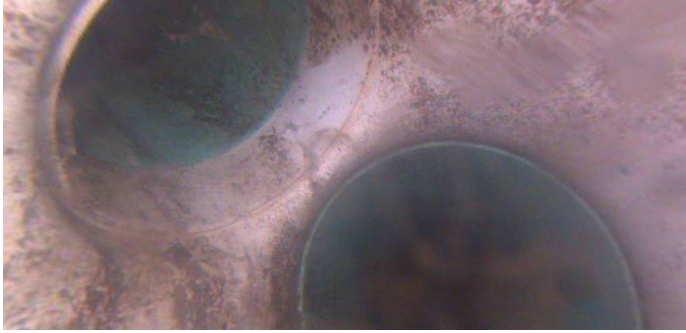
Code: **TF**
Description: **Tap Factory**

Distance (ft): **54.7**
Structural Grade: **0**
O&M Grade: **0**
Clock Start/From: **2**
Clock To:
1st Value: **4.000**
2nd Value:
Value Percent:
Continuous Index:
Within 8" of Joint:
Remarks:

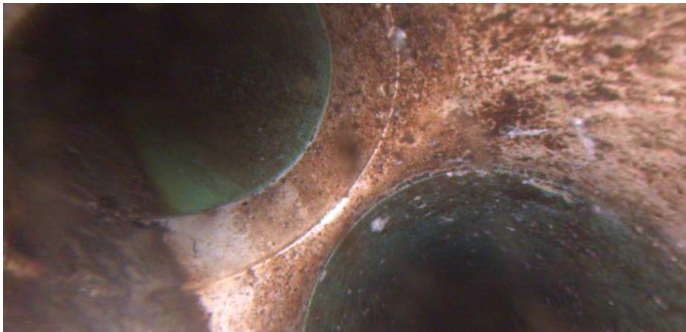
Code: **TF**
Description: **Tap Factory**

Distance (ft): **140.4**
Structural Grade: **0**
O&M Grade: **0**
Clock Start/From: **10**
Clock To:
1st Value: **4.000**
2nd Value:
Value Percent:
Continuous Index:
Within 8" of Joint:
Remarks:

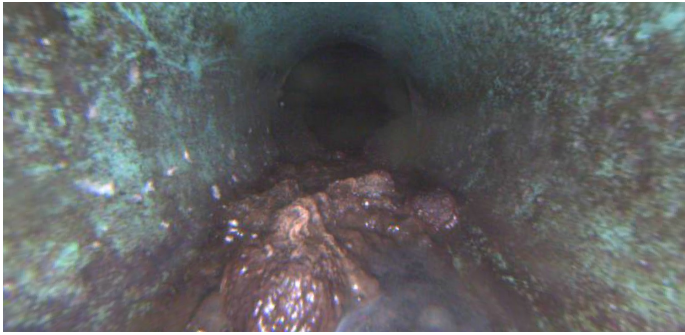
Code: **DSZ**
Description: **Deposits Settled Other**

Distance (ft): **141.5**
Structural Grade: **0**
O&M Grade: **3**
Clock Start/From: **4**
Clock To: **8**
1st Value:
2nd Value:
Value Percent: **20.000**
Continuous Index:
Within 8" of Joint: **NO**
Remarks: **MISC**

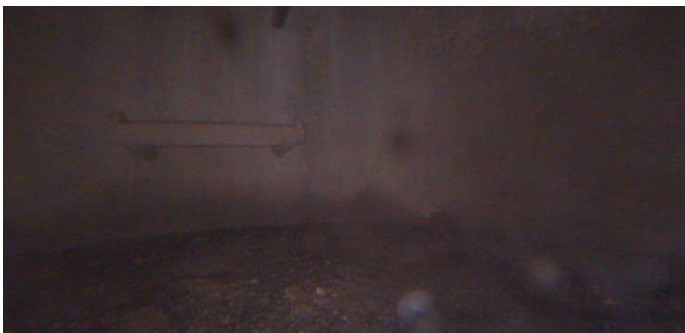
Code: **AMH**
Description: **Manhole**

Distance (ft): **144.6**
Structural Grade: **0**
O&M Grade: **0**
Clock Start/From:
Clock To:
1st Value:
2nd Value:
Value Percent:
Continuous Index:
Within 8" of Joint: **NO**
Remarks: **M-707-056**
