Profile/Photo Observation Report

Street:	13th	Flow Control:	Not Controlled
City:	Hobart, IN	Year Renewed:	
Location:	Light Highway	Tape/Media #:	
Purpose:	Maintenance Related	Dia/Height:	12"
Use:	Sanitary	Material:	PVC
Drain Area:	NA	Lining:	Cured in Place
Category:	NA		
Comment:

Location Details:		Direction of Survey:	Upstream
US MH:	M-707-056	DS MH:	M-707-055
		Total Length Surveyed (ft):	144.6

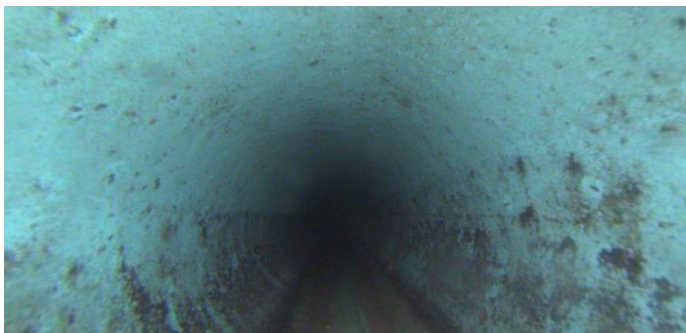
Code: **AMH**
Description: **Manhole**

Distance (ft): **.0**
Structural Grade: **0**
O&M Grade: **0**
Clock Start/From:
Clock To:
1st Value:
2nd Value:
Value Percent:
Continuous Index:
Within 8" of Joint: **NO**
Remarks: **M-707-055**

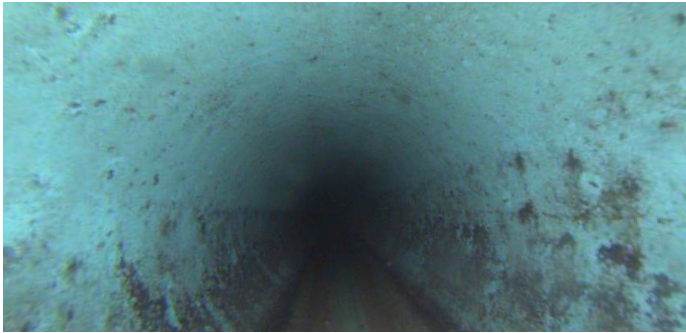
Code:	MWL
Description:	Water Level

Distance (ft):	.0
Structural Grade:	0
O&M Grade:	0
Clock Start/From:	
Clock To:	
1st Value:	
2nd Value:	
Value Percent:	5.000
Continuous Index:	
Within 8" of Joint:	NO
Remarks:

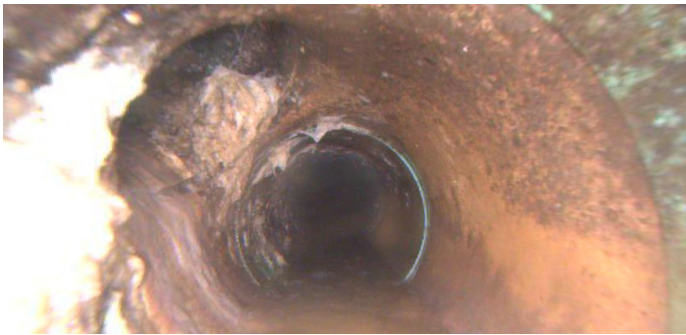
Code:	DAGS
Description:	Deposits Attached Grease

Distance (ft):	23.3
Structural Grade:	0
O&M Grade:	2
Clock Start/From:	7
Clock To:	10
1st Value:	
2nd Value:	
Value Percent:	5.000
Continuous Index:	
Within 8" of Joint:	NO
Remarks:

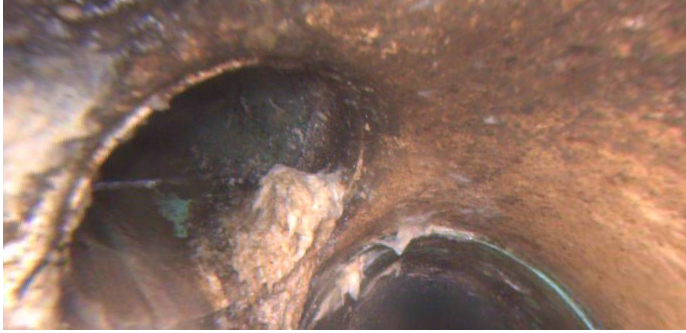
Code: **TF**
Description: **Tap Factory**

Distance (ft): **23.5**
Structural Grade: **0**
O&M Grade: **0**
Clock Start/From: **10**
Clock To:
1st Value: **4.000**
2nd Value:
Value Percent:
Continuous Index:
Within 8" of Joint:
Remarks:

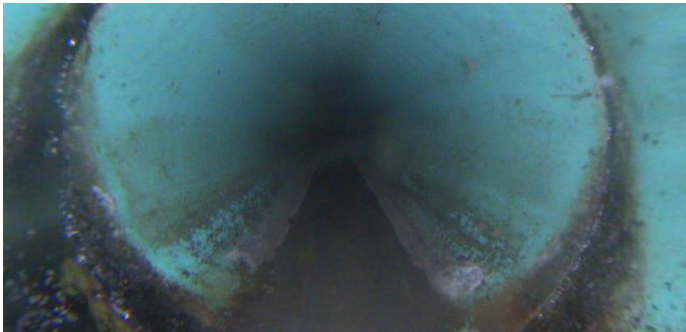
Code: **IW**
Description: **Infil Weeper**

Distance (ft): **47.9**
Structural Grade: **0**
O&M Grade: **2**
Clock Start/From: **8**
Clock To: **4**
1st Value:
2nd Value:
Value Percent:
Continuous Index:
Within 8" of Joint: **YES**
Remarks:

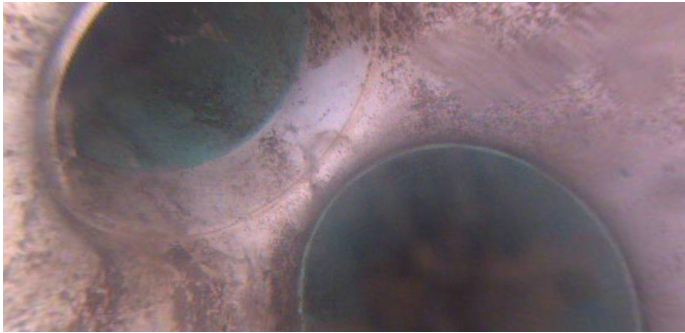
Code: **TF**
Description: **Tap Factory**

Distance (ft): **54.7**
Structural Grade: **0**
O&M Grade: **0**
Clock Start/From: **2**
Clock To:
1st Value: **4.000**
2nd Value:
Value Percent:
Continuous Index:
Within 8" of Joint:
Remarks:

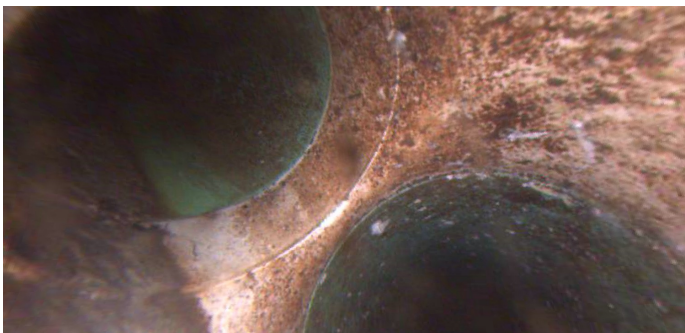
Code: **TF**
Description: **Tap Factory**

Distance (ft): **140.4**
Structural Grade: **0**
O&M Grade: **0**
Clock Start/From: **10**
Clock To:
1st Value: **4.000**
2nd Value:
Value Percent:
Continuous Index:
Within 8" of Joint:
Remarks:

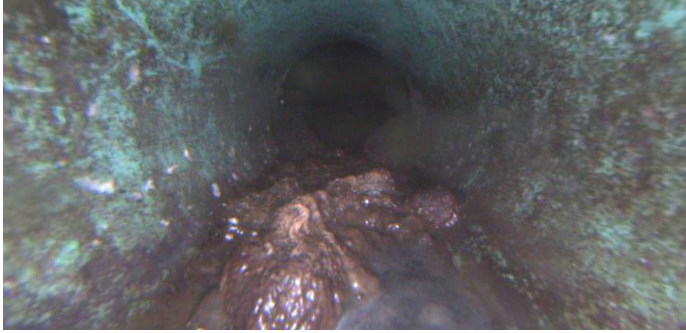
Code: **DSZ**
Description: **Deposits Settled Other**

Distance (ft): **141.5**
Structural Grade: **0**
O&M Grade: **3**
Clock Start/From: **4**
Clock To: **8**
1st Value:
2nd Value:
Value Percent: **20.000**
Continuous Index:
Within 8" of Joint: **NO**
Remarks: **MISC**

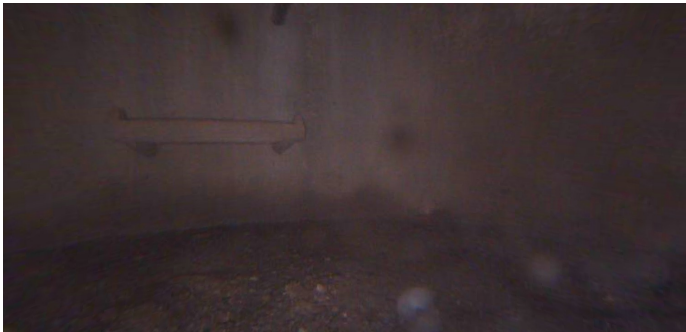
Code: **AMH**
Description: **Manhole**

Distance (ft): **144.6**
Structural Grade: **0**
O&M Grade: **0**
Clock Start/From:
Clock To:
1st Value:
2nd Value:
Value Percent:
Continuous Index:
Within 8" of Joint: **NO**
Remarks: **M-707-056**
