Profile/Photo Observation Report

Street:	12th	Flow Control:	Not Controlled
City:	Hobart, IN	Year Renewed:	
Location:	Light Highway	Tape/Media #:	
Purpose:	Maintenance Related	Dia/Height:	8"
Use:	Sanitary	Material:	PVC
Drain Area:	NA	Lining:	Cured in Place
Category:	NA		
Comment:	Flow direction wrong.

Location Details:		Direction of Survey:	Upstream
US MH:	M-707-060	DS MH:	M-707-059
		Total Length Surveyed (ft):	307.6

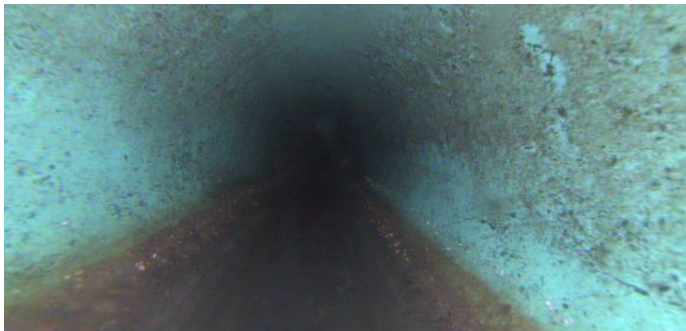
Code: **AMH**
Description: **Manhole**

Distance (ft): **.0**
Structural Grade: **0**
O&M Grade: **0**
Clock Start/From:
Clock To:
1st Value:
2nd Value:
Value Percent:
Continuous Index:
Within 8" of Joint: **NO**
Remarks: **M-707-059**

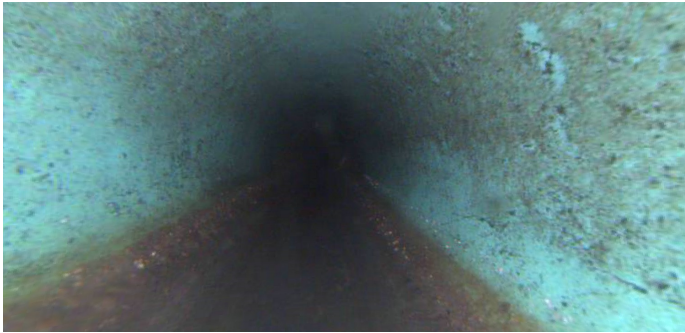
Code:	MWL
Description:	Water Level

Distance (ft):	.0
Structural Grade:	0
O&M Grade:	0
Clock Start/From:	
Clock To:	
1st Value:	
2nd Value:	
Value Percent:	5.000
Continuous Index:	
Within 8" of Joint:	NO
Remarks:

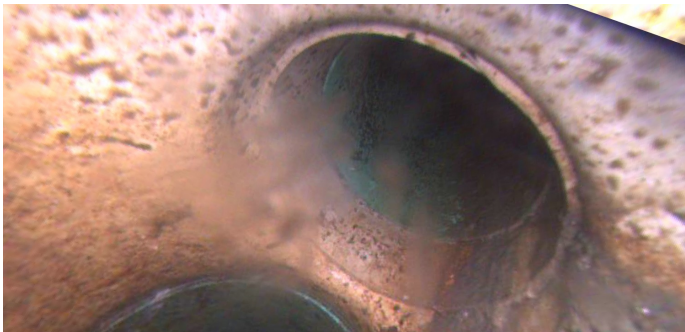
Code:	TF
Description:	Tap Factory

Distance (ft):	4.3
Structural Grade:	0
O&M Grade:	0
Clock Start/From:	1
Clock To:	
1st Value:	4.000
2nd Value:	
Value Percent:	
Continuous Index:	
Within 8" of Joint:	
Remarks:

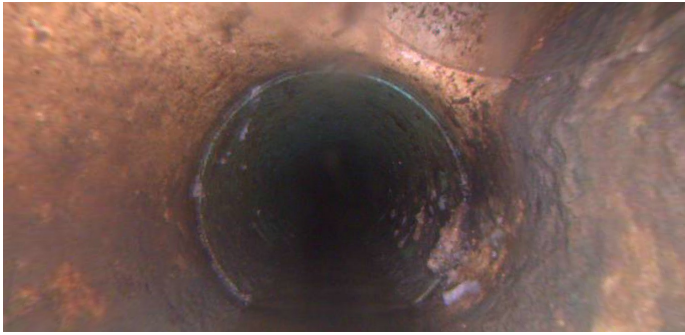
Code: **DAGS**
Description: **Deposits Attached Grease**

Distance (ft): **4.3**
Structural Grade: **0**
O&M Grade: **2**
Clock Start/From: **3**
Clock To: **4**
1st Value:
2nd Value:
Value Percent: **5.000**
Continuous Index:
Within 8" of Joint: **NO**
Remarks:

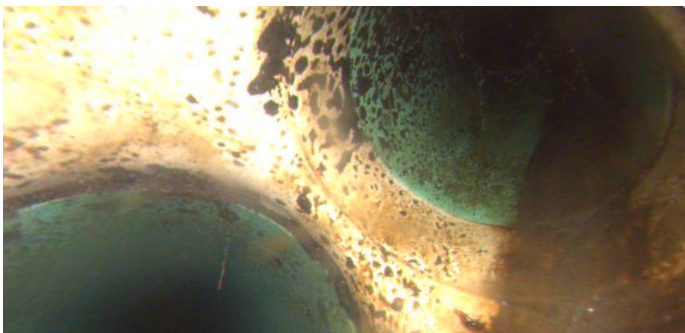
Code: **TF**
Description: **Tap Factory**

Distance (ft): **30.6**
Structural Grade: **0**
O&M Grade: **0**
Clock Start/From: **11**
Clock To:
1st Value: **4.000**
2nd Value:
Value Percent:
Continuous Index:
Within 8" of Joint:
Remarks:

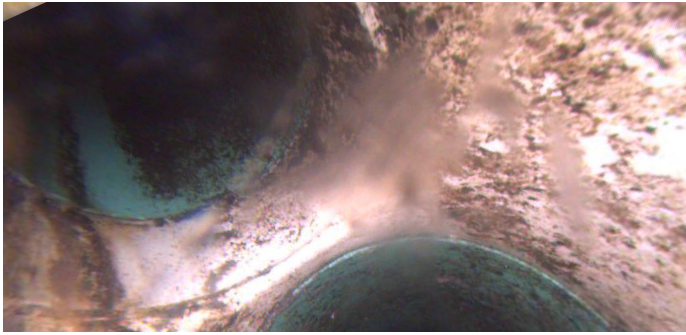
Code: **TF**
Description: **Tap Factory**

Distance (ft): **38.6**
Structural Grade: **0**
O&M Grade: **0**
Clock Start/From: **11**
Clock To:
1st Value: **4.000**
2nd Value:
Value Percent:
Continuous Index:
Within 8" of Joint:
Remarks:

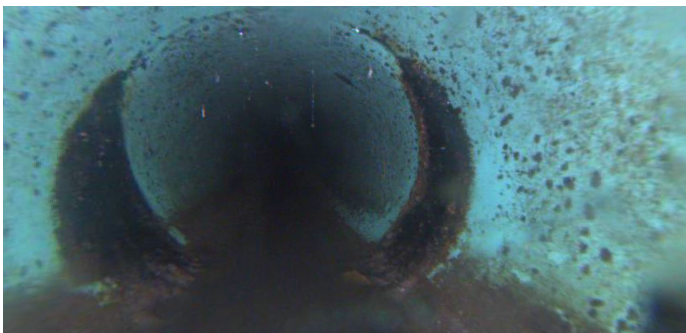
Code: **IW**
Description: **Infil Weeper**

Distance (ft): **43.3**
Structural Grade: **0**
O&M Grade: **2**
Clock Start/From: **8**
Clock To: **4**
1st Value:
2nd Value:
Value Percent:
Continuous Index:
Within 8" of Joint: **YES**
Remarks:

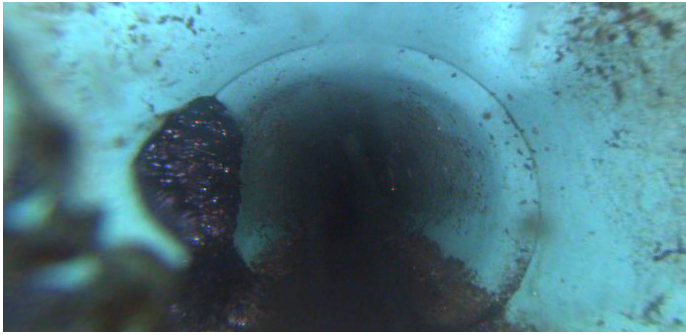
Code: **DAE**
Description: **Deposits Attached Encrustation**

Distance (ft): **81.2**
Structural Grade: **0**
O&M Grade: **2**
Clock Start/From: **7**
Clock To: **10**
1st Value:
2nd Value:
Value Percent: **10.000**
Continuous Index:
Within 8" of Joint: **YES**
Remarks:

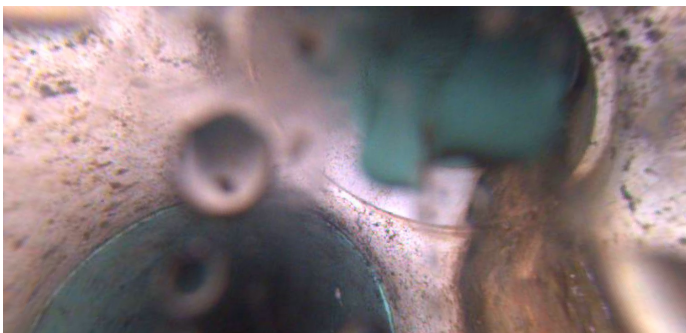
Code: **TF**
Description: **Tap Factory**

Distance (ft): **134.7**
Structural Grade: **0**
O&M Grade: **0**
Clock Start/From: **1**
Clock To:
1st Value: **4.000**
2nd Value:
Value Percent:
Continuous Index:
Within 8" of Joint:
Remarks:

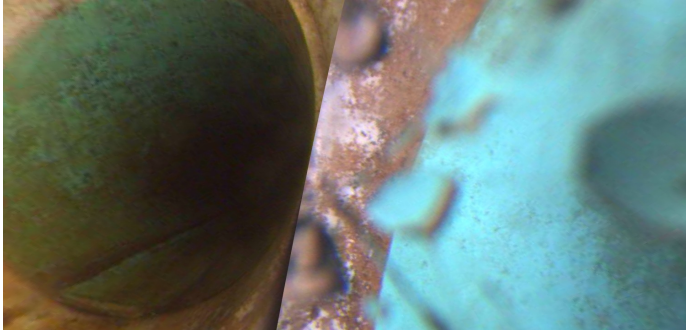
Code: **TF**
Description: **Tap Factory**

Distance (ft): **156.5**
Structural Grade: **0**
O&M Grade: **0**
Clock Start/From: **10**
Clock To:
1st Value: **4.000**
2nd Value:
Value Percent:
Continuous Index:
Within 8" of Joint:
Remarks:

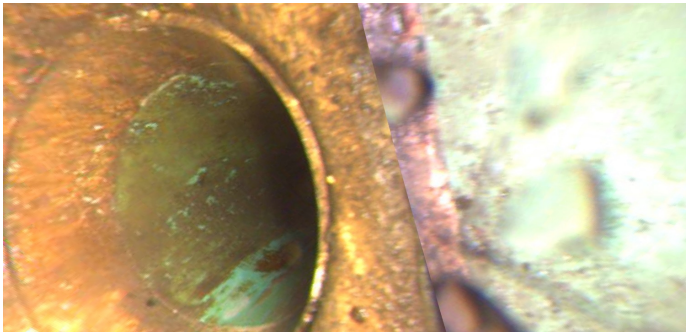
Code: **TF**
Description: **Tap Factory**

Distance (ft): **166.9**
Structural Grade: **0**
O&M Grade: **0**
Clock Start/From: **10**
Clock To:
1st Value: **4.000**
2nd Value:
Value Percent:
Continuous Index:
Within 8" of Joint:
Remarks:

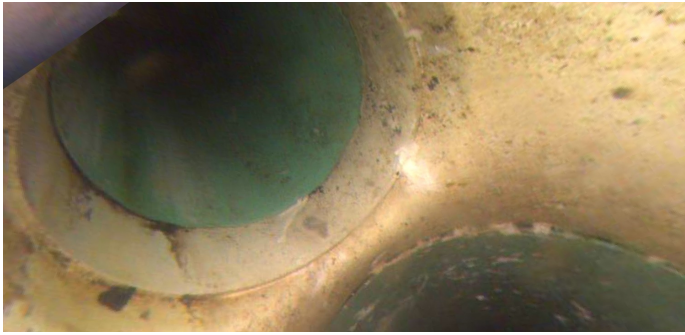
Code: **TF**
Description: **Tap Factory**

Distance (ft): **196.7**
Structural Grade: **0**
O&M Grade: **0**
Clock Start/From: **2**
Clock To:
1st Value: **4.000**
2nd Value:
Value Percent:
Continuous Index:
Within 8" of Joint:
Remarks:

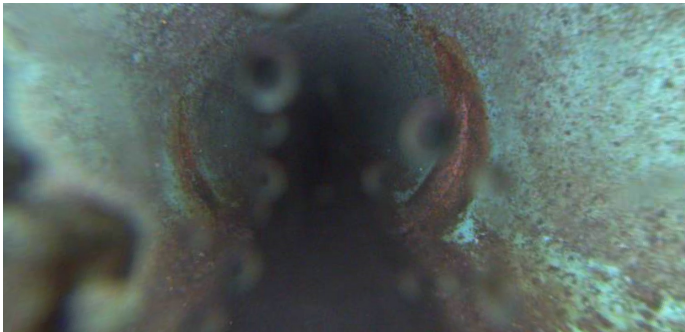
Code: **IW**
Description: **Infil Weeper**

Distance (ft): **221.2**
Structural Grade: **0**
O&M Grade: **2**
Clock Start/From: **8**
Clock To: **4**
1st Value:
2nd Value:
Value Percent:
Continuous Index:
Within 8" of Joint: **YES**
Remarks:

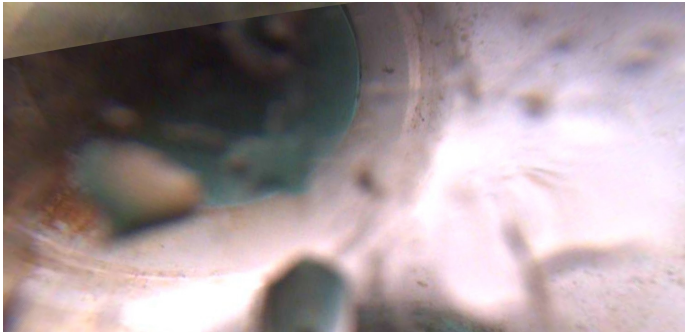
Code: **TF**
Description: **Tap Factory**

Distance (ft): **284.5**
Structural Grade: **0**
O&M Grade: **0**
Clock Start/From: **11**
Clock To:
1st Value: **4.000**
2nd Value:
Value Percent:
Continuous Index:
Within 8" of Joint:
Remarks:

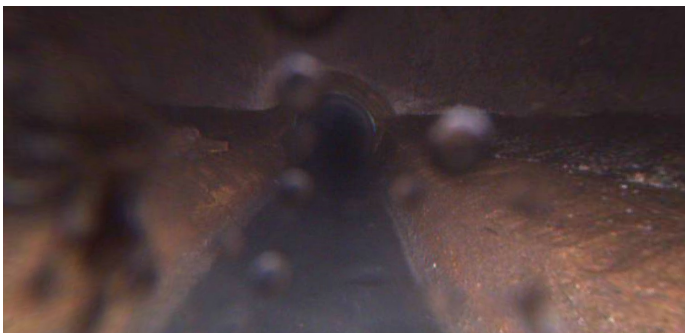
Code: **AMH**
Description: **Manhole**

Distance (ft): **307.6**
Structural Grade: **0**
O&M Grade: **0**
Clock Start/From:
Clock To:
1st Value:
2nd Value:
Value Percent:
Continuous Index:
Within 8" of Joint: **NO**
Remarks: **M-707-060**
