## Profile/Photo Observation Report

Street:	<b>LINCOLN ST</b>	Flow Control:	<b>Not Controlled</b>
City:	<b>Hobart, IN</b>	Year Renewed:	
Location:	<b>Light Highway</b>	Tape/Media #:	
Purpose:	<b>Maintenance Related</b>	Dia/Height:	<b>8"</b>
Use:	<b>Sanitary</b>	Material:	<b>PVC</b>
Drain Area:	<b>NA</b>	Lining:	
Category:	<b>NA</b>		
Comment:	<b>Flow direction wrong. Reverse setup.</b>

Location Details:		Direction of Survey:	<b>Upstream</b>
US MH:	<b>M-708-002</b>	DS MH:	<b>M-708-001</b>
		Total Length Surveyed (ft):	<b>380.4</b>

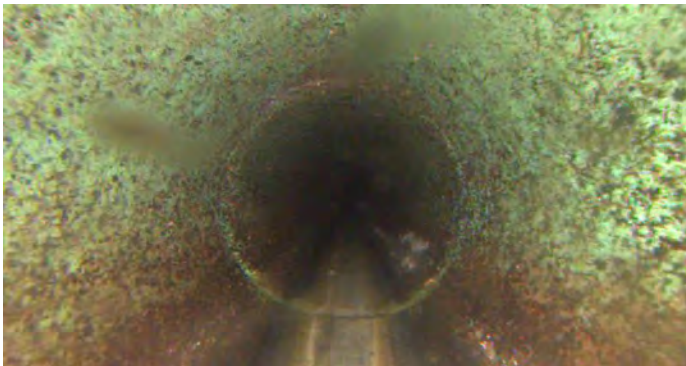
Position	Code	Observation	Video (sec)	Grade
.0	AMH	Manhole	10	NA
.0	MWL	Water Level	21	NA
50.4	TF	Tap Factory	135	NA
113.9	TF	Tap Factory	277	NA
149.8	TF	Tap Factory	361	NA
184.7	TF	Tap Factory	443	NA
255.1	TF	Tap Factory	596	NA
263.6	TF	Tap Factory	625	NA
298.3	TF	Tap Factory	706	NA
346.2	TF	Tap Factory	814	NA
380.4	AMH	Manhole	894	NA

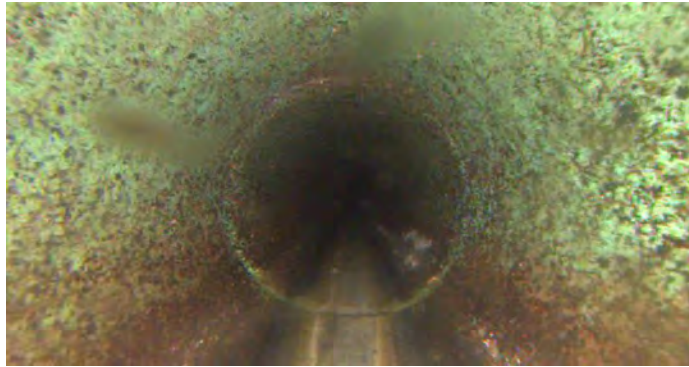
Code:	<b>MWL</b>
Description:	<b>Water Level</b>
Distance (ft):	<b>.0</b>
Structural Grade:	<b>0</b>
O&M Grade:	<b>0</b>
Clock Start/From:	
Clock To:	
1st Value:	
2nd Value:	
Value Percent:	<b>10.000</b>
Continuous Index:	
Within 8" of Joint:	<b>NO</b>
Remarks:

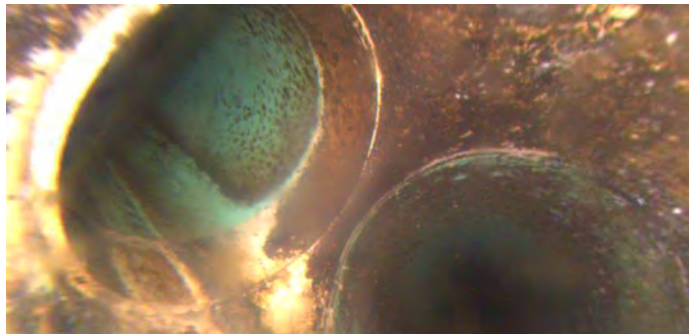
Code:	<b>TF</b>
Description:	<b>Tap Factory</b>
Distance (ft):	<b>50.4</b>
Structural Grade:	<b>0</b>
O&M Grade:	<b>0</b>
Clock Start/From:	<b>2</b>
Clock To:	
1st Value:	<b>4.000</b>
2nd Value:	
Value Percent:	
Continuous Index:	
Within 8" of Joint:	
Remarks:

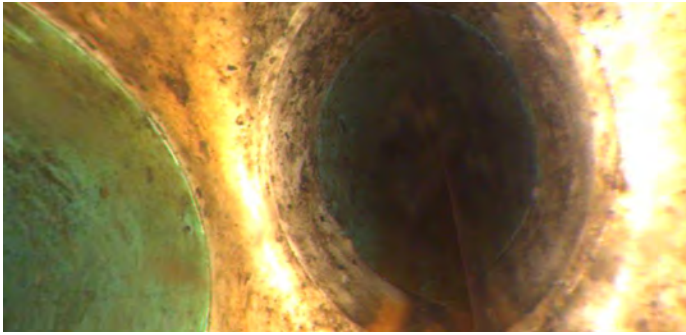
Code: **TF**  
Description: **Tap Factory**

Distance (ft): **113.9**  
Structural Grade: **0**  
O&M Grade: **0**  
Clock Start/From: **2**  
Clock To:  
1st Value: **4.000**  
2nd Value:  
Value Percent:  
Continuous Index:  
Within 8" of Joint:  
Remarks:

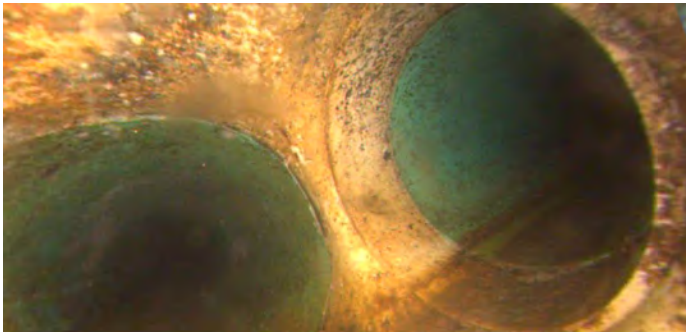
Code: **TF**  
Description: **Tap Factory**

Distance (ft): **149.8**  
Structural Grade: **0**  
O&M Grade: **0**  
Clock Start/From: **3**  
Clock To:  
1st Value: **4.000**  
2nd Value:  
Value Percent:  
Continuous Index:  
Within 8" of Joint:  
Remarks:

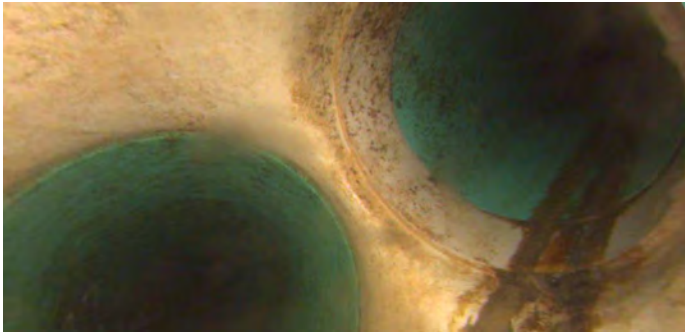
Code: **TF**  
Description: **Tap Factory**

Distance (ft): **184.7**  
Structural Grade: **0**  
O&M Grade: **0**  
Clock Start/From: **2**  
Clock To:  
1st Value: **4.000**  
2nd Value:  
Value Percent:  
Continuous Index:  
Within 8" of Joint:  
Remarks:

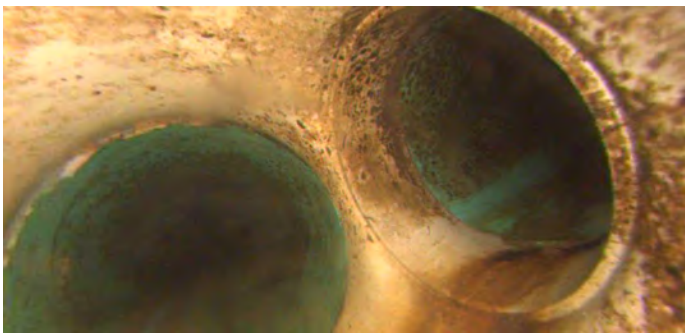
Code: **TF**  
Description: **Tap Factory**

Distance (ft): **255.1**  
Structural Grade: **0**  
O&M Grade: **0**  
Clock Start/From: **2**  
Clock To:  
1st Value: **4.000**  
2nd Value:  
Value Percent:  
Continuous Index:  
Within 8" of Joint:  
Remarks:

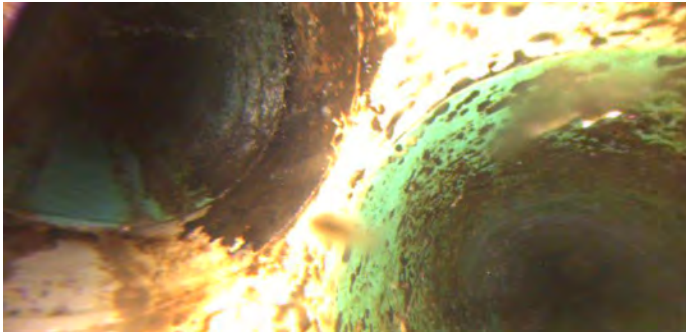
Code: **TF**  
Description: **Tap Factory**

Distance (ft): **263.6**  
Structural Grade: **0**  
O&M Grade: **0**  
Clock Start/From: **10**  
Clock To:  
1st Value: **4.000**  
2nd Value:  
Value Percent:  
Continuous Index:  
Within 8" of Joint:  
Remarks:

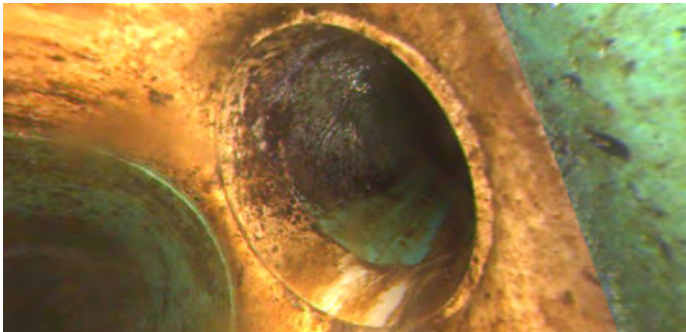
Code: **TF**  
Description: **Tap Factory**

Distance (ft): **298.3**  
Structural Grade: **0**  
O&M Grade: **0**  
Clock Start/From: **2**  
Clock To:  
1st Value: **4.000**  
2nd Value:  
Value Percent:  
Continuous Index:  
Within 8" of Joint:  
Remarks:

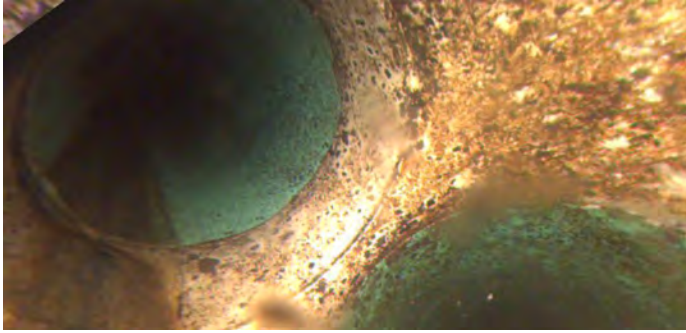
Code: **TF**  
Description: **Tap Factory**

Distance (ft): **346.2**  
Structural Grade: **0**  
O&M Grade: **0**  
Clock Start/From: **10**  
Clock To:  
1st Value: **4.000**  
2nd Value:  
Value Percent:  
Continuous Index:  
Within 8" of Joint:  
Remarks:

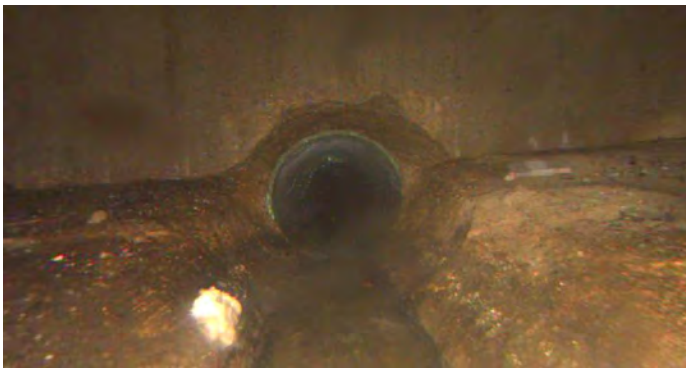
Code: **AMH**  
Description: **Manhole**

Distance (ft): **380.4**  
Structural Grade: **0**  
O&M Grade: **0**  
Clock Start/From:  
Clock To:  
1st Value:  
2nd Value:  
Value Percent:  
Continuous Index:  
Within 8" of Joint: **NO**  
Remarks: **M-708-002**
