## Profile/Photo Observation Report

Street:	<b>Lincoln</b>	Flow Control:	<b>Not Controlled</b>
City:	<b>Hobart, IN</b>	Year Renewed:	
Location:	<b>Light Highway</b>	Tape/Media #:	
Purpose:	<b>Maintenance Related</b>	Dia/Height:	<b>12"</b>
Use:	<b>Sanitary</b>	Material:	<b>PVC</b>
Drain Area:	<b>NA</b>	Lining:	
Category:	<b>NA</b>		
Comment:	<b>Debris at 203'.</b>

Location Details:		Direction of Survey:	<b>Downstream</b>
US MH:	<b>M-708-002</b>	DS MH:	<b>M-708-001</b>
		Total Length Surveyed (ft):	<b>204.8</b>

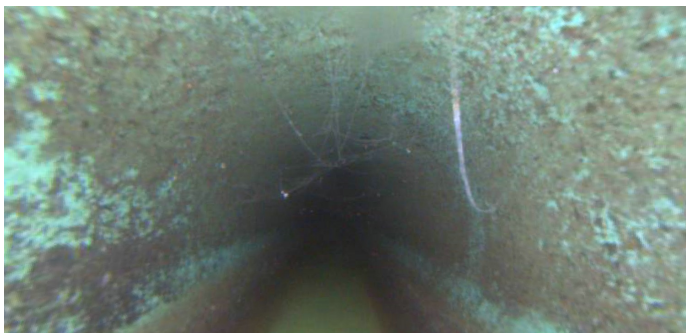
Code: **AMH**  
Description: **Manhole**

Distance (ft): **.0**  
Structural Grade: **0**  
O&M Grade: **0**  
Clock Start/From:  
Clock To:  
1st Value:  
2nd Value:  
Value Percent:  
Continuous Index:  
Within 8" of Joint: **NO**  
Remarks: **M-708-002**

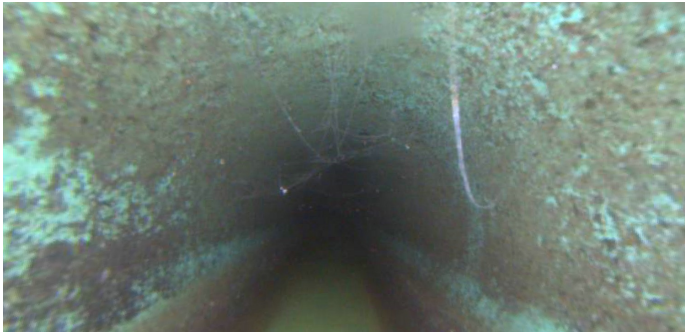
Code:	<b>MWL</b>
Description:	<b>Water Level</b>

Distance (ft):	<b>.0</b>
Structural Grade:	<b>0</b>
O&M Grade:	<b>0</b>
Clock Start/From:	
Clock To:	
1st Value:	
2nd Value:	
Value Percent:	<b>5.000</b>
Continuous Index:	
Within 8" of Joint:	<b>NO</b>
Remarks:

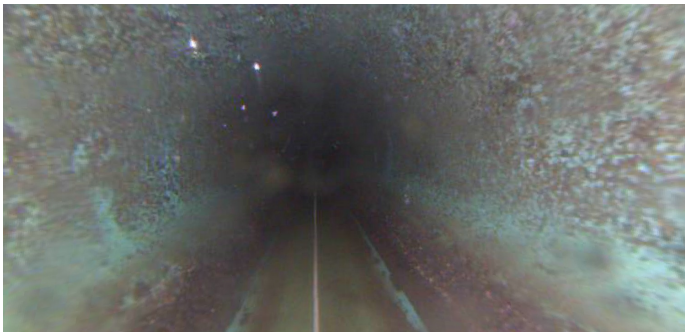
Code:	<b>MGO</b>
Description:	<b>General Observation</b>

Distance (ft):	<b>8.9</b>
Structural Grade:	<b>0</b>
O&M Grade:	<b>0</b>
Clock Start/From:	
Clock To:	
1st Value:	
2nd Value:	
Value Percent:	
Continuous Index:	
Within 8" of Joint:	<b>NO</b>
Remarks:	<b>rear camera</b>

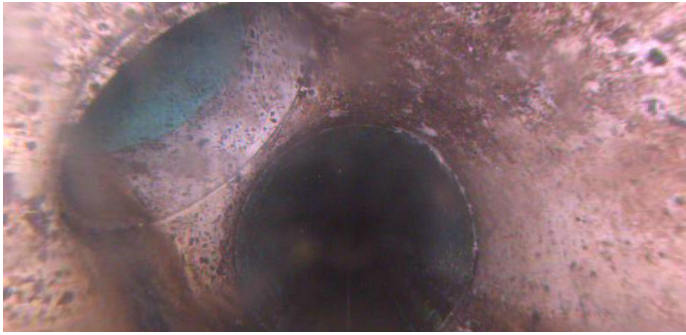
Code: **TF**  
Description: **Tap Factory**

Distance (ft): **28.8**  
Structural Grade: **0**  
O&M Grade: **0**  
Clock Start/From: **2**  
Clock To:  
1st Value: **4.000**  
2nd Value:  
Value Percent:  
Continuous Index:  
Within 8" of Joint:  
Remarks:

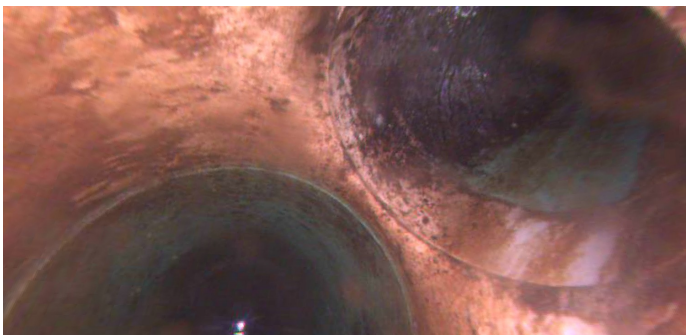
Code: **TF**  
Description: **Tap Factory**

Distance (ft): **71.3**  
Structural Grade: **0**  
O&M Grade: **0**  
Clock Start/From: **10**  
Clock To:  
1st Value: **4.000**  
2nd Value:  
Value Percent:  
Continuous Index:  
Within 8" of Joint:  
Remarks:

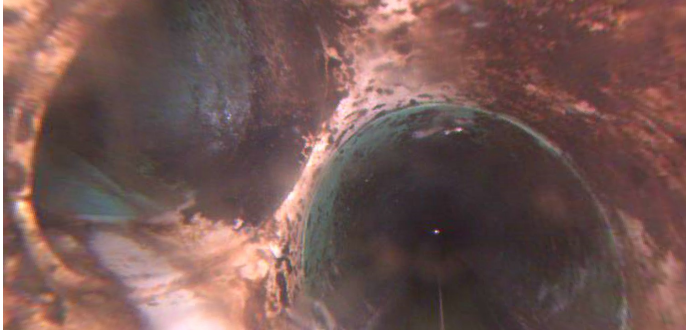
Code: **TF**  
Description: **Tap Factory**

Distance (ft): **102.6**  
Structural Grade: **0**  
O&M Grade: **0**  
Clock Start/From: **2**  
Clock To:  
1st Value: **4.000**  
2nd Value:  
Value Percent:  
Continuous Index:  
Within 8" of Joint:  
Remarks:

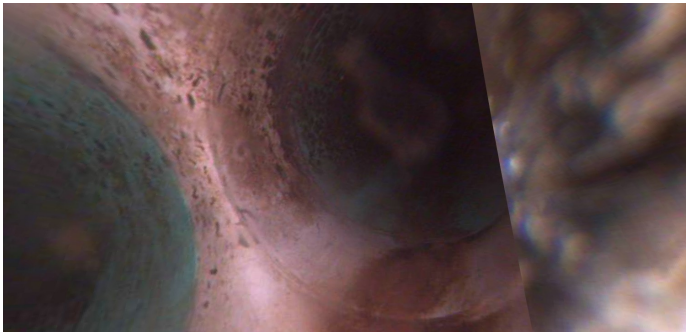
Code: **TF**  
Description: **Tap Factory**

Distance (ft): **109.8**  
Structural Grade: **0**  
O&M Grade: **0**  
Clock Start/From: **10**  
Clock To:  
1st Value: **4.000**  
2nd Value:  
Value Percent:  
Continuous Index:  
Within 8" of Joint:  
Remarks:

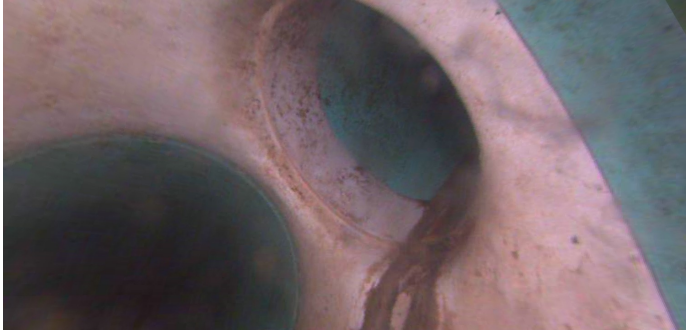
Code: **TF**  
Description: **Tap Factory**

Distance (ft): **173.1**  
Structural Grade: **0**  
O&M Grade: **0**  
Clock Start/From: **10**  
Clock To:  
1st Value: **4.000**  
2nd Value:  
Value Percent:  
Continuous Index:  
Within 8" of Joint:  
Remarks:

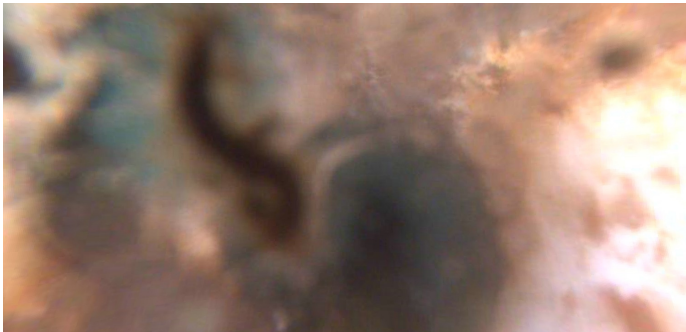
Code: **TF**  
Description: **Tap Factory**

Distance (ft): **203.5**  
Structural Grade: **0**  
O&M Grade: **0**  
Clock Start/From: **10**  
Clock To:  
1st Value: **4.000**  
2nd Value:  
Value Percent:  
Continuous Index:  
Within 8" of Joint:  
Remarks:

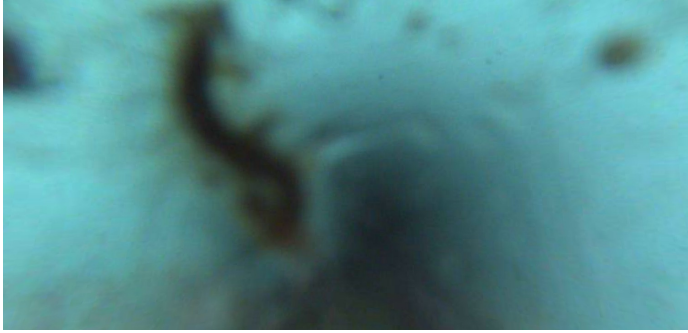
Code:	<b>MSA</b>
Description:	<b>Abandoned Survey</b>
Distance (ft):	<b>204.8</b>
Structural Grade:	<b>0</b>
O&M Grade:	<b>0</b>
Clock Start/From:	
Clock To:	
1st Value:	
2nd Value:	
Value Percent:	
Continuous Index:	
Within 8" of Joint:	<b>NO</b>
Remarks:	<b>unknown</b>
