## Profile/Photo Observation Report

Date:	<b>10/11/2018</b>	Weather:		Coding:	<b>PACP 6.0</b>
Pipe Length (ft):	<b>335.9</b>	Owner:	<b>NA</b>	Pre Clean:	<b>Not Known</b>
P.O.#:		Surveyor:	<b>Selasie Honu</b>	PSR:	<b>P-708-005-006</b>
Customer:		Clean Date:	<b>01/01/1900</b>	Shape:	<b>C</b>

Street:	<b>STATE ST</b>	Flow Control:	<b>Not Controlled</b>
City:	<b>Hobart, IN</b>	Year Renewed:	
Location:	<b>Light Highway</b>	Tape/Media #:	
Purpose:	<b>Routine Assessment</b>	Dia/Height:	<b>12"</b>
Use:	<b>Sanitary</b>	Material:	<b>PVC</b>
Drain Area:	<b>NA</b>	Lining:	
Category:	<b>NA</b>		
Comment:

Location Details:		Direction of Survey:	<b>Upstream</b>
US MH:	<b>M-708-006</b>	DS MH:	<b>M-708-005</b>
		Total Length Surveyed (ft):	<b>335.4</b>

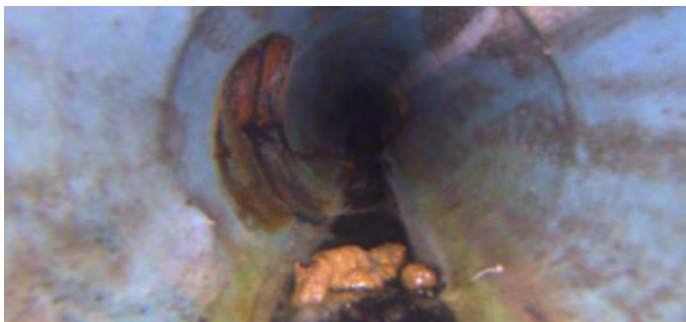
Code: **AMH**  
Description: **Manhole**

Distance (ft): **.0**  
Structural Grade: **0**  
O&M Grade: **0**  
Clock Start/From:  
Clock To:  
1st Value:  
2nd Value:  
Value Percent:  
Continuous Index:  
Within 8" of Joint: **NO**  
Remarks: **M-708-005**

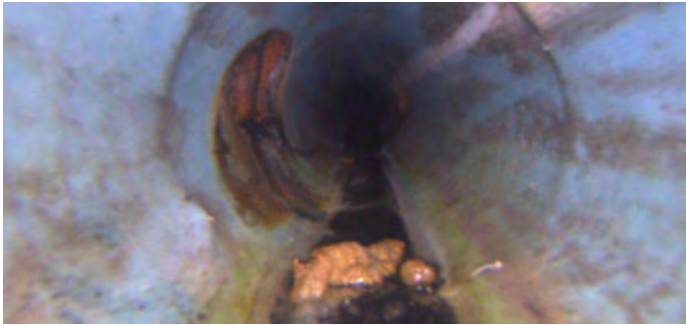
Code:	<b>MWL</b>
Description:	<b>Water Level</b>

Distance (ft):	<b>.0</b>
Structural Grade:	<b>0</b>
O&M Grade:	<b>0</b>
Clock Start/From:	
Clock To:	
1st Value:	
2nd Value:	
Value Percent:	<b>5.000</b>
Continuous Index:	
Within 8" of Joint:	<b>NO</b>
Remarks:

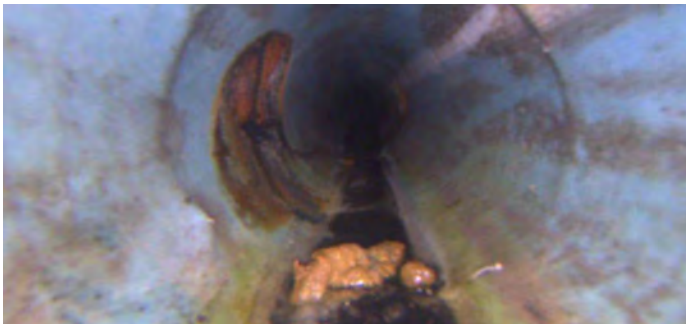
Code:	<b>TF</b>
Description:	<b>Tap Factory</b>

Distance (ft):	<b>.0</b>
Structural Grade:	<b>0</b>
O&M Grade:	<b>0</b>
Clock Start/From:	<b>9</b>
Clock To:	
1st Value:	<b>4.000</b>
2nd Value:	
Value Percent:	
Continuous Index:	
Within 8" of Joint:	
Remarks:

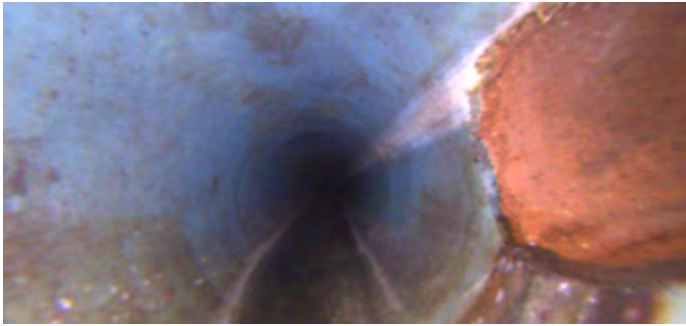
Code: **TF**  
Description: **Tap Factory**

Distance (ft): **3.9**  
Structural Grade: **0**  
O&M Grade: **0**  
Clock Start/From: **3**  
Clock To:  
1st Value: **4.000**  
2nd Value:  
Value Percent:  
Continuous Index:  
Within 8" of Joint: **NO**  
Remarks:

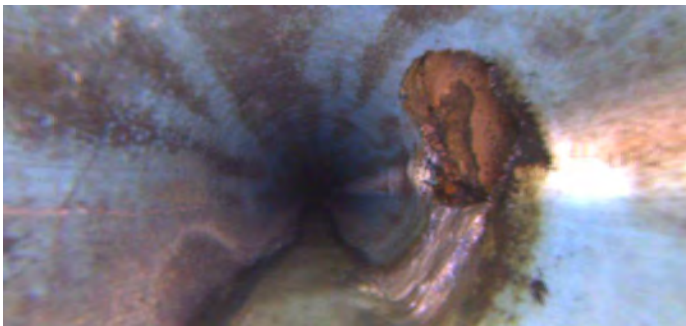
Code: **TF**  
Description: **Tap Factory**

Distance (ft): **33.6**  
Structural Grade: **0**  
O&M Grade: **0**  
Clock Start/From: **3**  
Clock To:  
1st Value: **4.000**  
2nd Value:  
Value Percent:  
Continuous Index:  
Within 8" of Joint:  
Remarks:

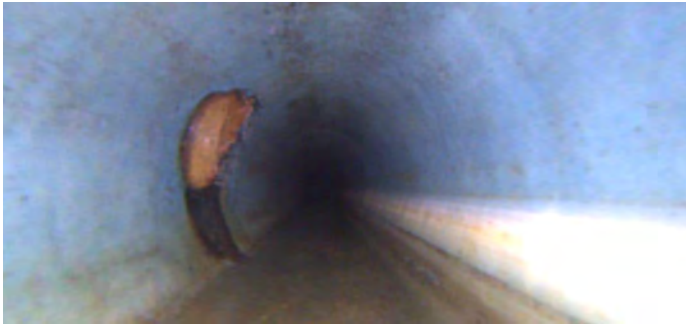
Code: **TF**  
Description: **Tap Factory**

Distance (ft): **59.4**  
Structural Grade: **0**  
O&M Grade: **0**  
Clock Start/From: **9**  
Clock To:  
1st Value: **4.000**  
2nd Value:  
Value Percent:  
Continuous Index:  
Within 8" of Joint:  
Remarks:

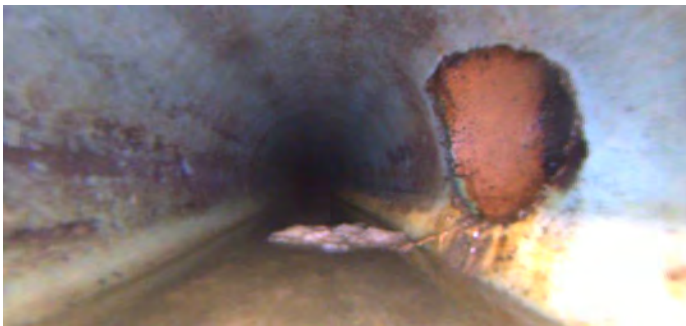
Code: **TF**  
Description: **Tap Factory**

Distance (ft): **74.2**  
Structural Grade: **0**  
O&M Grade: **0**  
Clock Start/From: **3**  
Clock To:  
1st Value: **4.000**  
2nd Value:  
Value Percent:  
Continuous Index:  
Within 8" of Joint:  
Remarks:

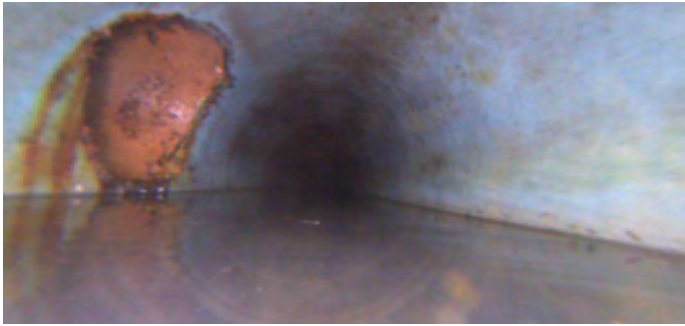
Code: **TF**  
Description: **Tap Factory**

Distance (ft): **131.3**  
Structural Grade: **0**  
O&M Grade: **0**  
Clock Start/From: **9**  
Clock To:  
1st Value: **4.000**  
2nd Value:  
Value Percent:  
Continuous Index:  
Within 8" of Joint:  
Remarks:

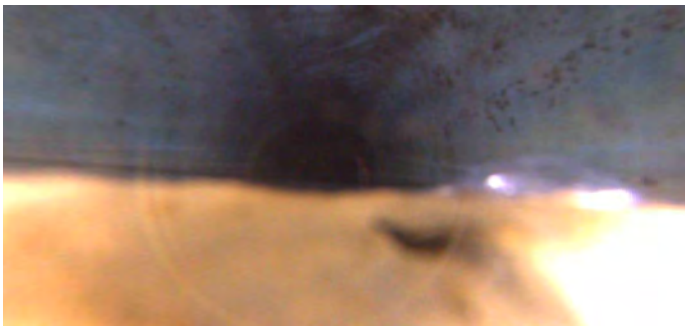
Code: **MWLS**  
Description: **Water Level Sag**

Distance (ft): **137.5**  
Structural Grade: **2**  
O&M Grade: **3**  
Clock Start/From:  
Clock To:  
1st Value:  
2nd Value:  
Value Percent: **20.000**  
Continuous Index:  
Within 8" of Joint: **NO**  
Remarks:

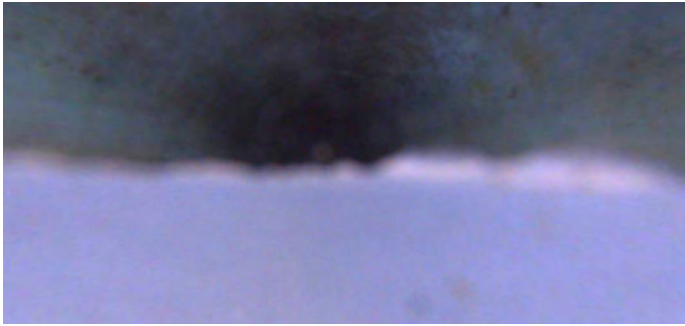
Code: **MWLS**  
Description: **Water Level Sag**

Distance (ft): **147.2**  
Structural Grade: **2**  
O&M Grade: **3**  
Clock Start/From:  
Clock To:  
1st Value:  
2nd Value:  
Value Percent: **15.000**  
Continuous Index:  
Within 8" of Joint: **NO**  
Remarks:

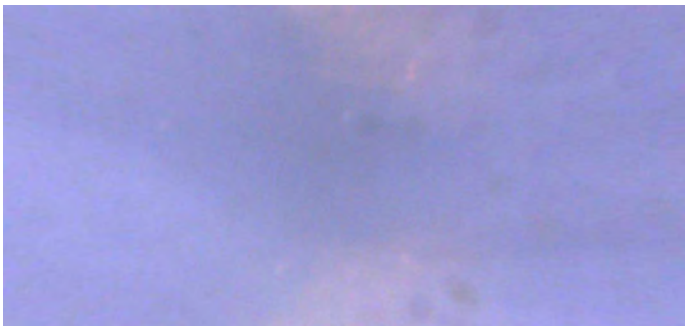
Code: **MWLS**  
Description: **Water Level Sag**

Distance (ft): **170.6**  
Structural Grade: **2**  
O&M Grade: **3**  
Clock Start/From:  
Clock To:  
1st Value:  
2nd Value:  
Value Percent: **20.000**  
Continuous Index:  
Within 8" of Joint: **NO**  
Remarks:

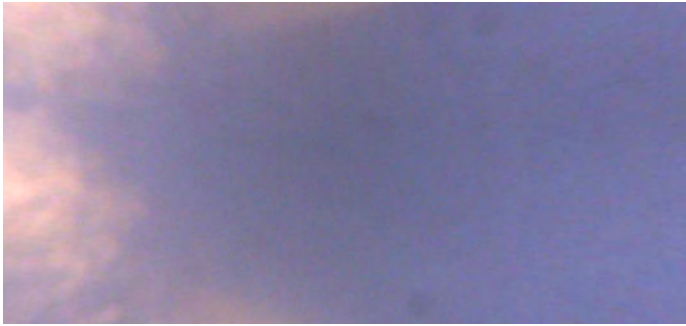
Code: **MWLS**  
Description: **Water Level Sag**

Distance (ft): **187.4**  
Structural Grade: **2**  
O&M Grade: **3**  
Clock Start/From:  
Clock To:  
1st Value:  
2nd Value:  
Value Percent: **20.000**  
Continuous Index: **S01**  
Within 8" of Joint: **NO**  
Remarks:

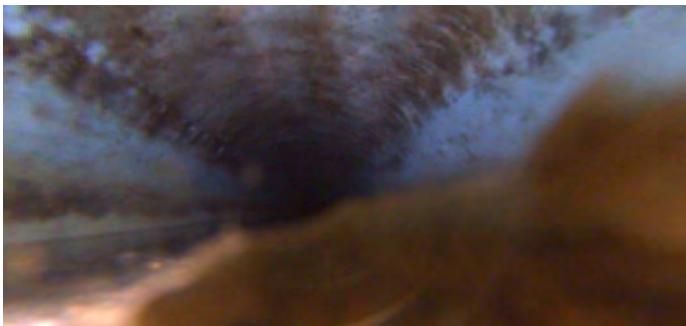
Code: **MWLS**  
Description: **Water Level Sag**

Distance (ft): **199.7**  
Structural Grade: **2**  
O&M Grade: **3**  
Clock Start/From:  
Clock To:  
1st Value:  
2nd Value:  
Value Percent: **20.000**  
Continuous Index: **F01**  
Within 8" of Joint: **NO**  
Remarks:

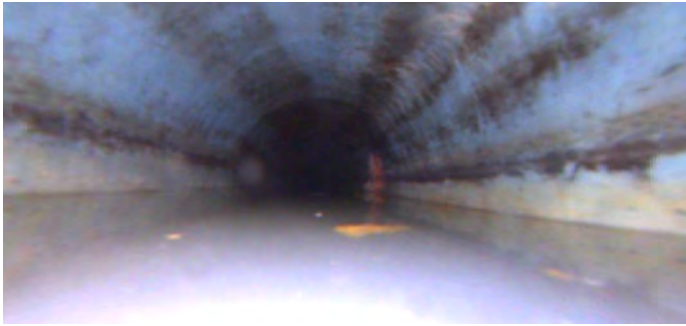
Code: **TF**  
Description: **Tap Factory**

Distance (ft): **209.5**  
Structural Grade: **0**  
O&M Grade: **0**  
Clock Start/From: **3**  
Clock To:  
1st Value: **4.000**  
2nd Value:  
Value Percent:  
Continuous Index:  
Within 8" of Joint:  
Remarks:

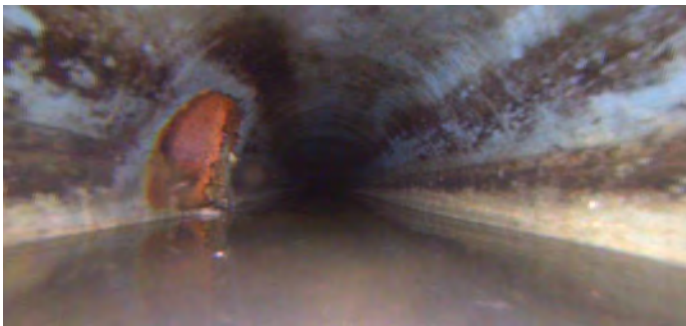
Code: **TF**  
Description: **Tap Factory**

Distance (ft): **267.7**  
Structural Grade: **0**  
O&M Grade: **0**  
Clock Start/From: **9**  
Clock To:  
1st Value: **4.000**  
2nd Value:  
Value Percent:  
Continuous Index:  
Within 8" of Joint:  
Remarks:

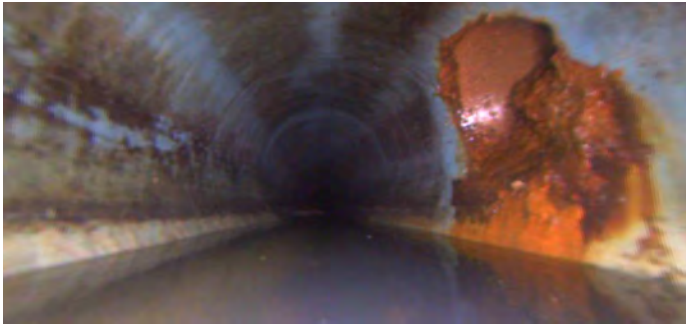
Code: **DAE**  
Description: **Deposits Attached Encrustation**

Distance (ft): **282.1**  
Structural Grade: **0**  
O&M Grade: **3**  
Clock Start/From: **1**  
Clock To: **4**  
1st Value:  
2nd Value:  
Value Percent: **15.000**  
Continuous Index:  
Within 8" of Joint: **NO**  
Remarks:

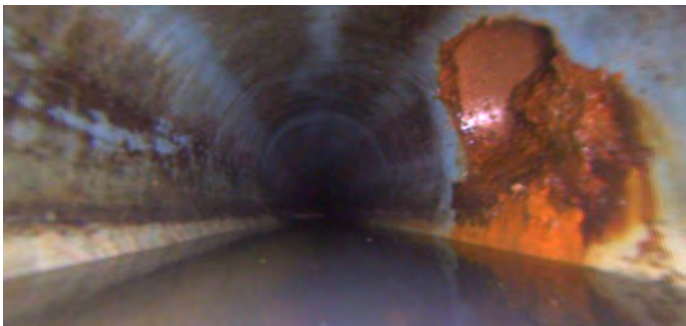
Code: **TF**  
Description: **Tap Factory**

Distance (ft): **282.1**  
Structural Grade: **0**  
O&M Grade: **0**  
Clock Start/From: **3**  
Clock To:  
1st Value: **4.000**  
2nd Value:  
Value Percent:  
Continuous Index:  
Within 8" of Joint:  
Remarks:

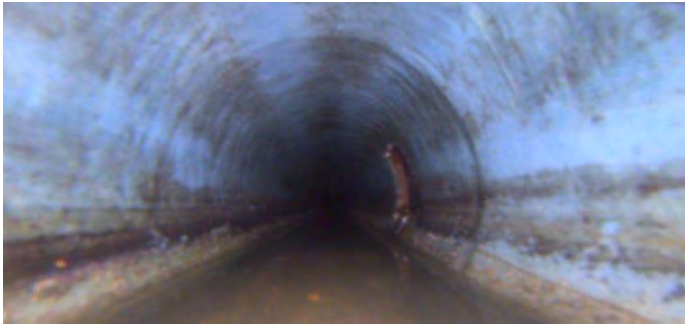
Code: **TF**  
Description: **Tap Factory**

Distance (ft): **295.4**  
Structural Grade: **0**  
O&M Grade: **0**  
Clock Start/From: **3**  
Clock To:  
1st Value: **4.000**  
2nd Value:  
Value Percent:  
Continuous Index:  
Within 8" of Joint:  
Remarks:

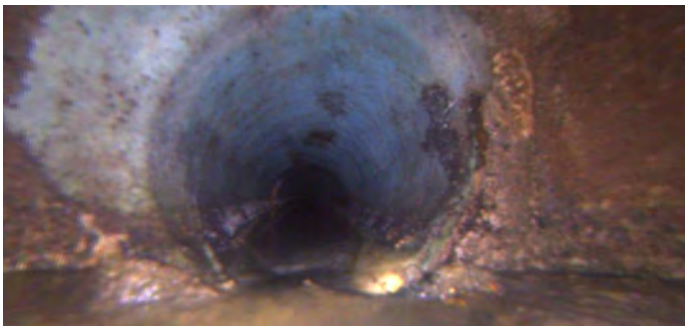
Code: **AMH**  
Description: **Manhole**

Distance (ft): **335.4**  
Structural Grade: **0**  
O&M Grade: **0**  
Clock Start/From:  
Clock To:  
1st Value:  
2nd Value:  
Value Percent:  
Continuous Index:  
Within 8" of Joint: **NO**  
Remarks: **M-708-006**
