Profile/Photo Observation Report

Street:	16th. St.	Flow Control:	Not Controlled
City:	Hobart, IN	Year Renewed:	
Location:	Light Highway	Tape/Media #:	
Purpose:	Routine Assessment	Dia/Height:	12"
Use:	Sanitary	Material:	PVC
Drain Area:	NA	Lining:	
Category:	NA		
Comment:

Location Details:		Direction of Survey:	Upstream
US MH:	M-708-006	DS MH:	M-708-005
		Total Length Surveyed (ft):	335.4

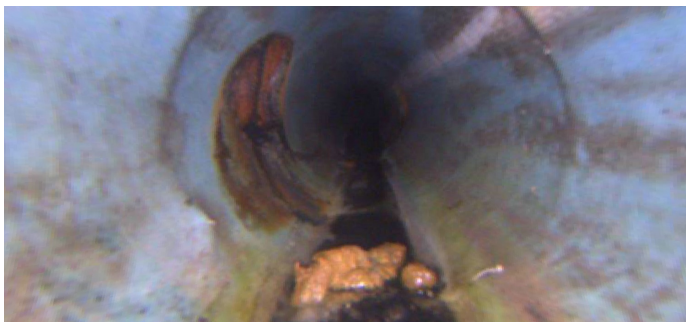
Code: **AMH**
Description: **Manhole**

Distance (ft): **.0**
Structural Grade: **0**
O&M Grade: **0**
Clock Start/From:
Clock To:
1st Value:
2nd Value:
Value Percent:
Continuous Index:
Within 8" of Joint: **NO**
Remarks: **M-708-005**

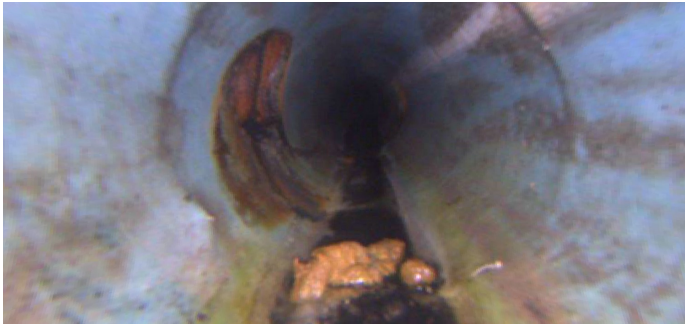
Code:	MWL
Description:	Water Level

Distance (ft):	.0
Structural Grade:	0
O&M Grade:	0
Clock Start/From:	
Clock To:	
1st Value:	
2nd Value:	
Value Percent:	5.000
Continuous Index:	
Within 8" of Joint:	NO
Remarks:

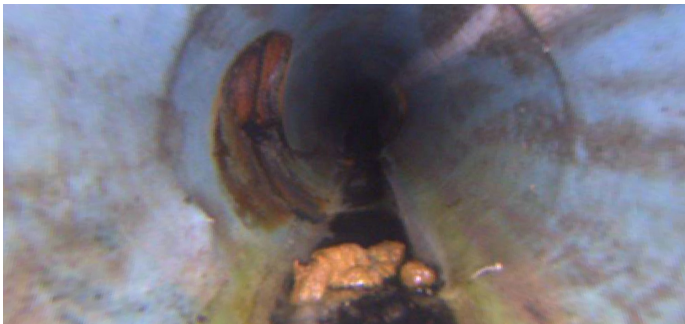
Code:	TF
Description:	Tap Factory

Distance (ft):	.0
Structural Grade:	0
O&M Grade:	0
Clock Start/From:	9
Clock To:	
1st Value:	4.000
2nd Value:	
Value Percent:	
Continuous Index:	
Within 8" of Joint:	
Remarks:

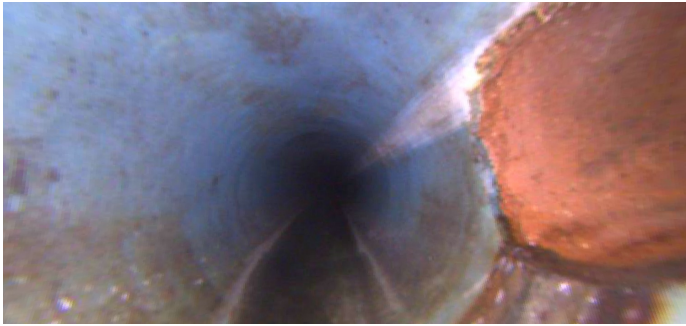
Code: **TF**
Description: **Tap Factory**

Distance (ft): **3.9**
Structural Grade: **0**
O&M Grade: **0**
Clock Start/From: **3**
Clock To:
1st Value: **4.000**
2nd Value:
Value Percent:
Continuous Index:
Within 8" of Joint: **NO**
Remarks:

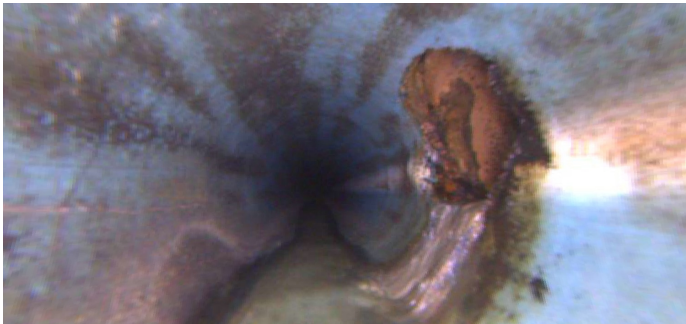
Code: **TF**
Description: **Tap Factory**

Distance (ft): **33.6**
Structural Grade: **0**
O&M Grade: **0**
Clock Start/From: **3**
Clock To:
1st Value: **4.000**
2nd Value:
Value Percent:
Continuous Index:
Within 8" of Joint:
Remarks:

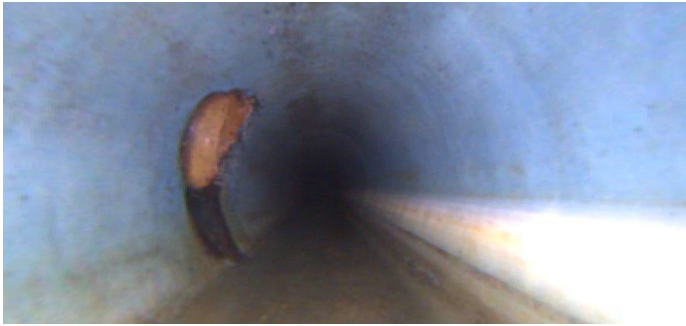
Code: **TF**
Description: **Tap Factory**

Distance (ft): **59.4**
Structural Grade: **0**
O&M Grade: **0**
Clock Start/From: **9**
Clock To:
1st Value: **4.000**
2nd Value:
Value Percent:
Continuous Index:
Within 8" of Joint:
Remarks:

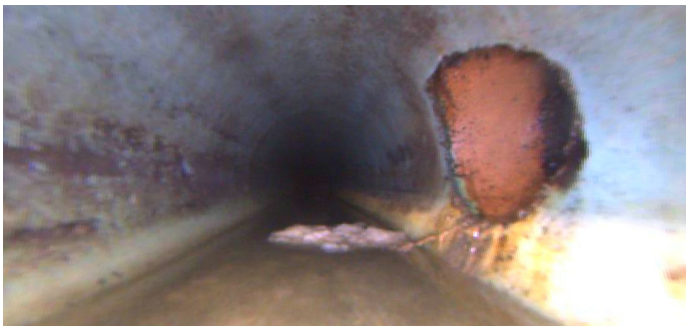
Code: **TF**
Description: **Tap Factory**

Distance (ft): **74.2**
Structural Grade: **0**
O&M Grade: **0**
Clock Start/From: **3**
Clock To:
1st Value: **4.000**
2nd Value:
Value Percent:
Continuous Index:
Within 8" of Joint:
Remarks:

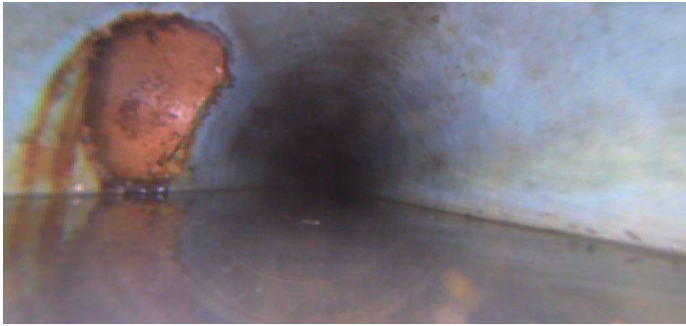
Code: **TF**
Description: **Tap Factory**

Distance (ft): **131.3**
Structural Grade: **0**
O&M Grade: **0**
Clock Start/From: **9**
Clock To:
1st Value: **4.000**
2nd Value:
Value Percent:
Continuous Index:
Within 8" of Joint:
Remarks:

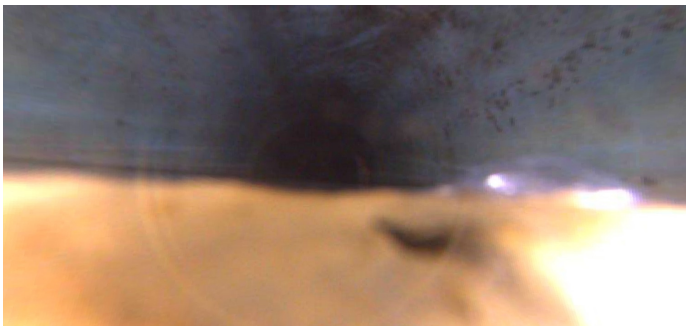
Code: **MWLS**
Description: **Water Level Sag**

Distance (ft): **137.5**
Structural Grade: **2**
O&M Grade: **3**
Clock Start/From:
Clock To:
1st Value:
2nd Value:
Value Percent: **20.000**
Continuous Index:
Within 8" of Joint: **NO**
Remarks:

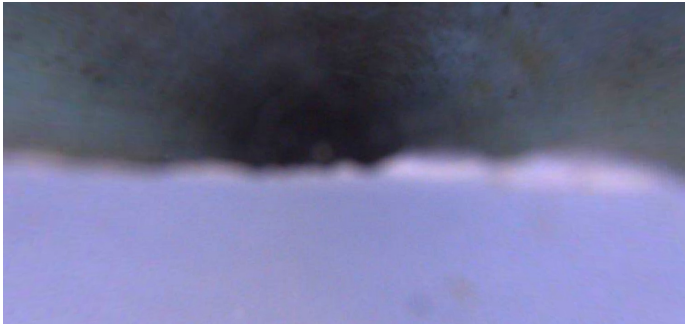
Code: **MWLS**
Description: **Water Level Sag**

Distance (ft): **147.2**
Structural Grade: **2**
O&M Grade: **3**
Clock Start/From:
Clock To:
1st Value:
2nd Value:
Value Percent: **15.000**
Continuous Index:
Within 8" of Joint: **NO**
Remarks:

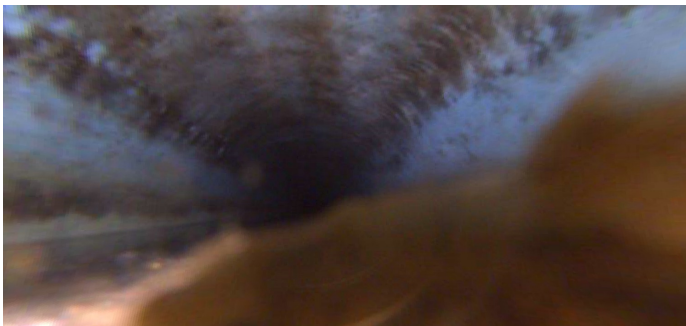
Code: **MWLS**
Description: **Water Level Sag**

Distance (ft): **199.7**
Structural Grade: **2**
O&M Grade: **3**
Clock Start/From:
Clock To:
1st Value:
2nd Value:
Value Percent: **20.000**
Continuous Index: **F01**
Within 8" of Joint: **NO**
Remarks:

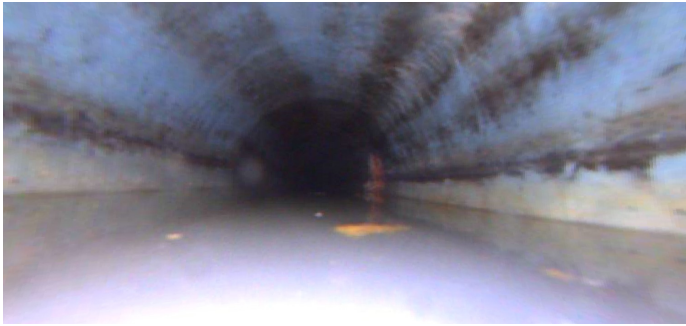
Code: **TF**
Description: **Tap Factory**

Distance (ft): **209.5**
Structural Grade: **0**
O&M Grade: **0**
Clock Start/From: **3**
Clock To:
1st Value: **4.000**
2nd Value:
Value Percent:
Continuous Index:
Within 8" of Joint:
Remarks:

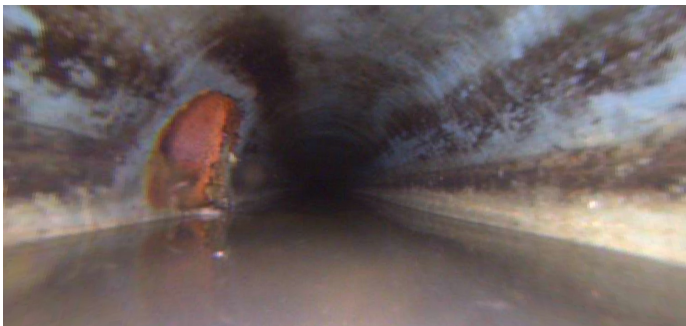
Code: **TF**
Description: **Tap Factory**

Distance (ft): **267.7**
Structural Grade: **0**
O&M Grade: **0**
Clock Start/From: **9**
Clock To:
1st Value: **4.000**
2nd Value:
Value Percent:
Continuous Index:
Within 8" of Joint:
Remarks:

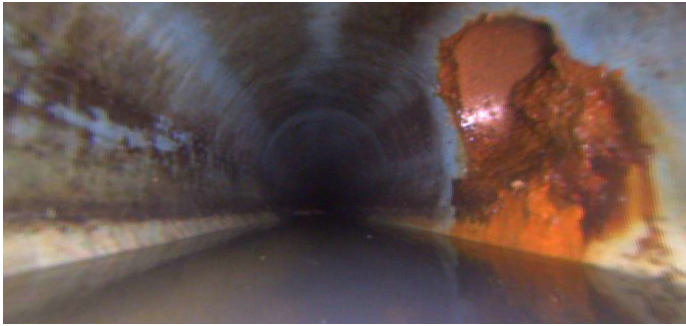
Code: **DAE**
Description: **Deposits Attached Encrustation**

Distance (ft): **282.1**
Structural Grade: **0**
O&M Grade: **3**
Clock Start/From: **1**
Clock To: **4**
1st Value:
2nd Value:
Value Percent: **15.000**
Continuous Index:
Within 8" of Joint: **NO**
Remarks:

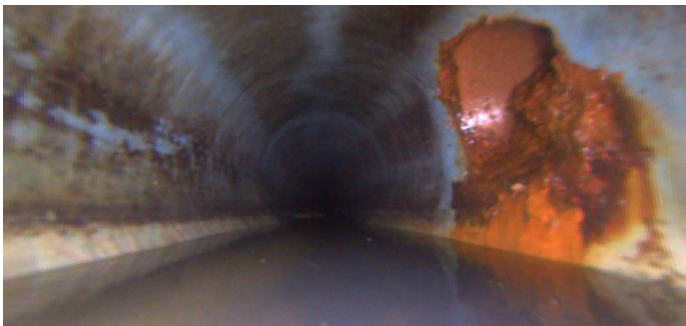
Code: **TF**
Description: **Tap Factory**

Distance (ft): **282.1**
Structural Grade: **0**
O&M Grade: **0**
Clock Start/From: **3**
Clock To:
1st Value: **4.000**
2nd Value:
Value Percent:
Continuous Index:
Within 8" of Joint:
Remarks:

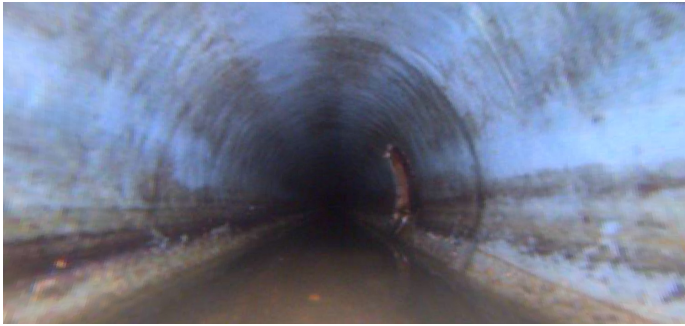
Code: **TF**
Description: **Tap Factory**

Distance (ft): **295.4**
Structural Grade: **0**
O&M Grade: **0**
Clock Start/From: **3**
Clock To:
1st Value: **4.000**
2nd Value:
Value Percent:
Continuous Index:
Within 8" of Joint:
Remarks:

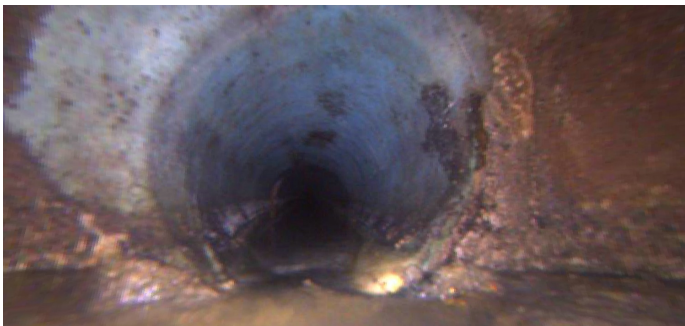
Code: **AMH**
Description: **Manhole**

Distance (ft): **335.4**
Structural Grade: **0**
O&M Grade: **0**
Clock Start/From:
Clock To:
1st Value:
2nd Value:
Value Percent:
Continuous Index:
Within 8" of Joint: **NO**
Remarks: **M-708-006**
