Profile/Photo Observation Report

Street:	HIDDEN OAK TRL	Flow Control:	Not Controlled
City:	Hobart, IN	Year Renewed:	
Location:	Sidewalk	Tape/Media #:	
Purpose:	Maintenance Related	Dia/Height:	8"
Use:	Sanitary	Material:	PVC
Drain Area:	NA	Lining:	
Category:	NA		
Comment:	Flow direction wrong.

Location Details:		Direction of Survey:	Downstream
US MH:	M-708-016	DS MH:	M-708-015
		Total Length Surveyed (ft):	198.8

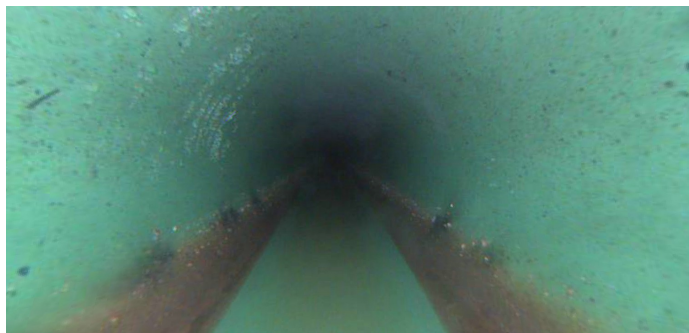
Code: **AMH**
Description: **Manhole**

Distance (ft): **.0**
Structural Grade: **0**
O&M Grade: **0**
Clock Start/From:
Clock To:
1st Value:
2nd Value:
Value Percent:
Continuous Index:
Within 8" of Joint: **NO**
Remarks: **M-708-016**

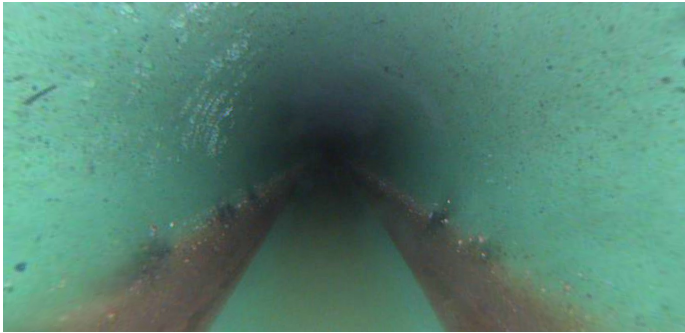
Code:	MWL
Description:	Water Level

Distance (ft):	.0
Structural Grade:	0
O&M Grade:	0
Clock Start/From:	
Clock To:	
1st Value:	
2nd Value:	
Value Percent:	5.000
Continuous Index:	
Within 8" of Joint:	NO
Remarks:

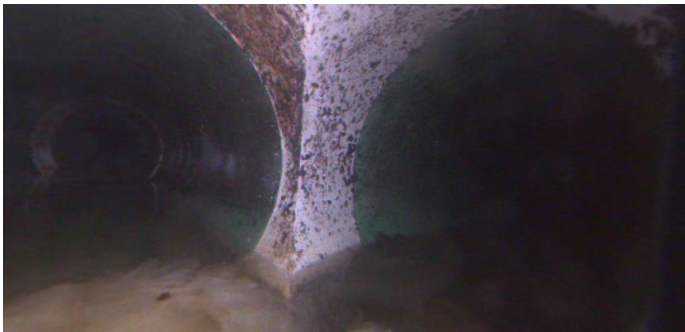
Code:	TFA
Description:	Tap Factory Active

Distance (ft):	184.0
Structural Grade:	0
O&M Grade:	0
Clock Start/From:	3
Clock To:	
1st Value:	4.000
2nd Value:	
Value Percent:	
Continuous Index:	
Within 8" of Joint:	
Remarks:

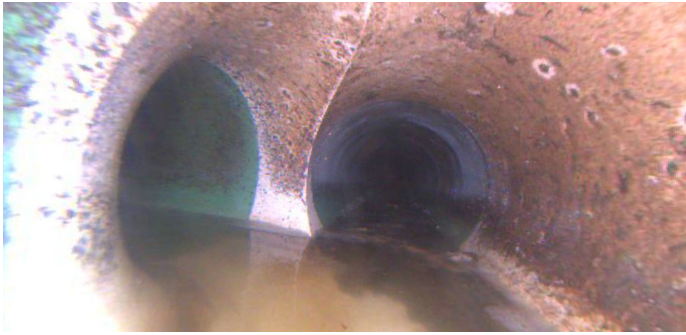
Code: **TFA**
Description: **Tap Factory Active**

Distance (ft): **186.4**
Structural Grade: **0**
O&M Grade: **0**
Clock Start/From: **9**
Clock To:
1st Value: **4.000**
2nd Value:
Value Percent:
Continuous Index:
Within 8" of Joint:
Remarks:

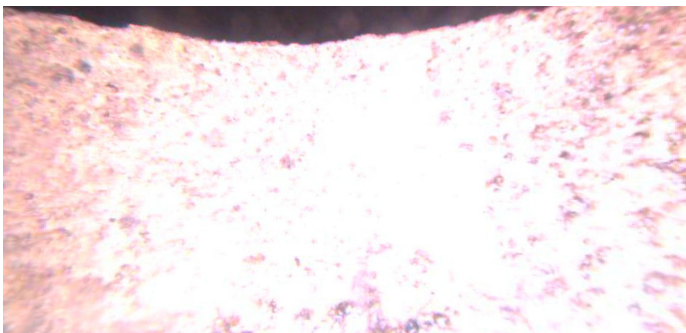
Code: **AMH**
Description: **Manhole**

Distance (ft): **198.8**
Structural Grade: **0**
O&M Grade: **0**
Clock Start/From:
Clock To:
1st Value:
2nd Value:
Value Percent:
Continuous Index:
Within 8" of Joint: **NO**
Remarks: **M-708-015**
