Profile/Photo Observation Report

Street:	HIDDEN OAK TRL	Flow Control:	Not Controlled
City:	Hobart, IN	Year Renewed:	
Location:	Sidewalk	Tape/Media #:	
Purpose:	Maintenance Related	Dia/Height:	8"
Use:	Sanitary	Material:	PVC
Drain Area:	NA	Lining:	
Category:	NA		
Comment:	Flow direction wrong.

Location Details:		Direction of Survey:	Upstream
US MH:	M-708-018	DS MH:	M-708-016
		Total Length Surveyed (ft):	274.5

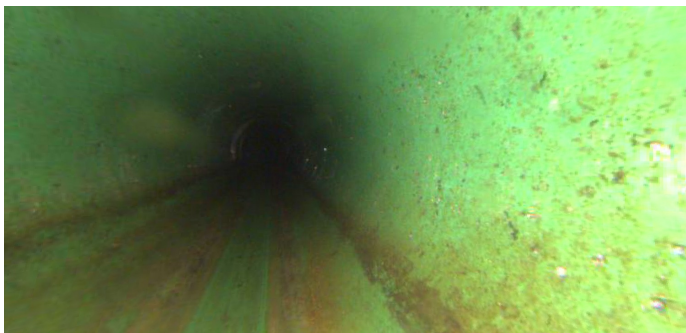
Code: **AMH**
Description: **Manhole**

Distance (ft): **.0**
Structural Grade: **0**
O&M Grade: **0**
Clock Start/From:
Clock To:
1st Value:
2nd Value:
Value Percent:
Continuous Index:
Within 8" of Joint: **NO**
Remarks: **M-708-016**

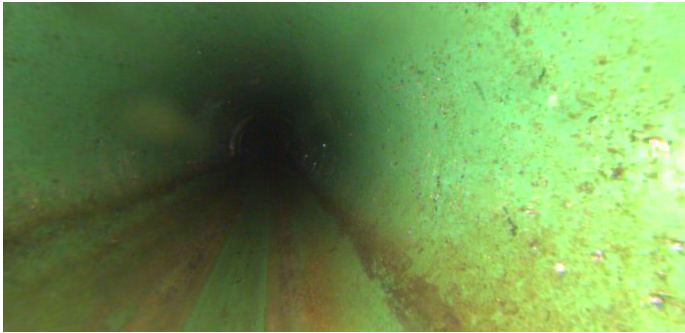
Code:	MWL
Description:	Water Level

Distance (ft):	.0
Structural Grade:	0
O&M Grade:	0
Clock Start/From:	
Clock To:	
1st Value:	
2nd Value:	
Value Percent:	5.000
Continuous Index:	
Within 8" of Joint:	NO
Remarks:

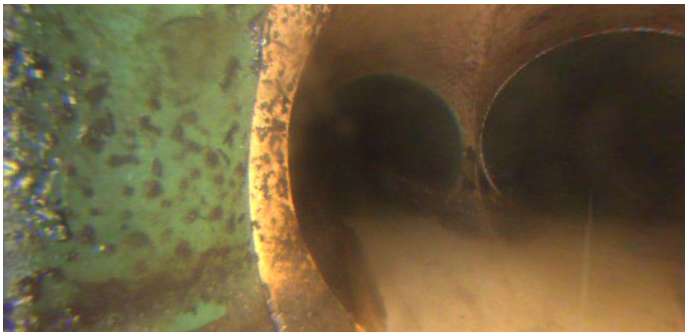
Code:	TFA
Description:	Tap Factory Active

Distance (ft):	22.9
Structural Grade:	0
O&M Grade:	0
Clock Start/From:	3
Clock To:	
1st Value:	4.000
2nd Value:	
Value Percent:	
Continuous Index:	
Within 8" of Joint:	
Remarks:

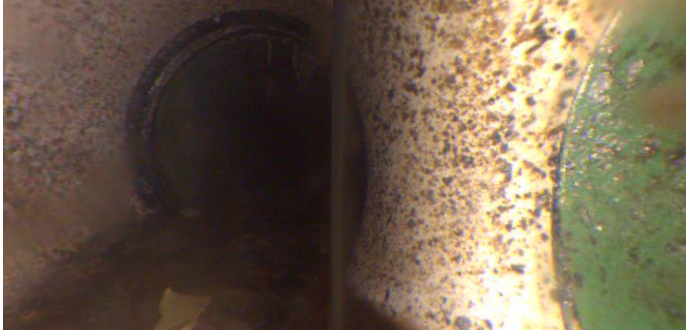
Code: **TFA**
Description: **Tap Factory Active**

Distance (ft): **119.6**
Structural Grade: **0**
O&M Grade: **0**
Clock Start/From: **9**
Clock To:
1st Value: **4.000**
2nd Value:
Value Percent:
Continuous Index:
Within 8" of Joint:
Remarks:

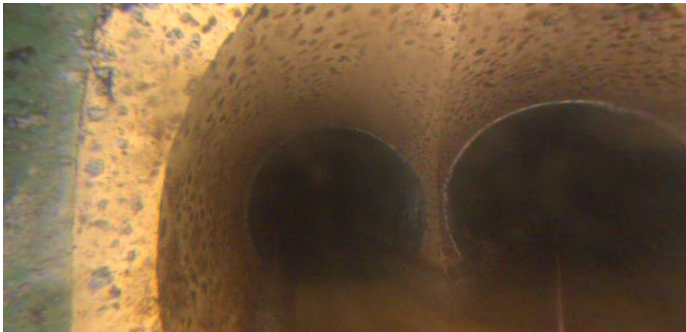
Code: **TFA**
Description: **Tap Factory Active**

Distance (ft): **169.8**
Structural Grade: **0**
O&M Grade: **0**
Clock Start/From: **3**
Clock To:
1st Value: **4.000**
2nd Value:
Value Percent:
Continuous Index:
Within 8" of Joint:
Remarks:

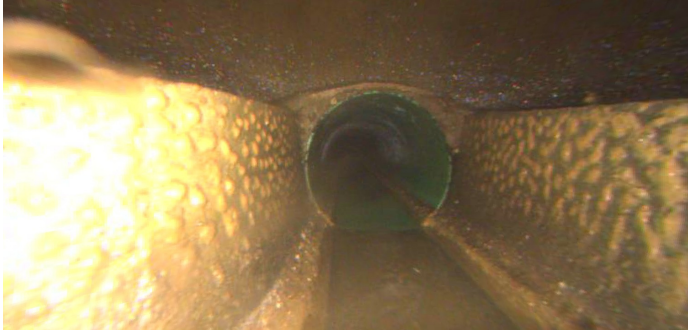
Code:	AMH
Description:	Manhole
Distance (ft):	274.5
Structural Grade:	0
O&M Grade:	0
Clock Start/From:	
Clock To:	
1st Value:	
2nd Value:	
Value Percent:	
Continuous Index:	
Within 8" of Joint:	NO
Remarks:	M-708-018
