Profile/Photo Observation Report

Date:	03/31/2018	Weather:		Coding:	PACP 6.0
Pipe Length (ft):	255.2	Owner:	NA	Pre Clean:	Not Known
P.O.#:		Surveyor:	Jen Costello	PSR:	P-708-016-018
Customer:		Clean Date:	01/01/1900	Shape:	C

Street:	Hidden Oak	Flow Control:	Not Controlled
City:	Hobart, IN	Year Renewed:	
Location:	Sidewalk	Tape/Media #:	
Purpose:	Maintenance Related	Dia/Height:	8"
Use:	Sanitary	Material:	PVC
Drain Area:	NA	Lining:	
Category:	NA		
Comment:	Flow direction wrong.

Location Details:		Direction of Survey:	Upstream
US MH:	M-708-018	DS MH:	M-708-016
		Total Length Surveyed (ft):	274.5

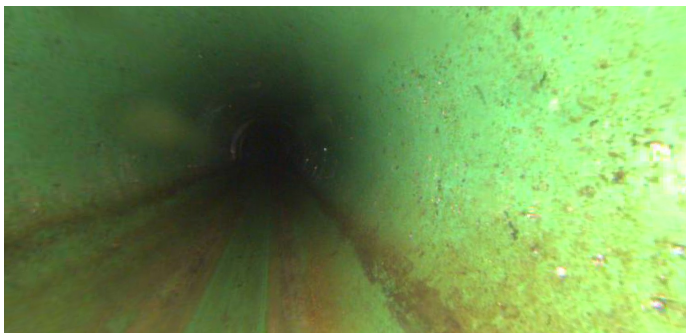
Code: **AMH**
Description: **Manhole**

Distance (ft): **.0**
Structural Grade: **0**
O&M Grade: **0**
Clock Start/From:
Clock To:
1st Value:
2nd Value:
Value Percent:
Continuous Index:
Within 8" of Joint: **NO**
Remarks: **M-708-016**

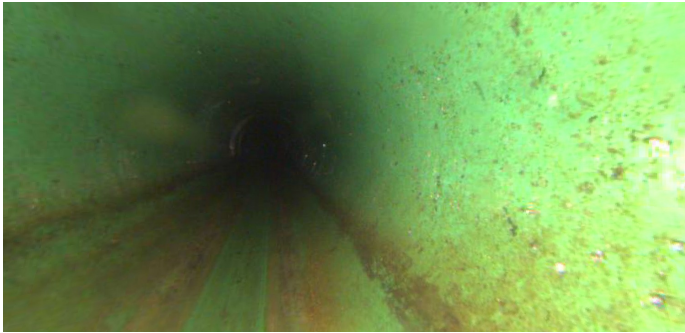
Code:	MWL
Description:	Water Level

Distance (ft):	.0
Structural Grade:	0
O&M Grade:	0
Clock Start/From:	
Clock To:	
1st Value:	
2nd Value:	
Value Percent:	5.000
Continuous Index:	
Within 8" of Joint:	NO
Remarks:

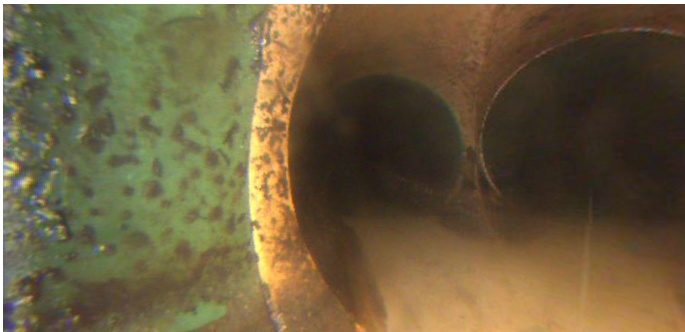
Code:	TFA
Description:	Tap Factory Active

Distance (ft):	22.9
Structural Grade:	0
O&M Grade:	0
Clock Start/From:	3
Clock To:	
1st Value:	4.000
2nd Value:	
Value Percent:	
Continuous Index:	
Within 8" of Joint:	
Remarks:

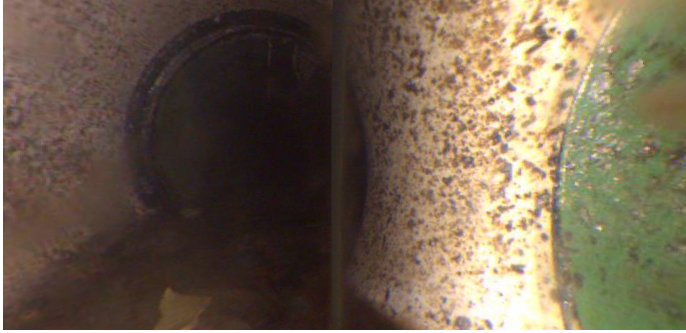
Code: **TFA**
Description: **Tap Factory Active**

Distance (ft): **119.6**
Structural Grade: **0**
O&M Grade: **0**
Clock Start/From: **9**
Clock To:
1st Value: **4.000**
2nd Value:
Value Percent:
Continuous Index:
Within 8" of Joint:
Remarks:

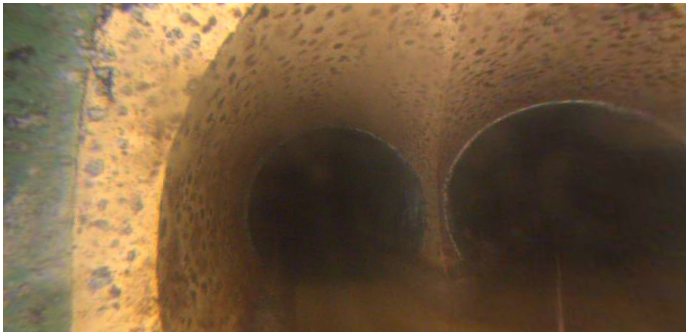
Code: **TFA**
Description: **Tap Factory Active**

Distance (ft): **169.8**
Structural Grade: **0**
O&M Grade: **0**
Clock Start/From: **3**
Clock To:
1st Value: **4.000**
2nd Value:
Value Percent:
Continuous Index:
Within 8" of Joint:
Remarks:

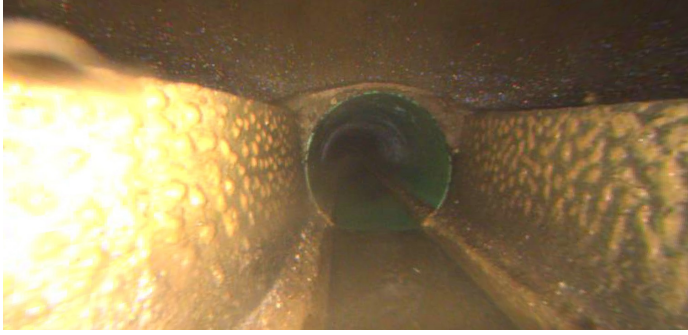
Code:	AMH
Description:	Manhole
Distance (ft):	274.5
Structural Grade:	0
O&M Grade:	0
Clock Start/From:	
Clock To:	
1st Value:	
2nd Value:	
Value Percent:	
Continuous Index:	
Within 8" of Joint:	NO
Remarks:	M-708-018
