Profile/Photo Observation Report

Street:	HIDDEN OAK TRL & WOODWARD TR	Flow Control:	Not Controlled
City:	Hobart, IN	Year Renewed:	
Location:	Sidewalk	Tape/Media #:	
Purpose:	Maintenance Related	Dia/Height:	8"
Use:	Sanitary	Material:	PVC
Drain Area:	NA	Lining:	Cured in Place
Category:	NA		
Comment:

Location Details:		Direction of Survey:	Upstream
US MH:	M-708-018	DS MH:	M-708-113
		Total Length Surveyed (ft):	293.8

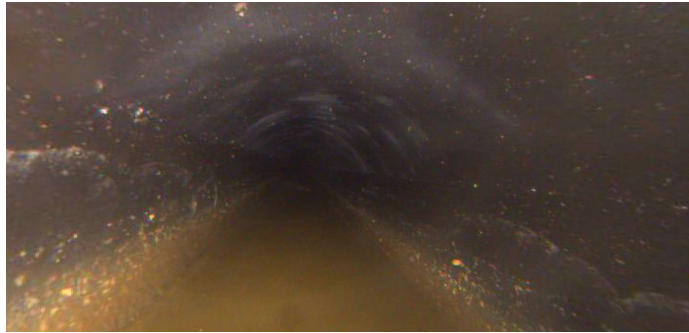
Code: **AMH**
Description: **Manhole**

Distance (ft):	.0
Structural Grade:	0
O&M Grade:	0
Clock Start/From:	
Clock To:	
1st Value:	
2nd Value:	
Value Percent:	
Continuous Index:	
Within 8" of Joint:	NO
Remarks:	M-708-113

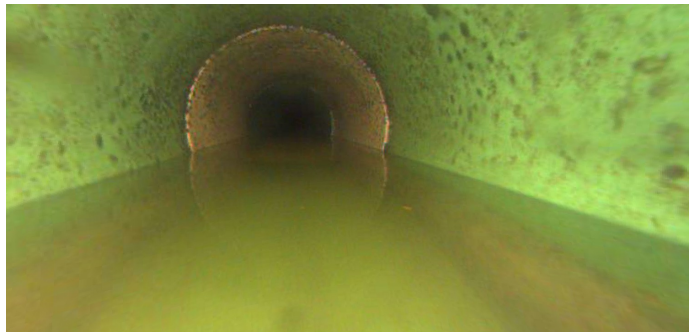
Code:	MWL
Description:	Water Level
Distance (ft):	.0
Structural Grade:	0
O&M Grade:	0
Clock Start/From:	
Clock To:	
1st Value:	
2nd Value:	
Value Percent:	10.000
Continuous Index:	
Within 8" of Joint:	NO
Remarks:

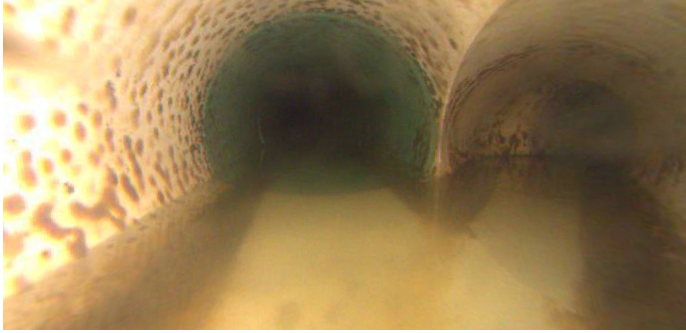
Code: **TFA**
Description: **Tap Factory Active**

Distance (ft): **178.8**
Structural Grade: **0**
O&M Grade: **0**
Clock Start/From: **3**
Clock To:
1st Value: **4.000**
2nd Value:
Value Percent:
Continuous Index:
Within 8" of Joint:
Remarks:

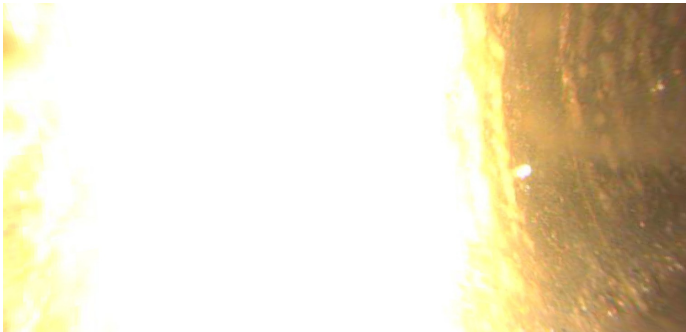
Code: **AMH**
Description: **Manhole**

Distance (ft): **293.8**
Structural Grade: **0**
O&M Grade: **0**
Clock Start/From:
Clock To:
1st Value:
2nd Value:
Value Percent:
Continuous Index:
Within 8" of Joint: **NO**
Remarks: **M-708-018**
