## Profile/Photo Observation Report

Street:	<b>Bracken</b>	Flow Control:	<b>Not Controlled</b>
City:	<b>Hobart, IN</b>	Year Renewed:	
Location:	<b>Sidewalk</b>	Tape/Media #:	
Purpose:	<b>Maintenance Related</b>	Dia/Height:	<b>8"</b>
Use:	<b>Sanitary</b>	Material:	<b>PVC</b>
Drain Area:	<b>NA</b>	Lining:	<b>Cured in Place</b>
Category:	<b>NA</b>		
Comment:

Location Details:		Direction of Survey:	<b>Upstream</b>
US MH:	<b>M-708-018</b>	DS MH:	<b>M-708-113</b>
		Total Length Surveyed (ft):	<b>293.8</b>

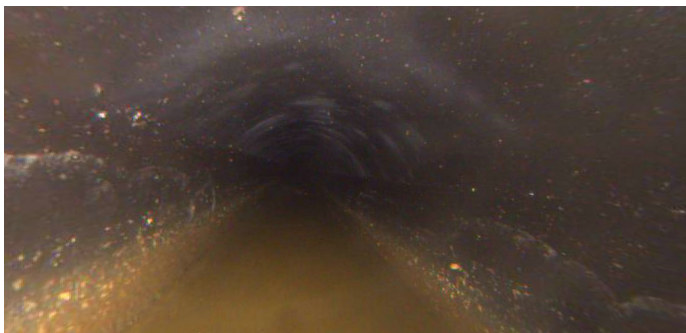
Code: **AMH**  
Description: **Manhole**

Distance (ft): **.0**  
Structural Grade: **0**  
O&M Grade: **0**  
Clock Start/From:  
Clock To:  
1st Value:  
2nd Value:  
Value Percent:  
Continuous Index:  
Within 8" of Joint: **NO**  
Remarks: **M-708-113**

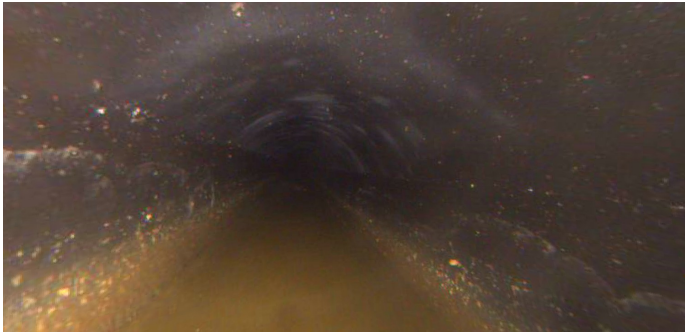
Code:	<b>MWL</b>
Description:	<b>Water Level</b>

Distance (ft):	<b>.0</b>
Structural Grade:	<b>0</b>
O&M Grade:	<b>0</b>
Clock Start/From:	
Clock To:	
1st Value:	
2nd Value:	
Value Percent:	<b>10.000</b>
Continuous Index:	
Within 8" of Joint:	<b>NO</b>
Remarks:

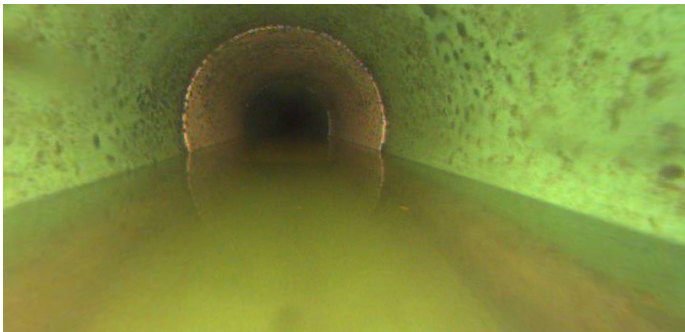
Code:	<b>MWL</b>
Description:	<b>Water Level</b>

Distance (ft):	<b>86.8</b>
Structural Grade:	<b>0</b>
O&M Grade:	<b>0</b>
Clock Start/From:	
Clock To:	
1st Value:	
2nd Value:	
Value Percent:	<b>40.000</b>
Continuous Index:	
Within 8" of Joint:	<b>NO</b>
Remarks:

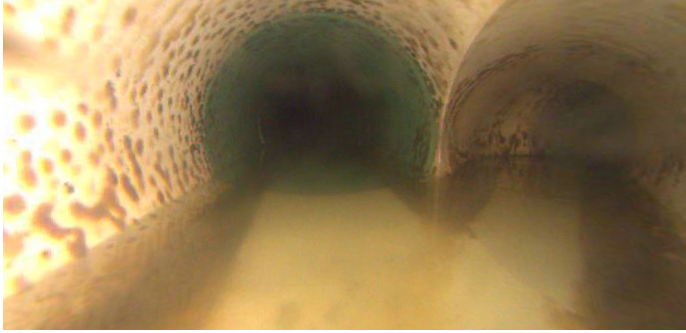
Code: **TFA**  
Description: **Tap Factory Active**

Distance (ft): **178.8**  
Structural Grade: **0**  
O&M Grade: **0**  
Clock Start/From: **3**  
Clock To:  
1st Value: **4.000**  
2nd Value:  
Value Percent:  
Continuous Index:  
Within 8" of Joint:  
Remarks:

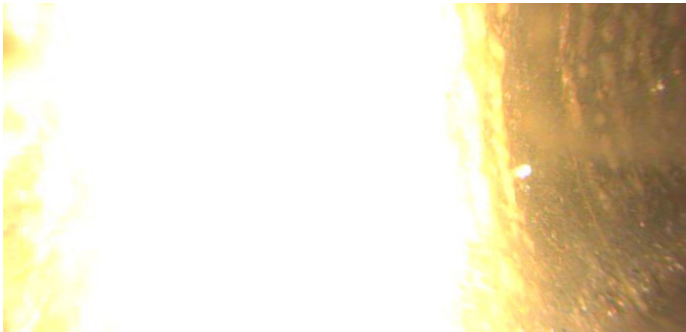
Code: **AMH**  
Description: **Manhole**

Distance (ft): **293.8**  
Structural Grade: **0**  
O&M Grade: **0**  
Clock Start/From:  
Clock To:  
1st Value:  
2nd Value:  
Value Percent:  
Continuous Index:  
Within 8" of Joint: **NO**  
Remarks: **M-708-018**
