Profile/Photo Observation Report

Date:	04/06/2018	Weather:		Coding:	PACP 6.0
Pipe Length (ft):	132.5	Owner:	NA	Pre Clean:	Not Known
P.O.#:		Surveyor:	Jen Costello	PSR:	P-708-022-023
Customer:		Clean Date:	01/01/1900	Shape:	C

Street:	Hobart	Flow Control:	Not Controlled
City:	Hobart, IN	Year Renewed:	
Location:	Parking Lot	Tape/Media #:	
Purpose:	Maintenance Related	Dia/Height:	8"
Use:	Sanitary	Material:	PVC
Drain Area:	NA	Lining:	Cured in Place
Category:	NA		
Comment:	Grease at 11'.

Location Details:		Direction of Survey:	Downstream
US MH:	M-708-022	DS MH:	M-708-023
		Total Length Surveyed (ft):	12.6

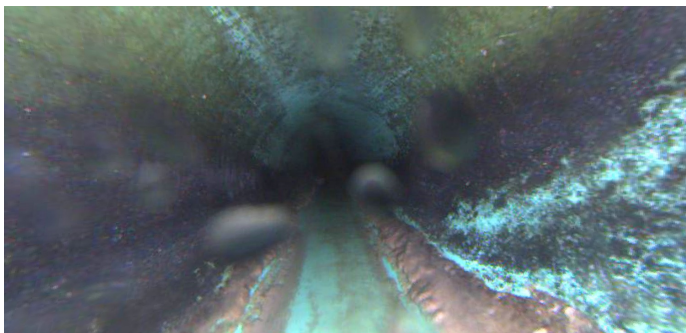
Code: **AMH**
Description: **Manhole**

Distance (ft): **.0**
Structural Grade: **0**
O&M Grade: **0**
Clock Start/From:
Clock To:
1st Value:
2nd Value:
Value Percent:
Continuous Index:
Within 8" of Joint: **NO**
Remarks: **M-708-022**

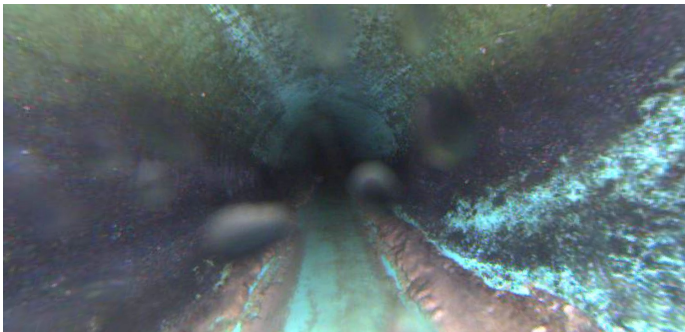
Code:	DAGS
Description:	Deposits Attached Grease

Distance (ft):	.0
Structural Grade:	0
O&M Grade:	2
Clock Start/From:	7
Clock To:	5
1st Value:	
2nd Value:	
Value Percent:	5.000
Continuous Index:	S01
Within 8" of Joint:	NO
Remarks:
