Profile/Photo Observation Report

Date:	10/12/2018	Weather:		Coding:	PACP 6.0
Pipe Length (ft):	132.5	Owner:	NA	Pre Clean:	Not Known
P.O.#:		Surveyor:	Selasie Honu	PSR:	P-708-022-023
Customer:		Clean Date:	01/01/1900	Shape:	C

Street:	Lake Park Ave.	Flow Control:	Not Controlled
City:	Hobart, IN	Year Renewed:	
Location:	Light Highway	Tape/Media #:	
Purpose:	Routine Assessment	Dia/Height:	8"
Use:	Sanitary	Material:	PVC
Drain Area:	NA	Lining:	
Category:	NA		
Comment:

Location Details:		Direction of Survey:	Downstream
US MH:	M-708-022	DS MH:	M-708-023
		Total Length Surveyed (ft):	131.1

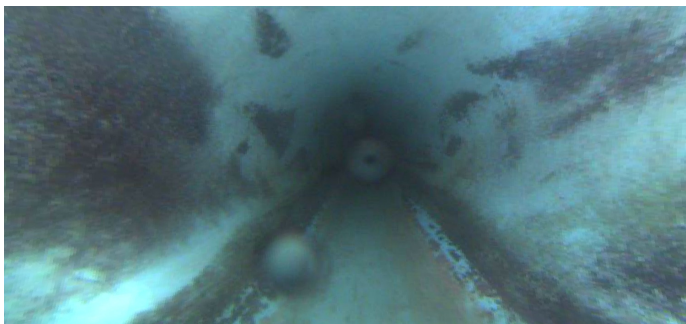
Code: **AMH**
Description: **Manhole**

Distance (ft): **.0**
Structural Grade: **0**
O&M Grade: **0**
Clock Start/From:
Clock To:
1st Value:
2nd Value:
Value Percent:
Continuous Index:
Within 8" of Joint: **NO**
Remarks: **M-708-022**

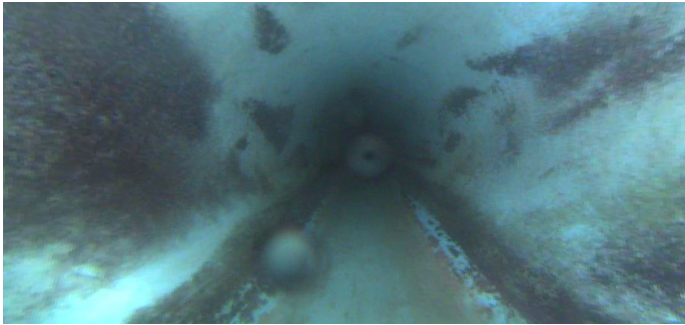
Code:	MWL
Description:	Water Level

Distance (ft):	.0
Structural Grade:	0
O&M Grade:	0
Clock Start/From:	
Clock To:	
1st Value:	
2nd Value:	
Value Percent:	5.000
Continuous Index:	
Within 8" of Joint:	NO
Remarks:

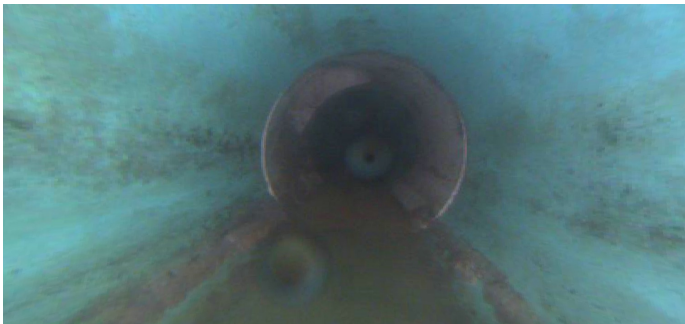
Code:	TF
Description:	Tap Factory

Distance (ft):	24.3
Structural Grade:	0
O&M Grade:	0
Clock Start/From:	10
Clock To:	
1st Value:	4.000
2nd Value:	
Value Percent:	
Continuous Index:	
Within 8" of Joint:	
Remarks:

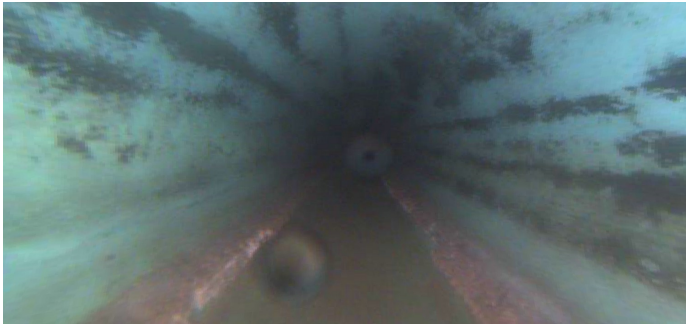
Code: **DAGS**
Description: **Deposits Attached Grease**

Distance (ft): **58.0**
Structural Grade: **0**
O&M Grade: **3**
Clock Start/From: **8**
Clock To: **4**
1st Value:
2nd Value:
Value Percent: **15.000**
Continuous Index: **S01**
Within 8" of Joint: **NO**
Remarks:

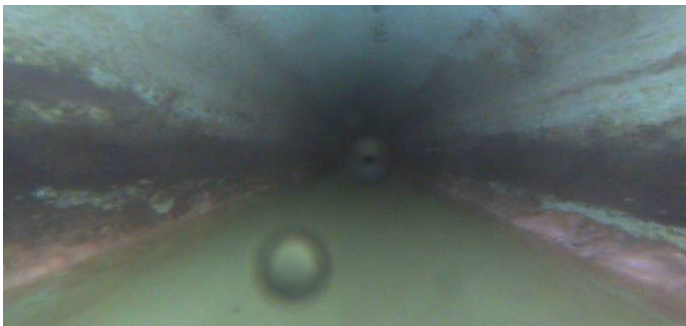
Code: **DAGS**
Description: **Deposits Attached Grease**

Distance (ft): **111.6**
Structural Grade: **0**
O&M Grade: **3**
Clock Start/From: **8**
Clock To: **4**
1st Value:
2nd Value:
Value Percent: **15.000**
Continuous Index: **F01**
Within 8" of Joint: **NO**
Remarks:

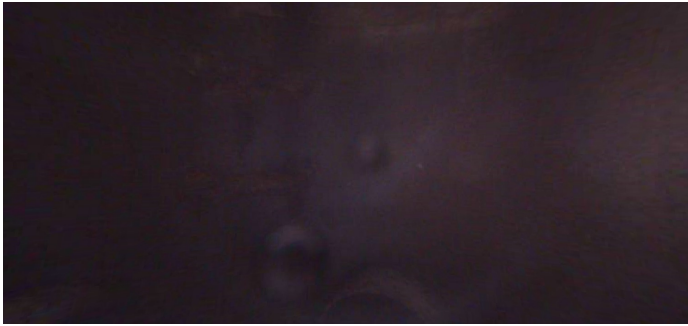
Code:	AMH
Description:	Manhole
Distance (ft):	131.1
Structural Grade:	0
O&M Grade:	0
Clock Start/From:	
Clock To:	
1st Value:	
2nd Value:	
Value Percent:	
Continuous Index:	
Within 8" of Joint:	NO
Remarks:	M-708-023
