## Profile/Photo Observation Report

Date:	<b>04/10/2018</b>	Weather:		Coding:	<b>PACP 6.0</b>
Pipe Length (ft):		Owner:	<b>City of Hobart</b>	Pre Clean:	<b>Not Known</b>
P.O.#:	<b>220</b>	Surveyor:	<b>B. Helbling</b>	PSR:	<b>P-708-012-024</b>
Customer:	<b>City of Hobart</b>	Clean Date:		Shape:	<b>C</b>

Street:	<b>South Lake Park Avenue</b>	Flow Control:	<b>Not Controlled</b>
City:	<b>Hobart, IN</b>	Year Renewed:	
Location:	<b>Parking Lot</b>	Tape/Media #:	<b>DEP220</b>
Purpose:	<b>Routine Assessment</b>	Dia/Height:	<b>12"</b>
Use:	<b>Sanitary</b>	Material:	<b>PVC</b>
Drain Area:		Lining:	
Category:	<b>NA</b>		
Comment:	<b>YES501824 Submittal 2</b>		
Location Details:		Direction of Survey:	<b>Downstream</b>
US MH:	<b>M-708-024</b>	DS MH:	<b>M-708-012</b>
		Total Length Surveyed (ft):	<b>294.6</b>

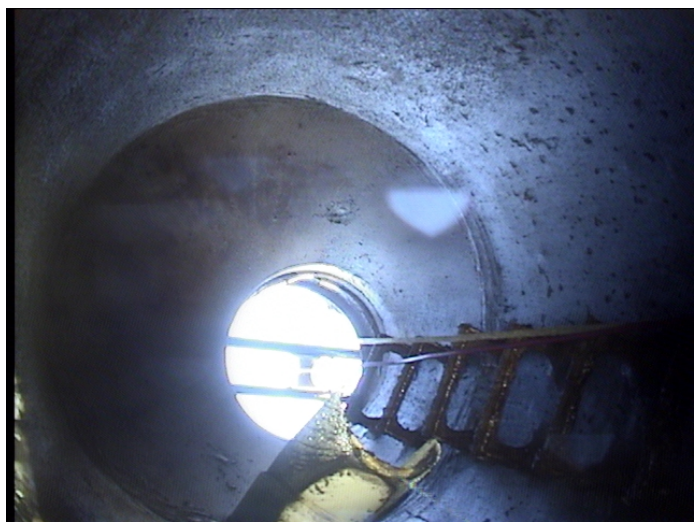
Code: **AMH**  
Description: **Manhole**

Distance (ft): **.0**  
Structural Grade: **0**  
O&M Grade: **0**  
Clock Start/From:  
Clock To:  
1st Value:  
2nd Value:  
Value Percent:  
Continuous Index:  
Within 8" of Joint: **NO**  
Remarks: **M-708-012**

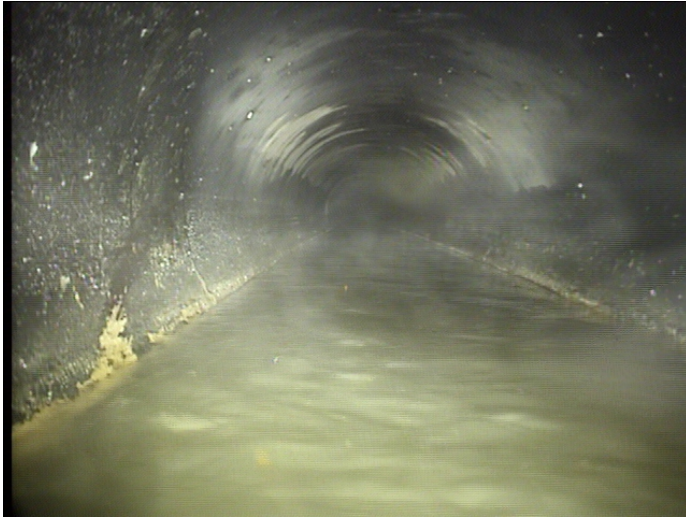
Code: **MWL**  
Description: **Water Level**

Distance (ft): **.0**  
Structural Grade: **0**  
O&M Grade: **0**  
Clock Start/From:  
Clock To:  
1st Value:  
2nd Value:  
Value Percent: **10.000**  
Continuous Index:  
Within 8" of Joint: **NO**  
Remarks:

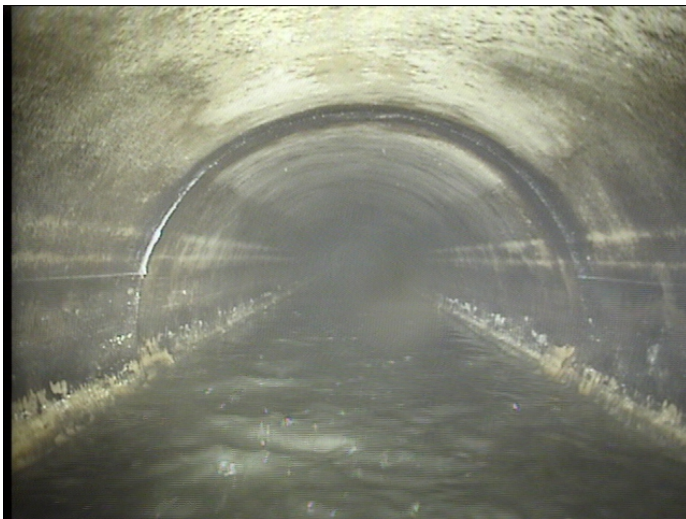
Code: **DSF**  
Description: **Deposits Settled Fine**

Distance (ft): **270.7**  
Structural Grade: **0**  
O&M Grade: **2**  
Clock Start/From: **5**  
Clock To: **7**  
1st Value:  
2nd Value:  
Value Percent: **5.000**  
Continuous Index: **S01**  
Within 8" of Joint: **NO**  
Remarks:

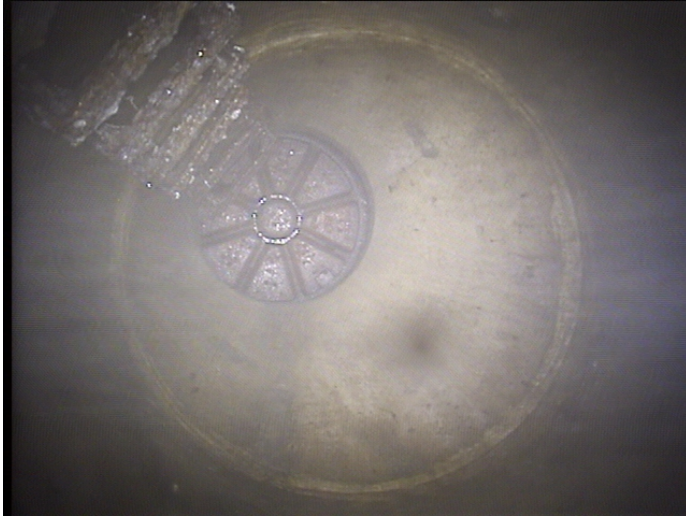
Code: **DSF**  
Description: **Deposits Settled Fine**

Distance (ft): **294.6**  
Structural Grade: **0**  
O&M Grade: **2**  
Clock Start/From: **5**  
Clock To: **7**  
1st Value:  
2nd Value:  
Value Percent: **5.000**  
Continuous Index: **F01**  
Within 8" of Joint: **NO**  
Remarks:

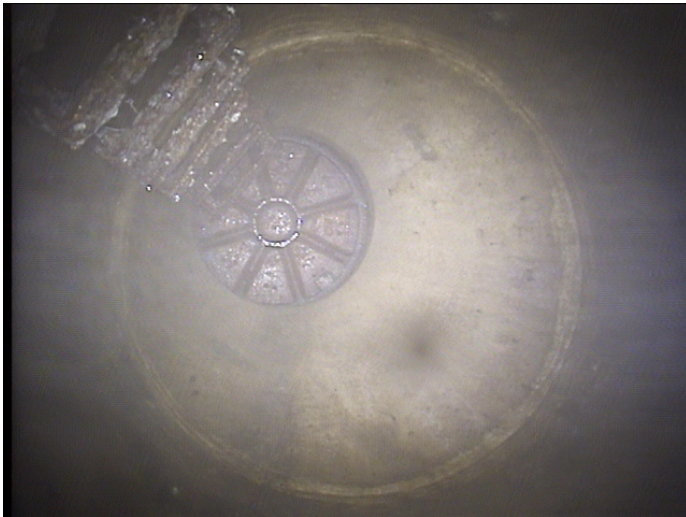
Code: **AMH**  
Description: **Manhole**

Distance (ft): **294.6**  
Structural Grade: **0**  
O&M Grade: **0**  
Clock Start/From:  
Clock To:  
1st Value:  
2nd Value:  
Value Percent:  
Continuous Index:  
Within 8" of Joint: **NO**  
Remarks: **M-708-024**
