Profile/Photo Observation Report

Date:	04/06/2018	Weather:		Coding:	PACP 6.0
Pipe Length (ft):	392.2	Owner:	NA	Pre Clean:	Not Known
P.O.#:		Surveyor:	Jen Costello	PSR:	P-708-025-019
Customer:		Clean Date:	01/01/1900	Shape:	C

Street:	OFF LAKE ST	Flow Control:	Not Controlled
City:	Hobart, IN	Year Renewed:	
Location:	Light Highway	Tape/Media #:	
Purpose:	Maintenance Related	Dia/Height:	8"
Use:	Sanitary	Material:	PVC
Drain Area:	NA	Lining:	Cured in Place
Category:	NA		
Comment:

Location Details:		Direction of Survey:	Upstream
US MH:	M-708-025	DS MH:	M-708-198
		Total Length Surveyed (ft):	172.5

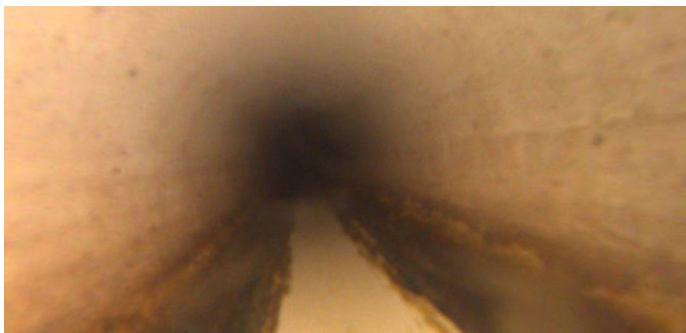
Code: **AMH**
Description: **Manhole**

Distance (ft): **.0**
Structural Grade: **0**
O&M Grade: **0**
Clock Start/From:
Clock To:
1st Value:
2nd Value:
Value Percent:
Continuous Index:
Within 8" of Joint: **NO**
Remarks: **M-708-198**

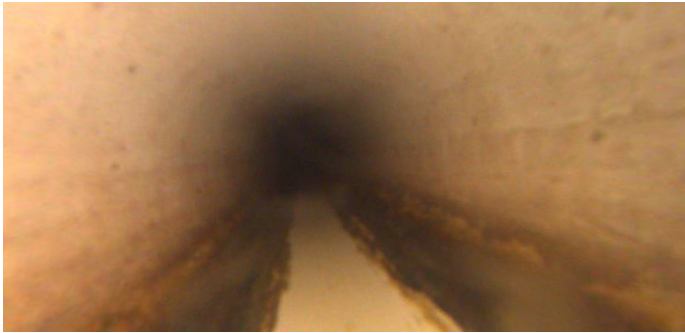
Code:	MWL
Description:	Water Level

Distance (ft):	.0
Structural Grade:	0
O&M Grade:	0
Clock Start/From:	
Clock To:	
1st Value:	
2nd Value:	
Value Percent:	5.000
Continuous Index:	
Within 8" of Joint:	NO
Remarks:

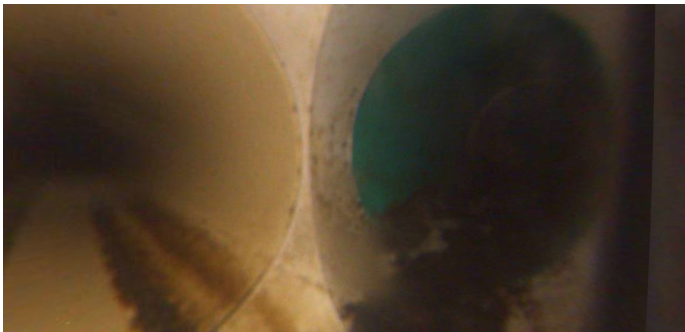
Code:	TF
Description:	Tap Factory

Distance (ft):	55.9
Structural Grade:	0
O&M Grade:	0
Clock Start/From:	3
Clock To:	
1st Value:	4.000
2nd Value:	
Value Percent:	
Continuous Index:	
Within 8" of Joint:	
Remarks:

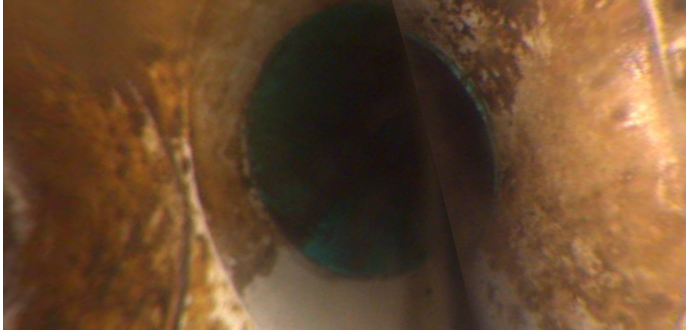
Code: **TF**
Description: **Tap Factory**

Distance (ft): **99.2**
Structural Grade: **0**
O&M Grade: **0**
Clock Start/From: **2**
Clock To:
1st Value: **4.000**
2nd Value:
Value Percent:
Continuous Index:
Within 8" of Joint:
Remarks:

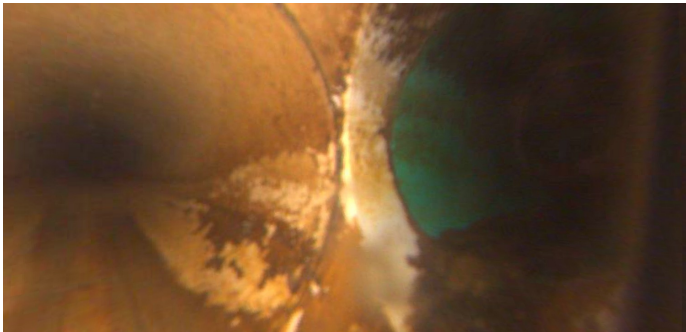
Code: **TFA**
Description: **Tap Factory Active**

Distance (ft): **143.7**
Structural Grade: **0**
O&M Grade: **0**
Clock Start/From: **3**
Clock To:
1st Value: **4.000**
2nd Value:
Value Percent:
Continuous Index:
Within 8" of Joint:
Remarks:

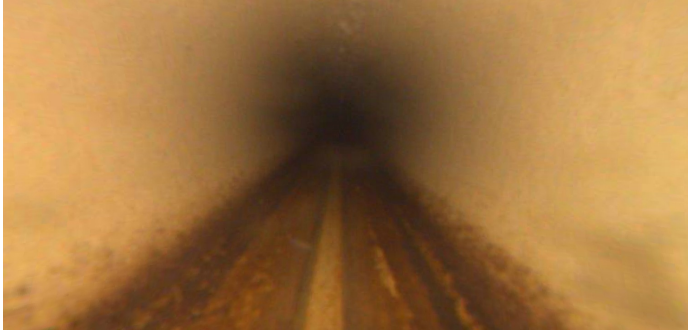
Code:	MSA
Description:	Abandoned Survey
Distance (ft):	172.5
Structural Grade:	0
O&M Grade:	0
Clock Start/From:	
Clock To:	
1st Value:	
2nd Value:	
Value Percent:	
Continuous Index:	
Within 8" of Joint:	NO
Remarks:	unknown
