## Profile/Photo Observation Report

Date:	<b>04/07/2018</b>	Weather:		Coding:	<b>PACP 6.0</b>
Pipe Length (ft):	<b>392.2</b>	Owner:	<b>NA</b>	Pre Clean:	<b>Not Known</b>
P.O.#:		Surveyor:	<b>Jen Costello</b>	PSR:	<b>P-708-025-019</b>
Customer:		Clean Date:	<b>01/01/1900</b>	Shape:	<b>C</b>

Street:	<b>Hobart</b>	Flow Control:	<b>Not Controlled</b>
City:	<b>Hobart, IN</b>	Year Renewed:	
Location:	<b>Parking Lot</b>	Tape/Media #:	
Purpose:	<b>Maintenance Related</b>	Dia/Height:	<b>8"</b>
Use:	<b>Sanitary</b>	Material:	<b>PVC</b>
Drain Area:	<b>NA</b>	Lining:	<b>Cured in Place</b>
Category:	<b>NA</b>		
Comment:	<b>Reverse setup. Vertical crossboar at 317'.</b>		
Location Details:		Direction of Survey:	<b>Upstream</b>
US MH:	<b>M-708-025</b>	DS MH:	<b>M-708-198</b>
		Total Length Surveyed (ft):	<b>317.9</b>

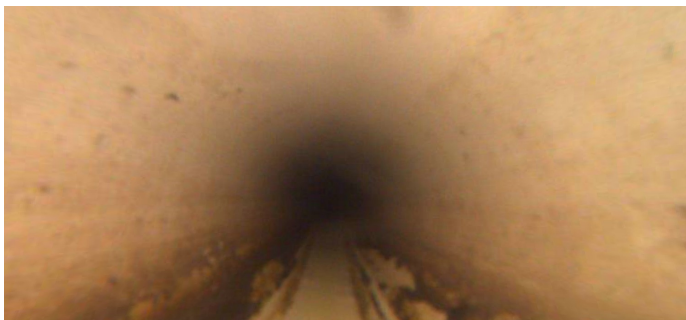
Code: **AMH**  
Description: **Manhole**

Distance (ft): **.0**  
Structural Grade: **0**  
O&M Grade: **0**  
Clock Start/From:  
Clock To:  
1st Value:  
2nd Value:  
Value Percent:  
Continuous Index:  
Within 8" of Joint: **NO**  
Remarks: **M-708-198**

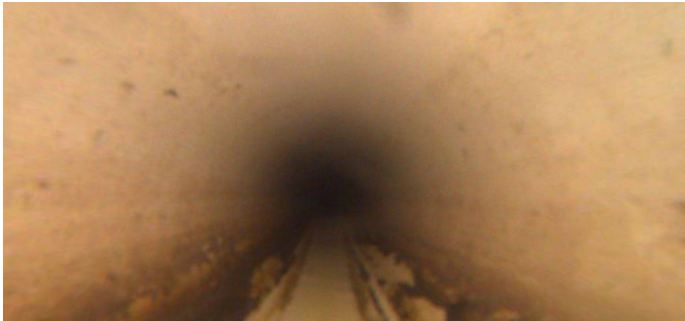
Code:	<b>MWL</b>
Description:	<b>Water Level</b>

Distance (ft):	<b>.0</b>
Structural Grade:	<b>0</b>
O&M Grade:	<b>0</b>
Clock Start/From:	
Clock To:	
1st Value:	
2nd Value:	
Value Percent:	<b>5.000</b>
Continuous Index:	
Within 8" of Joint:	<b>NO</b>
Remarks:

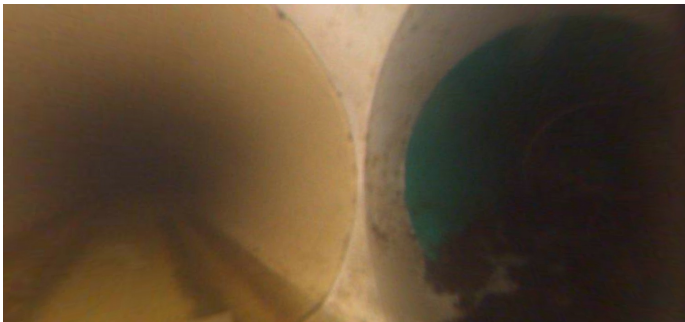
Code:	<b>TF</b>
Description:	<b>Tap Factory</b>

Distance (ft):	<b>56.4</b>
Structural Grade:	<b>0</b>
O&M Grade:	<b>0</b>
Clock Start/From:	<b>3</b>
Clock To:	
1st Value:	<b>4.000</b>
2nd Value:	
Value Percent:	
Continuous Index:	
Within 8" of Joint:	
Remarks:

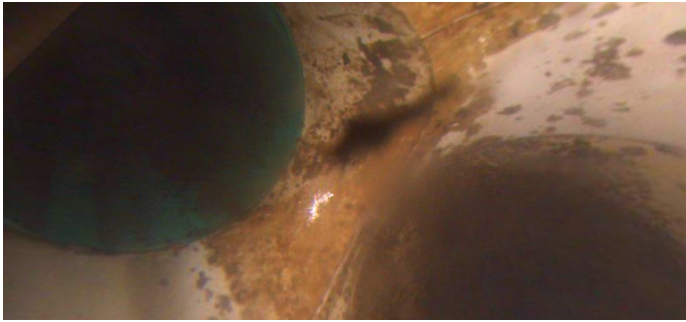
Code: **TF**  
Description: **Tap Factory**

Distance (ft): **100.0**  
Structural Grade: **0**  
O&M Grade: **0**  
Clock Start/From: **2**  
Clock To:  
1st Value: **4.000**  
2nd Value:  
Value Percent:  
Continuous Index:  
Within 8" of Joint:  
Remarks:

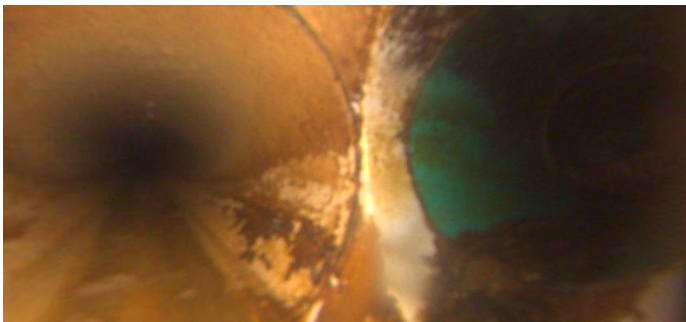
Code: **TF**  
Description: **Tap Factory**

Distance (ft): **144.1**  
Structural Grade: **0**  
O&M Grade: **0**  
Clock Start/From: **3**  
Clock To:  
1st Value: **4.000**  
2nd Value:  
Value Percent:  
Continuous Index:  
Within 8" of Joint:  
Remarks:

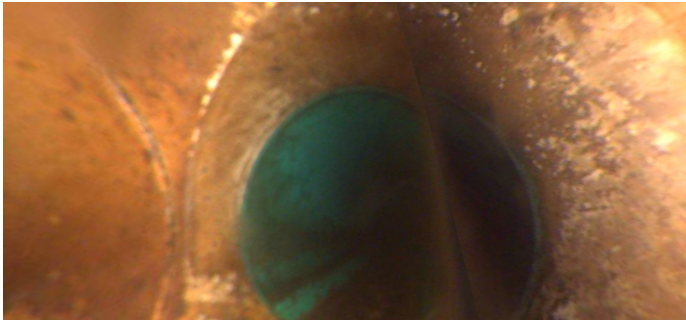
Code: **TF**  
Description: **Tap Factory**

Distance (ft): **190.1**  
Structural Grade: **0**  
O&M Grade: **0**  
Clock Start/From: **3**  
Clock To:  
1st Value: **4.000**  
2nd Value:  
Value Percent:  
Continuous Index:  
Within 8" of Joint:  
Remarks:

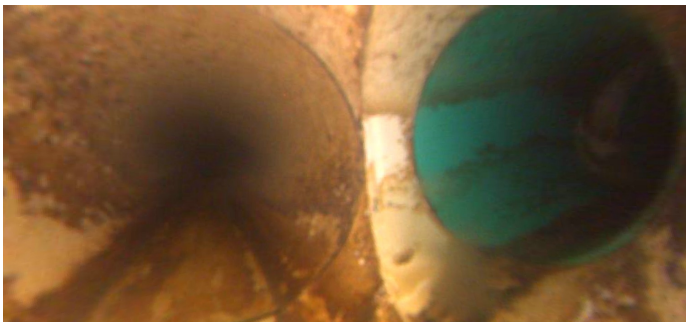
Code: **TF**  
Description: **Tap Factory**

Distance (ft): **254.0**  
Structural Grade: **0**  
O&M Grade: **0**  
Clock Start/From: **3**  
Clock To:  
1st Value: **4.000**  
2nd Value:  
Value Percent:  
Continuous Index:  
Within 8" of Joint:  
Remarks:

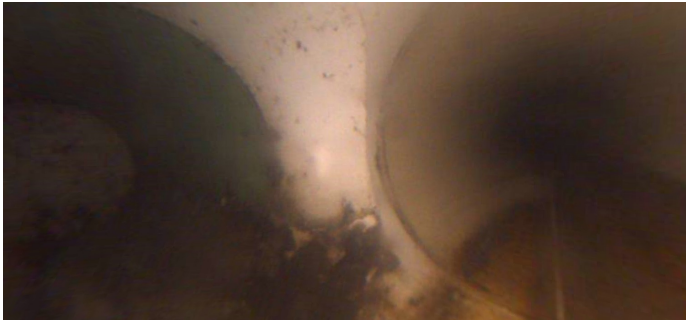
Code: **TFC**  
Description: **Tap Factory Capped**

Distance (ft): **286.8**  
Structural Grade: **0**  
O&M Grade: **0**  
Clock Start/From: **3**  
Clock To:  
1st Value: **4.000**  
2nd Value:  
Value Percent:  
Continuous Index:  
Within 8" of Joint:  
Remarks:

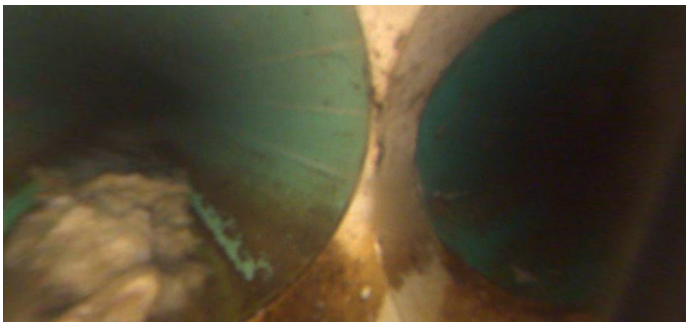
Code: **TF**  
Description: **Tap Factory**

Distance (ft): **307.0**  
Structural Grade: **0**  
O&M Grade: **0**  
Clock Start/From: **3**  
Clock To:  
1st Value: **4.000**  
2nd Value:  
Value Percent:  
Continuous Index:  
Within 8" of Joint:  
Remarks:

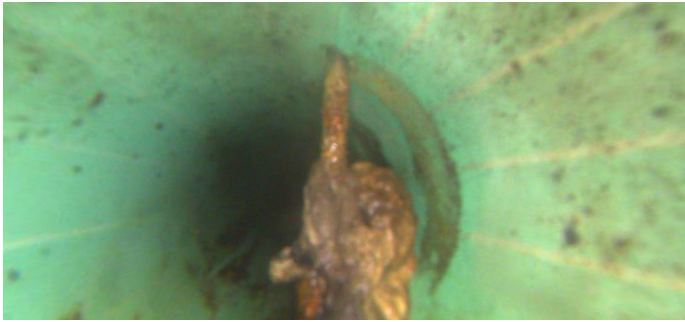
Code: **OBP**  
Description: **Obstacle External Pipe or Cable**

Distance (ft): **316.5**  
Structural Grade: **0**  
O&M Grade: **2**  
Clock Start/From: **12**  
Clock To: **6**  
1st Value:  
2nd Value:  
Value Percent: **10.000**  
Continuous Index:  
Within 8" of Joint: **NO**  
Remarks:

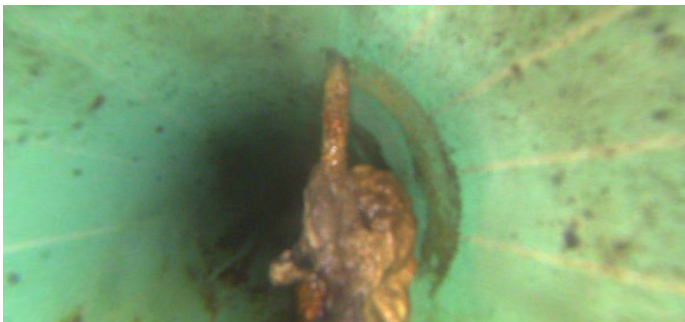
Code: **DAGS**  
Description: **Deposits Attached Grease**

Distance (ft): **316.5**  
Structural Grade: **0**  
O&M Grade: **3**  
Clock Start/From: **3**  
Clock To: **6**  
1st Value:  
2nd Value:  
Value Percent: **20.000**  
Continuous Index:  
Within 8" of Joint: **NO**  
Remarks:

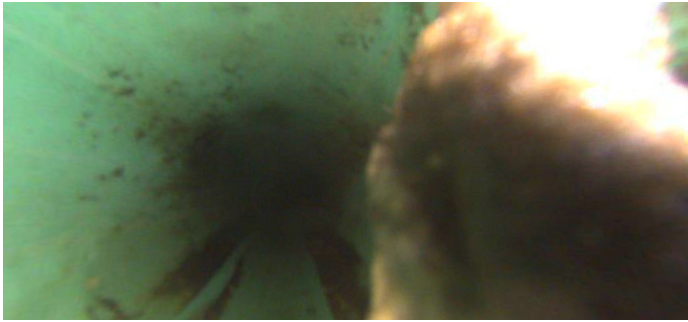
Code:	<b>MSA</b>
Description:	<b>Abandoned Survey</b>
Distance (ft):	<b>317.5</b>
Structural Grade:	<b>0</b>
O&M Grade:	<b>0</b>
Clock Start/From:	
Clock To:	
1st Value:	
2nd Value:	
Value Percent:	
Continuous Index:	
Within 8" of Joint:	<b>NO</b>
Remarks:	<b>obp</b>
