## Profile/Photo Observation Report

Date:	<b>04/10/2018</b>	Weather:		Coding:	<b>PACP 6.0</b>
Pipe Length (ft):		Owner:	<b>City of Hobart</b>	Pre Clean:	<b>Not Known</b>
P.O.#:	<b>224</b>	Surveyor:	<b>B. Helbling</b>	PSR:	<b>P-708-010-101</b>
Customer:	<b>City of Hobart</b>	Clean Date:		Shape:	<b>C</b>

Street:	<b>South Lake Park Avenue</b>	Flow Control:	<b>Not Controlled</b>
City:	<b>Hobart, IN</b>	Year Renewed:	
Location:	<b>Yard</b>	Tape/Media #:	<b>DEP224</b>
Purpose:	<b>Routine Assessment</b>	Dia/Height:	<b>15"</b>
Use:	<b>Sanitary</b>	Material:	<b>PVC</b>
Drain Area:		Lining:	
Category:	<b>NA</b>		
Comment:	<b>YES501824 Submittal 2</b>		
Location Details:		Direction of Survey:	<b>Upstream</b>
US MH:	<b>M-708-101</b>	DS MH:	<b>M-708-010</b>
		Total Length Surveyed (ft):	<b>161.4</b>

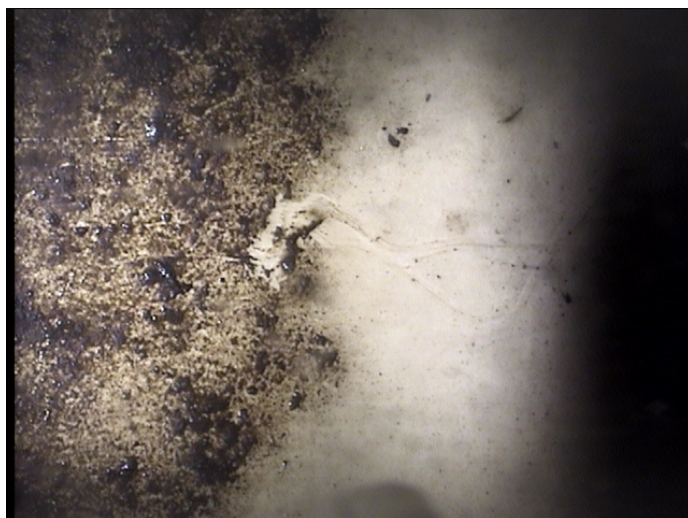
Code: **AMH**  
Description: **Manhole**

Distance (ft): **.0**  
Structural Grade: **0**  
O&M Grade: **0**  
Clock Start/From:  
Clock To:  
1st Value:  
2nd Value:  
Value Percent:  
Continuous Index:  
Within 8" of Joint: **NO**  
Remarks: **M-708-101**

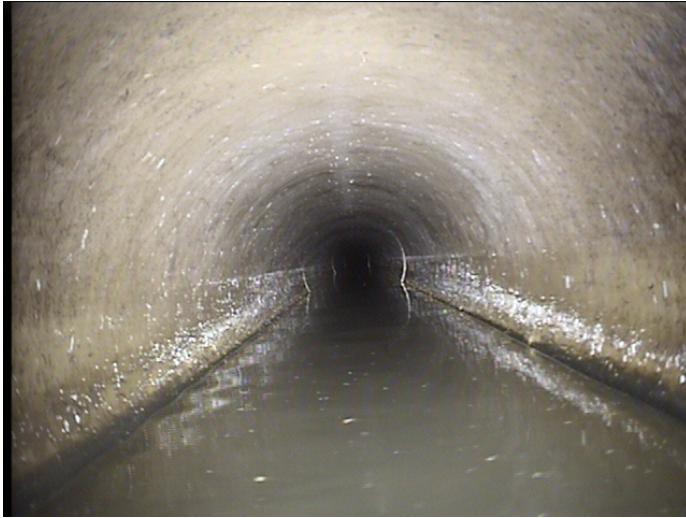
Code: **MWL**  
Description: **Water Level**

Distance (ft): **.0**  
Structural Grade: **0**  
O&M Grade: **0**  
Clock Start/From:  
Clock To:  
1st Value:  
2nd Value:  
Value Percent: **15.000**  
Continuous Index:  
Within 8" of Joint: **NO**  
Remarks:

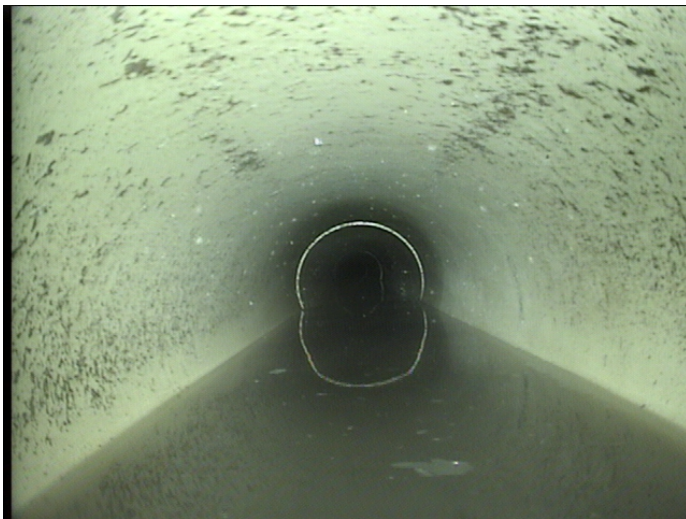
Code: **DSF**  
Description: **Deposits Settled Fine**

Distance (ft): **79.9**  
Structural Grade: **0**  
O&M Grade: **2**  
Clock Start/From: **4**  
Clock To: **8**  
1st Value:  
2nd Value:  
Value Percent: **10.000**  
Continuous Index: **S01**  
Within 8" of Joint: **NO**  
Remarks:

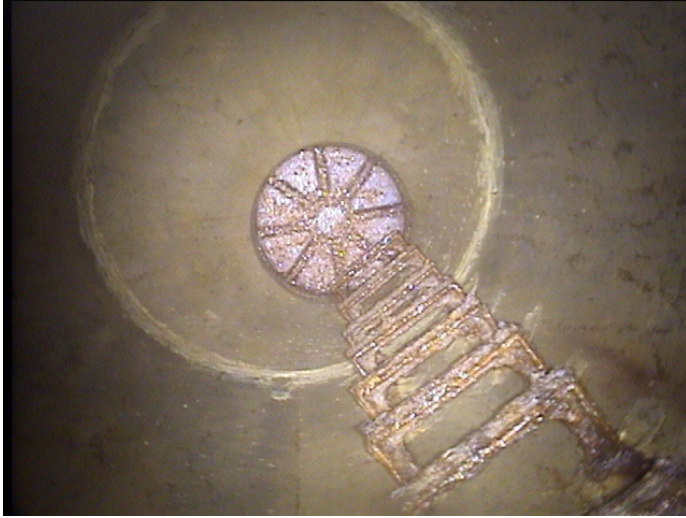
Code: **AMH**  
Description: **Manhole**

Distance (ft): **161.4**  
Structural Grade: **0**  
O&M Grade: **0**  
Clock Start/From:  
Clock To:  
1st Value:  
2nd Value:  
Value Percent:  
Continuous Index:  
Within 8" of Joint: **NO**  
Remarks: **M-708-010**

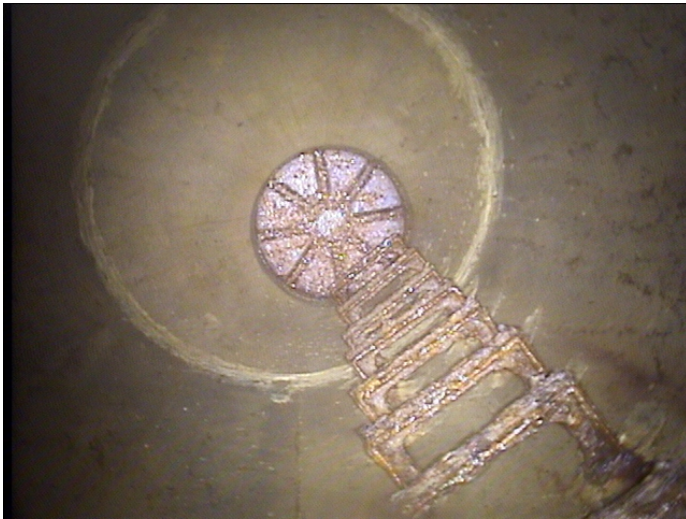
Code: **DSF**  
Description: **Deposits Settled Fine**

Distance (ft): **161.4**  
Structural Grade: **0**  
O&M Grade: **2**  
Clock Start/From: **4**  
Clock To: **8**  
1st Value:  
2nd Value:  
Value Percent: **10.000**  
Continuous Index: **F01**  
Within 8" of Joint: **NO**  
Remarks:
