## Profile/Photo Observation Report

Street:	<b>Bracken</b>	Flow Control:	<b>Not Controlled</b>
City:	<b>Hobart, IN</b>	Year Renewed:	
Location:	<b>Sidewalk</b>	Tape/Media #:	
Purpose:	<b>Maintenance Related</b>	Dia/Height:	<b>12"</b>
Use:	<b>Sanitary</b>	Material:	<b>PVC</b>
Drain Area:	<b>NA</b>	Lining:	<b>Cured in Place</b>
Category:	<b>NA</b>		
Comment:

Location Details:		Direction of Survey:	<b>Downstream</b>
US MH:	<b>M-708-102</b>	DS MH:	<b>M-708-101</b>
		Total Length Surveyed (ft):	<b>261.0</b>

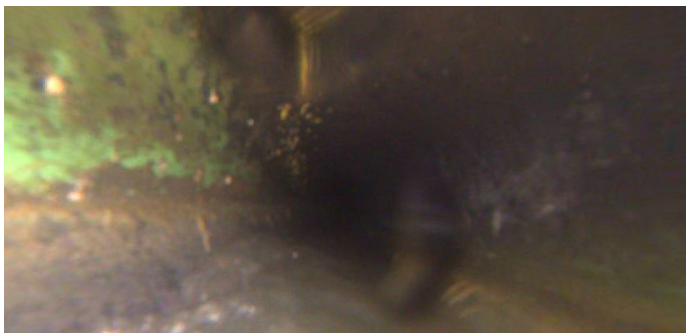
Code: **AMH**  
Description: **Manhole**

Distance (ft): **.0**  
Structural Grade: **0**  
O&M Grade: **0**  
Clock Start/From:  
Clock To:  
1st Value:  
2nd Value:  
Value Percent:  
Continuous Index:  
Within 8" of Joint: **NO**  
Remarks: **M-708-102**

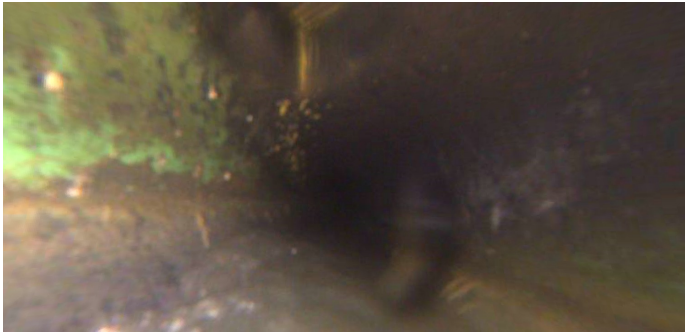
Code:	<b>MWL</b>
Description:	<b>Water Level</b>

Distance (ft):	<b>.0</b>
Structural Grade:	<b>0</b>
O&M Grade:	<b>0</b>
Clock Start/From:	
Clock To:	
1st Value:	
2nd Value:	
Value Percent:	<b>10.000</b>
Continuous Index:	
Within 8" of Joint:	<b>NO</b>
Remarks:

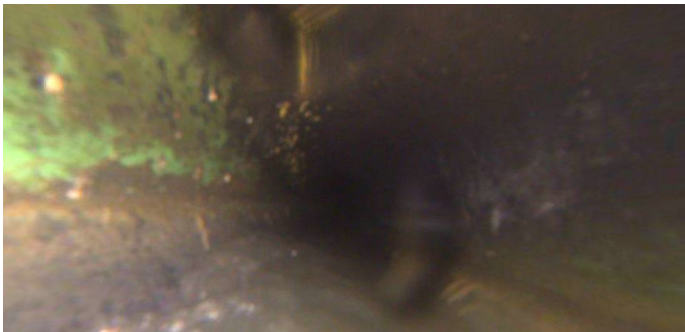
Code:	<b>DAGS</b>
Description:	<b>Deposits Attached Grease</b>

Distance (ft):	<b>.0</b>
Structural Grade:	<b>0</b>
O&M Grade:	<b>2</b>
Clock Start/From:	<b>8</b>
Clock To:	<b>4</b>
1st Value:	
2nd Value:	
Value Percent:	<b>5.000</b>
Continuous Index:	<b>S01</b>
Within 8" of Joint:	<b>NO</b>
Remarks:

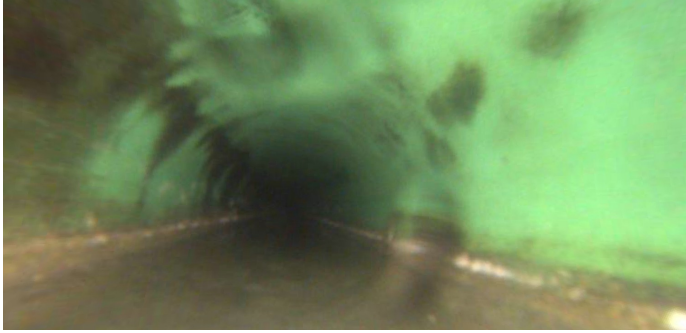
Code: **MWL**  
Description: **Water Level**

Distance (ft): **204.4**  
Structural Grade: **0**  
O&M Grade: **0**  
Clock Start/From:  
Clock To:  
1st Value:  
2nd Value:  
Value Percent: **30.000**  
Continuous Index:  
Within 8" of Joint: **NO**  
Remarks:

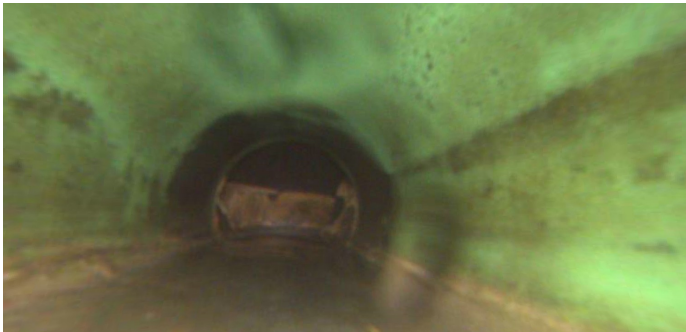
Code: **DAGS**  
Description: **Deposits Attached Grease**

Distance (ft): **257.2**  
Structural Grade: **0**  
O&M Grade: **2**  
Clock Start/From: **8**  
Clock To: **4**  
1st Value:  
2nd Value:  
Value Percent: **5.000**  
Continuous Index: **F01**  
Within 8" of Joint: **NO**  
Remarks:

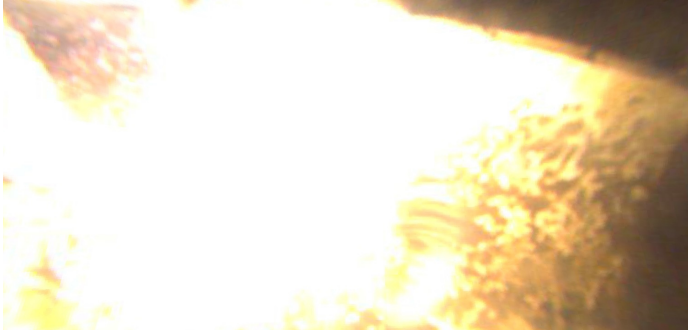
Code:	AMH
Description:	Manhole
Distance (ft):	261.0
Structural Grade:	0
O&M Grade:	0
Clock Start/From:	
Clock To:	
1st Value:	
2nd Value:	
Value Percent:	
Continuous Index:	
Within 8" of Joint:	NO
Remarks:	M-708-101
