Profile/Photo Observation Report

Street:	BRACKEN PKWY	Flow Control:	Not Controlled
City:	Hobart, IN	Year Renewed:	
Location:	Light Highway	Tape/Media #:	
Purpose:	Routine Assessment	Dia/Height:	12"
Use:	Sanitary	Material:	VCP
Drain Area:	NA	Lining:	
Category:	NA		
Comment:

Location Details:		Direction of Survey:	Upstream
US MH:	M-708-103	DS MH:	M-708-102
		Total Length Surveyed (ft):	48.4

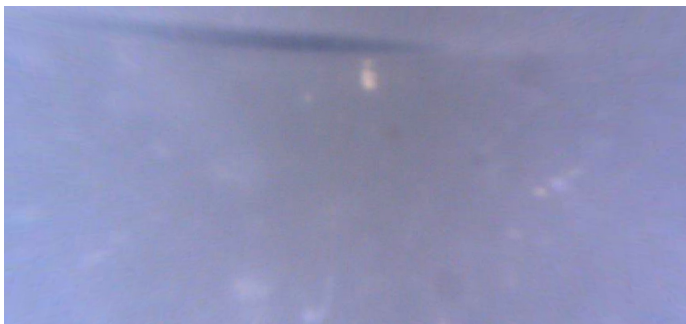
Code: **AMH**
Description: **Manhole**

Distance (ft): **.0**
Structural Grade: **0**
O&M Grade: **0**
Clock Start/From:
Clock To:
1st Value:
2nd Value:
Value Percent:
Continuous Index:
Within 8" of Joint: **NO**
Remarks: **M-708-102**

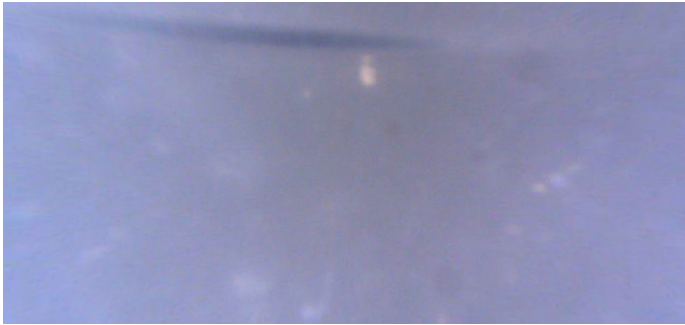
Code:	MWL
Description:	Water Level

Distance (ft):	.0
Structural Grade:	0
O&M Grade:	0
Clock Start/From:	
Clock To:	
1st Value:	
2nd Value:	
Value Percent:	5.000
Continuous Index:	
Within 8" of Joint:	NO
Remarks:

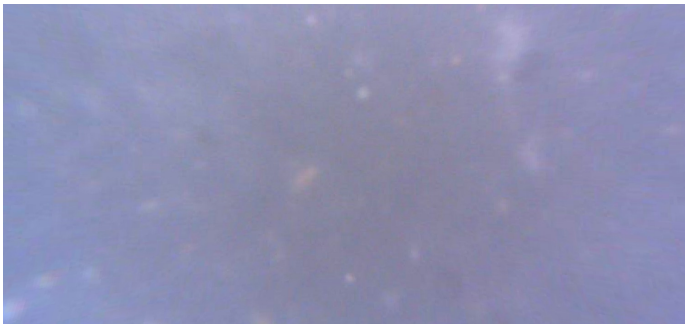
Code:	MWLS
Description:	Water Level Sag

Distance (ft):	.0
Structural Grade:	2
O&M Grade:	3
Clock Start/From:	
Clock To:	
1st Value:	
2nd Value:	
Value Percent:	10.000
Continuous Index:	S01
Within 8" of Joint:	NO
Remarks:

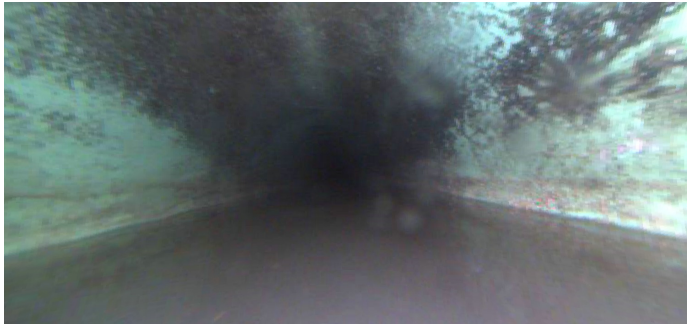
Code: **MWLS**
Description: **Water Level Sag**

Distance (ft): **3.6**
Structural Grade: **2**
O&M Grade: **3**
Clock Start/From:
Clock To:
1st Value:
2nd Value:
Value Percent: **10.000**
Continuous Index: **F01**
Within 8" of Joint: **NO**
Remarks:

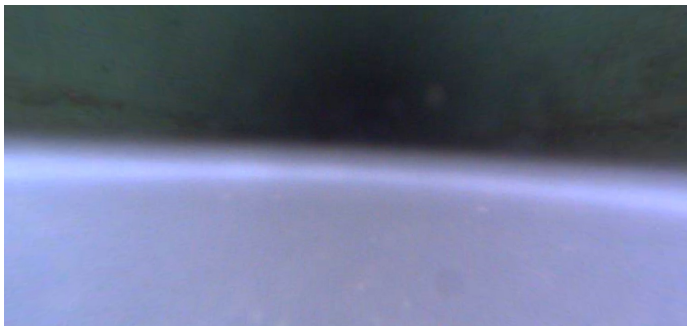
Code: **MWLS**
Description: **Water Level Sag**

Distance (ft): **6.8**
Structural Grade: **2**
O&M Grade: **3**
Clock Start/From:
Clock To:
1st Value:
2nd Value:
Value Percent: **10.000**
Continuous Index:
Within 8" of Joint: **NO**
Remarks:

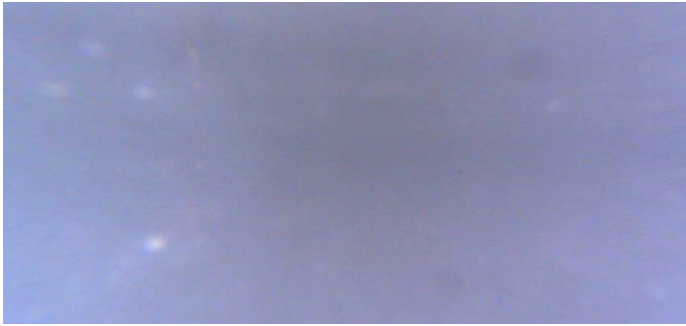
Code: **MWLS**
Description: **Water Level Sag**

Distance (ft): **19.3**
Structural Grade: **2**
O&M Grade: **3**
Clock Start/From:
Clock To:
1st Value:
2nd Value:
Value Percent: **20.000**
Continuous Index: **S02**
Within 8" of Joint: **NO**
Remarks:

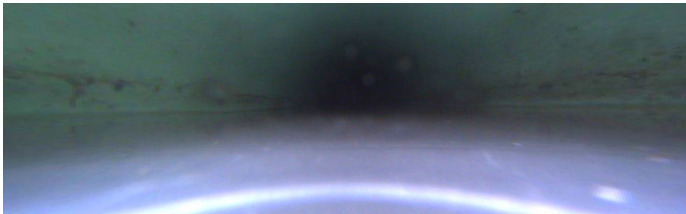
Code: **MWLS**
Description: **Water Level Sag**

Distance (ft): **34.1**
Structural Grade: **2**
O&M Grade: **3**
Clock Start/From:
Clock To:
1st Value:
2nd Value:
Value Percent: **20.000**
Continuous Index: **F02**
Within 8" of Joint: **NO**
Remarks:

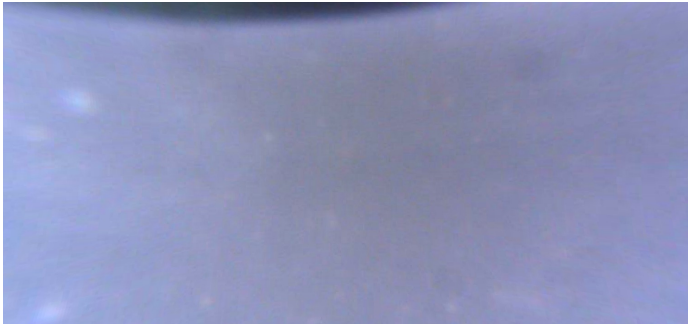
Code:	MSA
Description:	Abandoned Survey
Distance (ft):	48.4
Structural Grade:	0
O&M Grade:	0
Clock Start/From:	
Clock To:	
1st Value:	
2nd Value:	
Value Percent:	
Continuous Index:	
Within 8" of Joint:	NO
Remarks:	camera stopped
