Profile/Photo Observation Report

Date:	10/11/2018	Weather:		Coding:	PACP 6.0
Pipe Length (ft):	396.8	Owner:	NA	Pre Clean:	Not Known
P.O.#:		Surveyor:	Selasie Honu	PSR:	P-708-103-102
Customer:		Clean Date:	01/01/1900	Shape:	C

Street:	Bracken Pkwy.	Flow Control:	Not Controlled
City:	Hobart, IN	Year Renewed:	
Location:	Light Highway	Tape/Media #:	
Purpose:	Routine Assessment	Dia/Height:	12"
Use:	Sanitary	Material:	VCP
Drain Area:	NA	Lining:	
Category:	NA		
Comment:

Location Details:		Direction of Survey:	Upstream
US MH:	M-708-103	DS MH:	M-708-102
		Total Length Surveyed (ft):	48.4

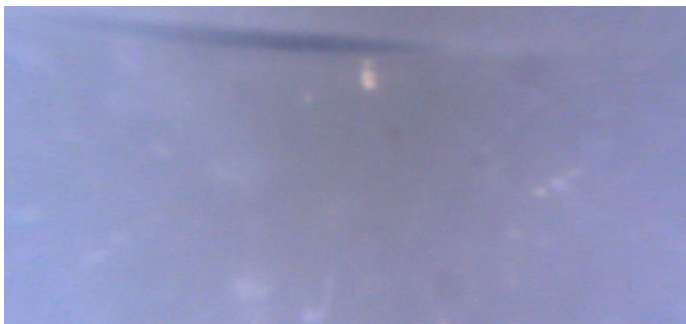
Code: **AMH**
Description: **Manhole**

Distance (ft): **.0**
Structural Grade: **0**
O&M Grade: **0**
Clock Start/From:
Clock To:
1st Value:
2nd Value:
Value Percent:
Continuous Index:
Within 8" of Joint: **NO**
Remarks: **M-708-102**

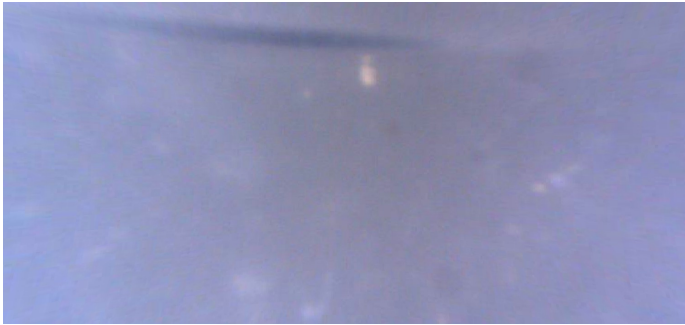
Code:	MWL
Description:	Water Level

Distance (ft):	.0
Structural Grade:	0
O&M Grade:	0
Clock Start/From:	
Clock To:	
1st Value:	
2nd Value:	
Value Percent:	5.000
Continuous Index:	
Within 8" of Joint:	NO
Remarks:

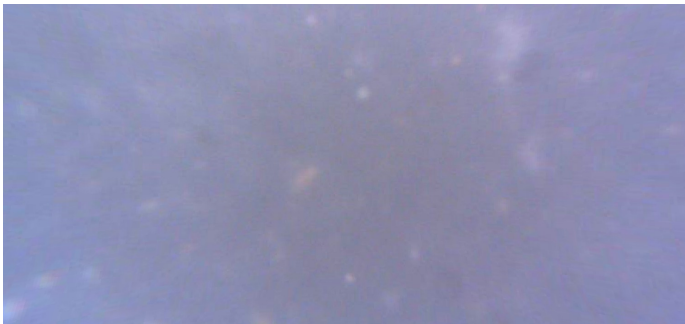
Code:	MWLS
Description:	Water Level Sag

Distance (ft):	.0
Structural Grade:	2
O&M Grade:	3
Clock Start/From:	
Clock To:	
1st Value:	
2nd Value:	
Value Percent:	10.000
Continuous Index:	S01
Within 8" of Joint:	NO
Remarks:

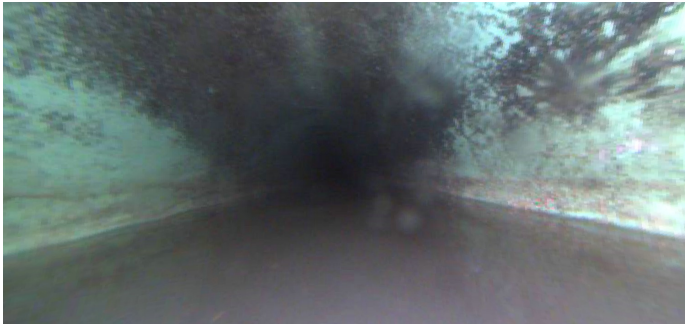
Code: **MWLS**
Description: **Water Level Sag**

Distance (ft): **3.6**
Structural Grade: **2**
O&M Grade: **3**
Clock Start/From:
Clock To:
1st Value:
2nd Value:
Value Percent: **10.000**
Continuous Index: **F01**
Within 8" of Joint: **NO**
Remarks:

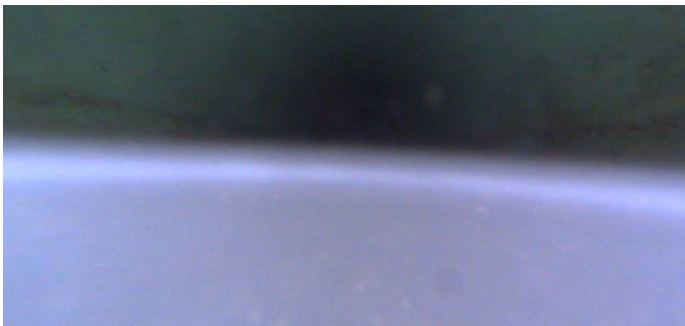
Code: **MWLS**
Description: **Water Level Sag**

Distance (ft): **6.8**
Structural Grade: **2**
O&M Grade: **3**
Clock Start/From:
Clock To:
1st Value:
2nd Value:
Value Percent: **10.000**
Continuous Index:
Within 8" of Joint: **NO**
Remarks:

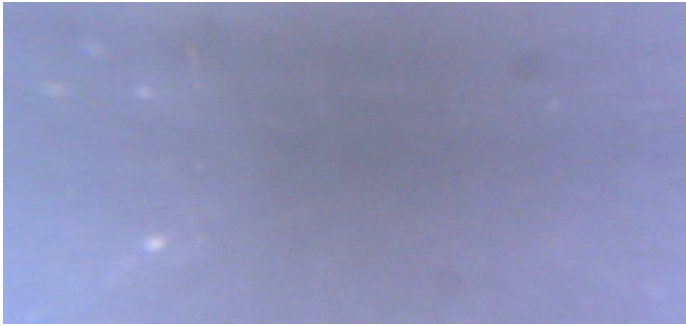
Code: **MWLS**
Description: **Water Level Sag**

Distance (ft): **19.3**
Structural Grade: **2**
O&M Grade: **3**
Clock Start/From:
Clock To:
1st Value:
2nd Value:
Value Percent: **20.000**
Continuous Index: **S02**
Within 8" of Joint: **NO**
Remarks:

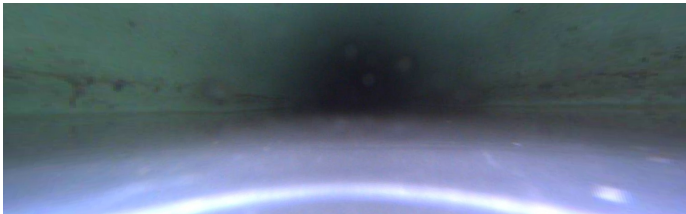
Code: **MWLS**
Description: **Water Level Sag**

Distance (ft): **34.1**
Structural Grade: **2**
O&M Grade: **3**
Clock Start/From:
Clock To:
1st Value:
2nd Value:
Value Percent: **20.000**
Continuous Index: **F02**
Within 8" of Joint: **NO**
Remarks:

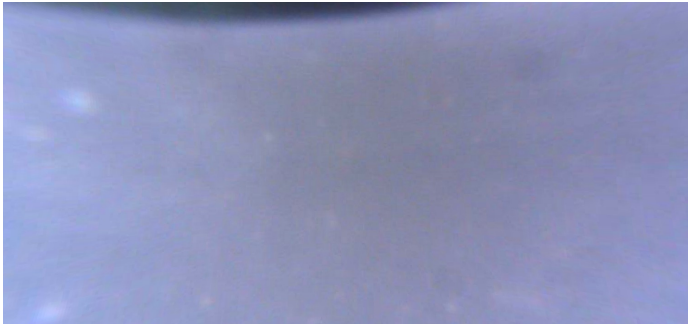
Code:	MSA
Description:	Abandoned Survey
Distance (ft):	48.4
Structural Grade:	0
O&M Grade:	0
Clock Start/From:	
Clock To:	
1st Value:	
2nd Value:	
Value Percent:	
Continuous Index:	
Within 8" of Joint:	NO
Remarks:	camera stopped
